**Final Dam Inspection Report**

**Neustadt Dam and  
Flood Control Wall**

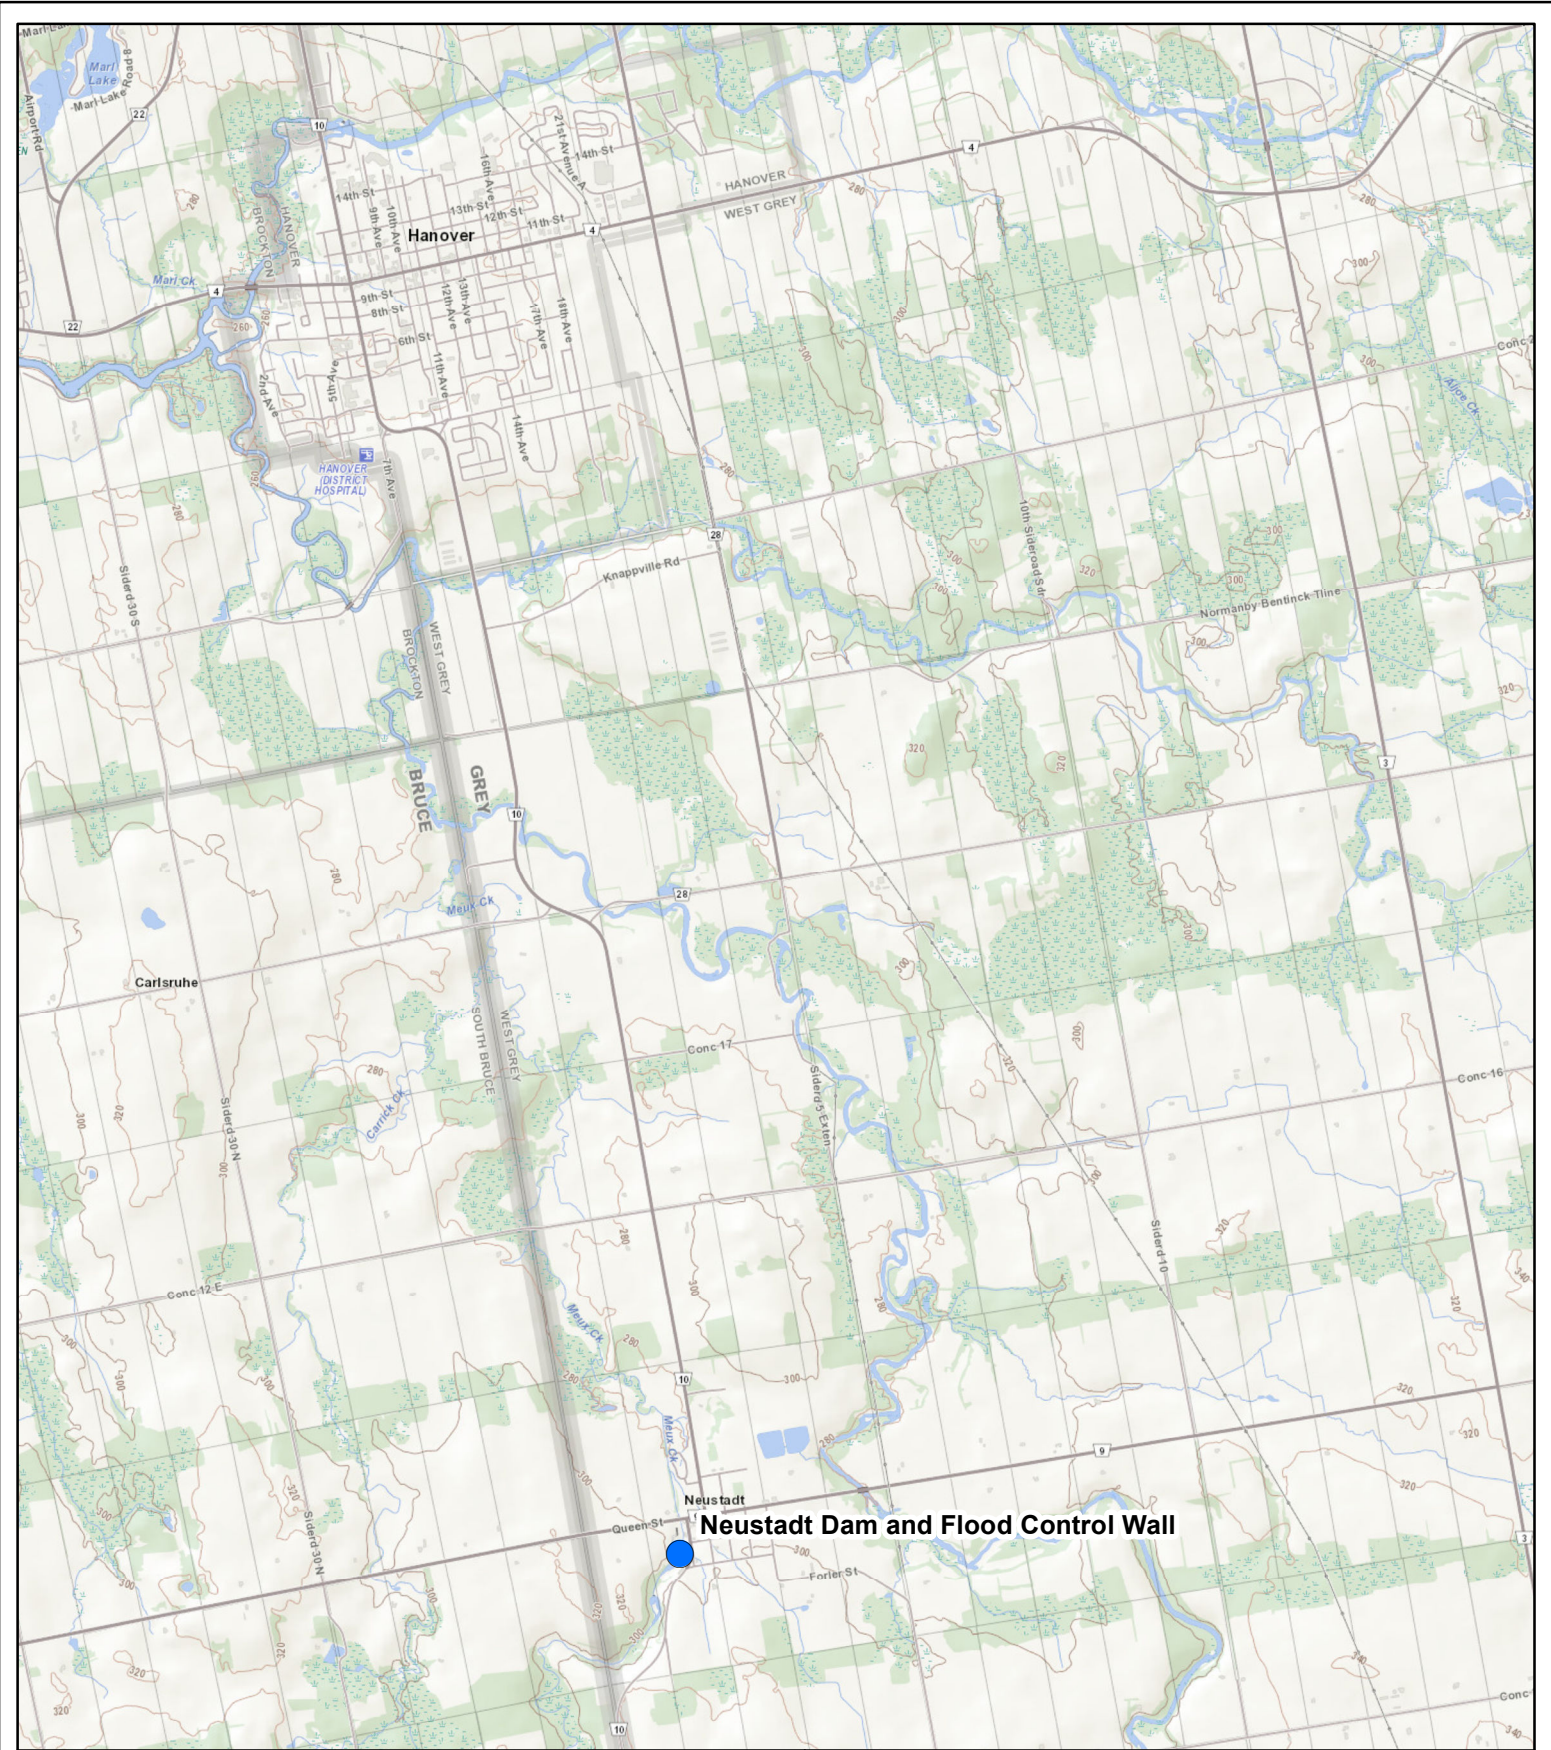
It is noted that the dam is owned by the Municipality of West Grey and the SVCA has been involved with past rehabilitation, operation, and annual inspections of the dam on their behalf.

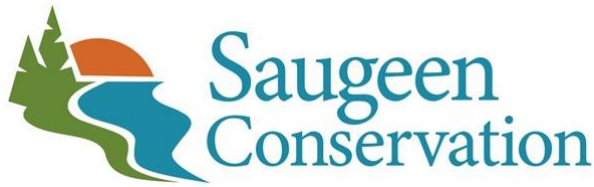
adjacent to the weir wall is in very poor condition. The concrete is disintegrating, exposing large aggregates. The concrete acting as diaphragms infilling the girders is severely cracked and displaced with large sections missing. In several cases the girders are not bearing on any concrete because the concrete is missing.

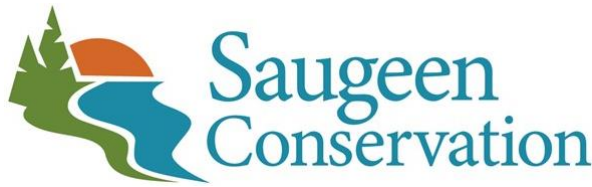
abrasions. Several post bases have minor spalling with them that has been repaired with a caulking product.
