Structure Name:	Concession 4 NDR Lot 30 Culvert	Site Number:	B-105
District:		Road Name:	Concession 4
County:	Grey County	Owner:	West Grey
Township:	West Grey	Skew:	0
Bridge or Culvert:	Culvert	AADT:	250
Structure Type:	CSP (arch)	Overall Struct. Width:	25 m
Number of Spans:	2	Roadway Width:	6.6 m
Direction of Structure:	North-South	Total Deck Length:	7.4 m
GPS Coordinates (Degrees)		Span (s):	5.4 m
General	Latitude: 44.211104	Total Deck Area:	185 sq.m
	Longitude: -80.895677	Current Load Limit:	0

Inspection Data

Date of Inspection:	10-Jun-24
Name of Inspector:	A. Burgess P.Eng. & J. Ziegler CET
Equipment Used:	Sounding hammer, measuring equipment, GPS
Weather Conditions:	Cloudy
Temperature:	12
Special Notes:	Culvert is in good condition, recommend railing system repair.

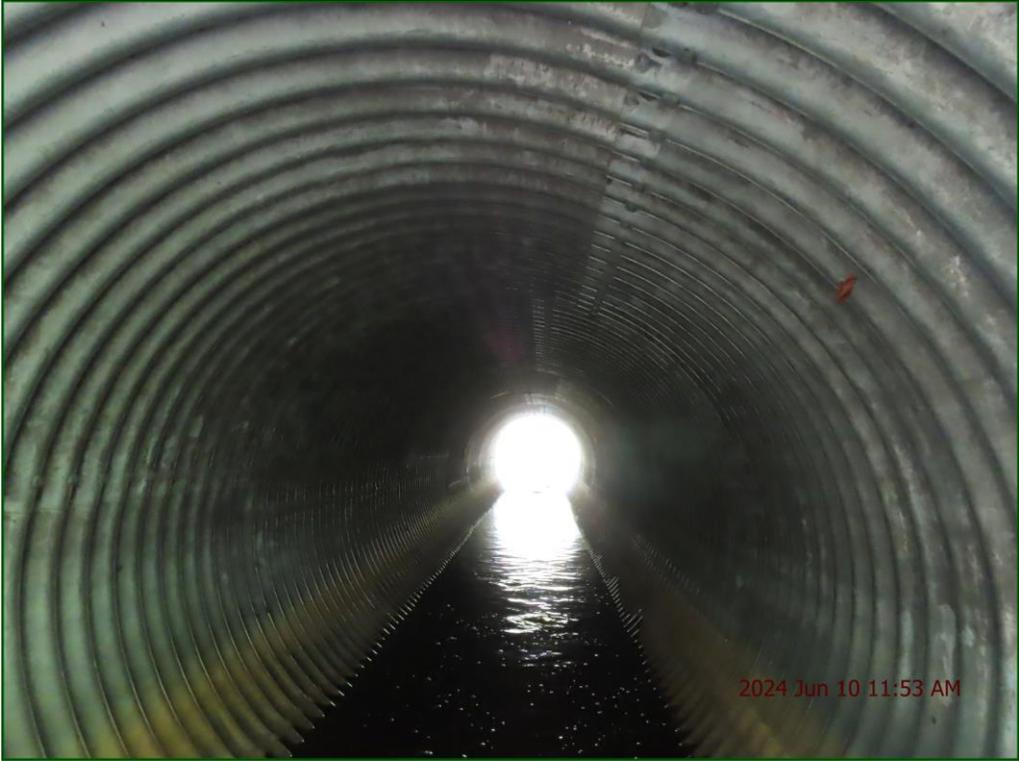
Description: East Barrel: View from south.

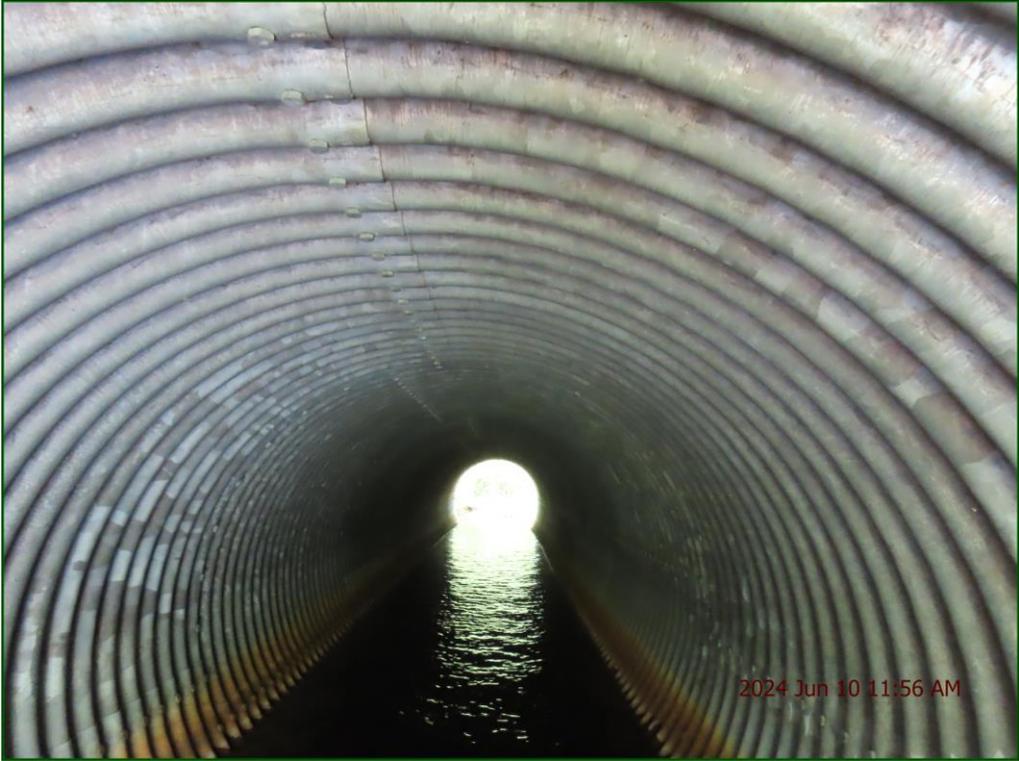
Description: West Barrel: View from north.

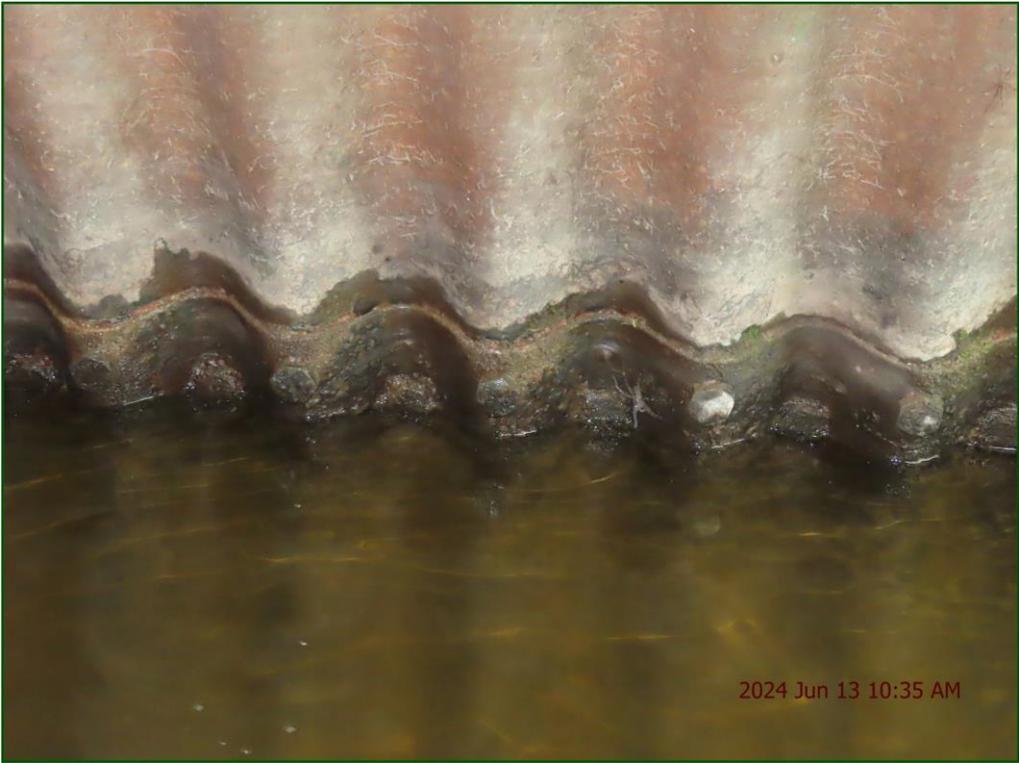
Description: Barrel: Improper splice bolt pattern, no cracking noted.

Improper splice bolt pattern, no cracking noted. Light corrosion along waterline. Moderate deformation mid barrel.

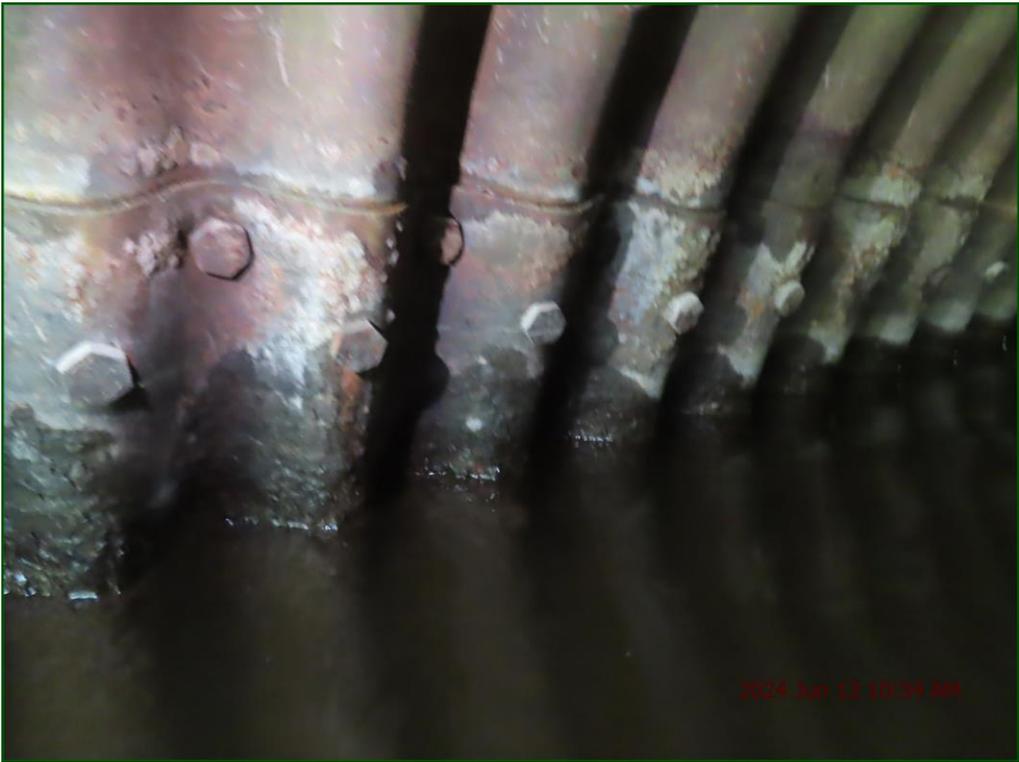
Description: Barrel: Light corrosion along waterline.

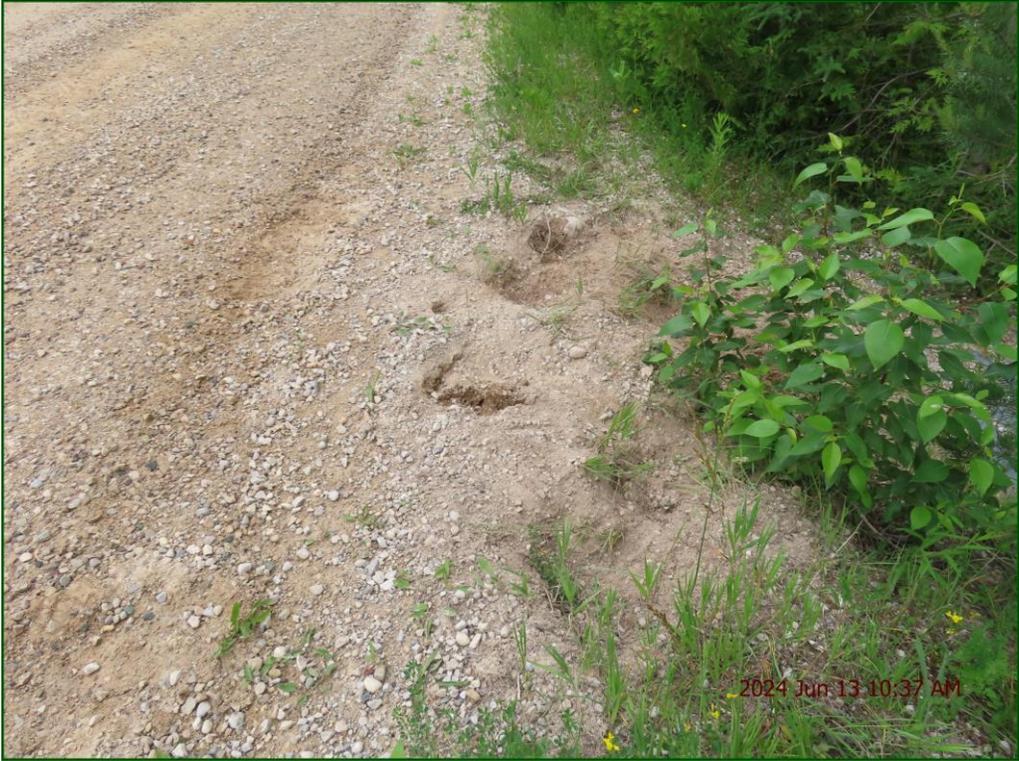
Description: Wearing surface: Moderate erosion at edges.

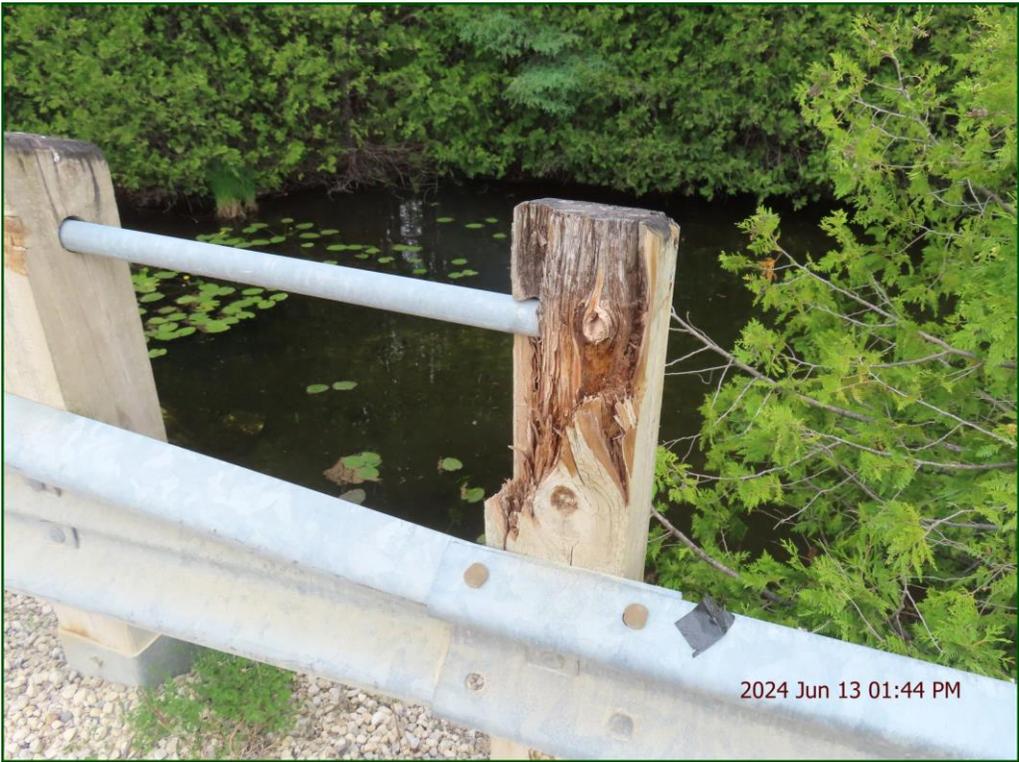
Description: Hand Railings: Minor localized damage.

Minor localized damage.

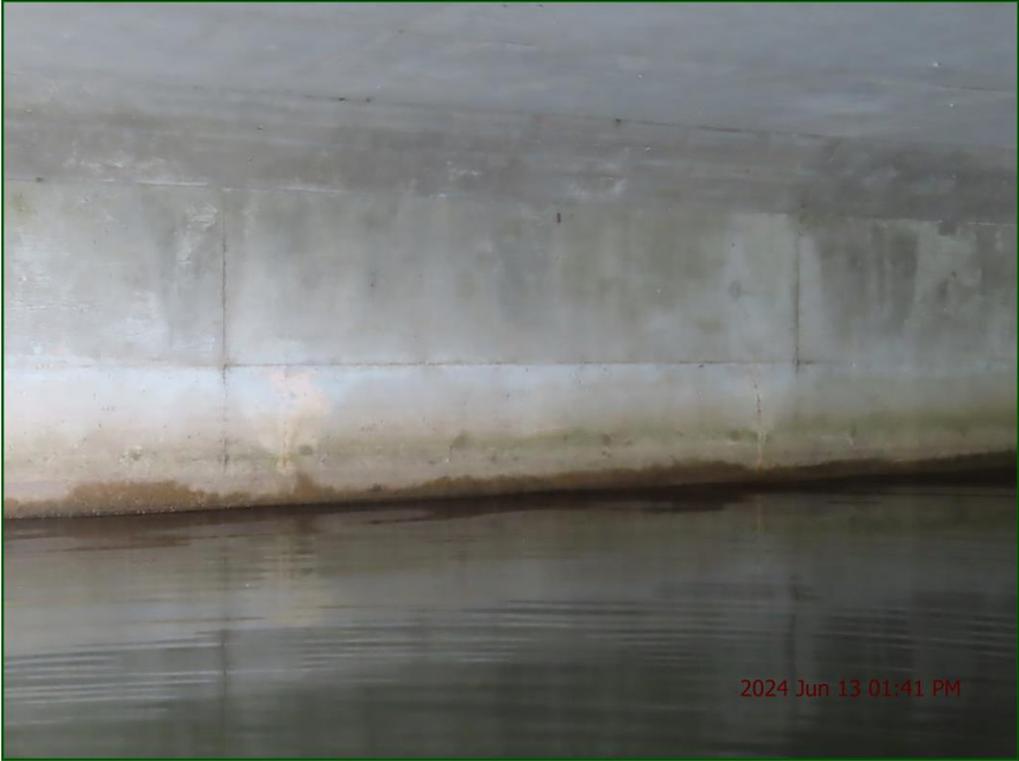
Description: Barrel: Medium vertical crack with wetness staining.

Medium vertical crack with wetness staining.

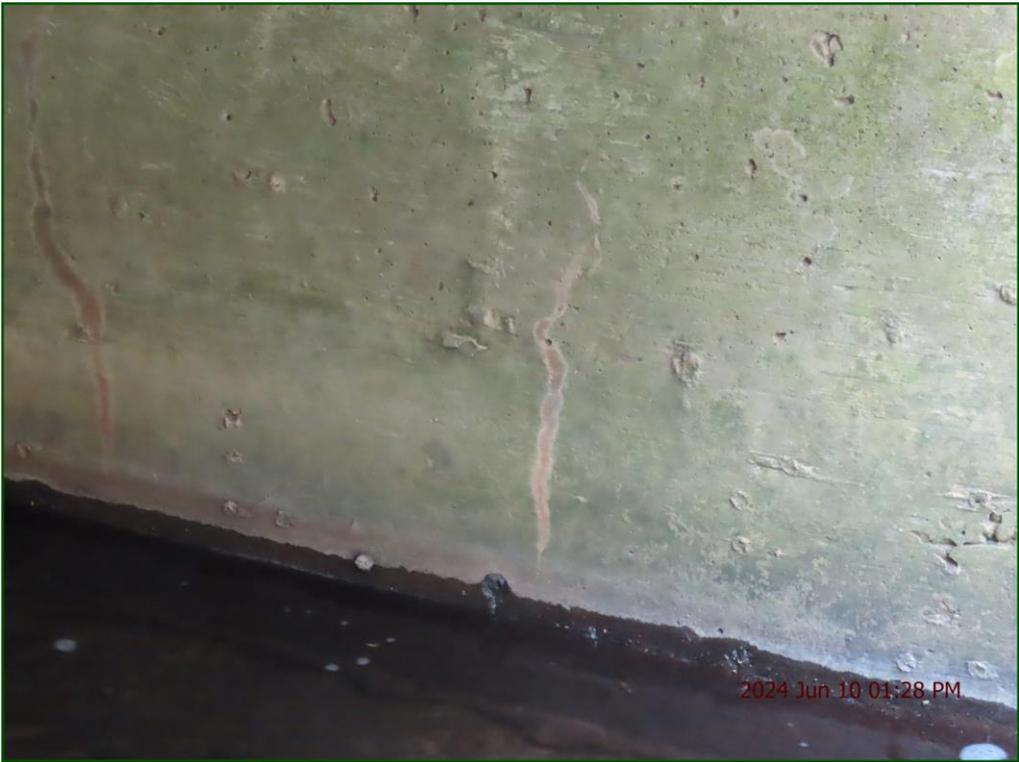
Description: Barrel: Light vertical cracks with wetness and leachate staining.

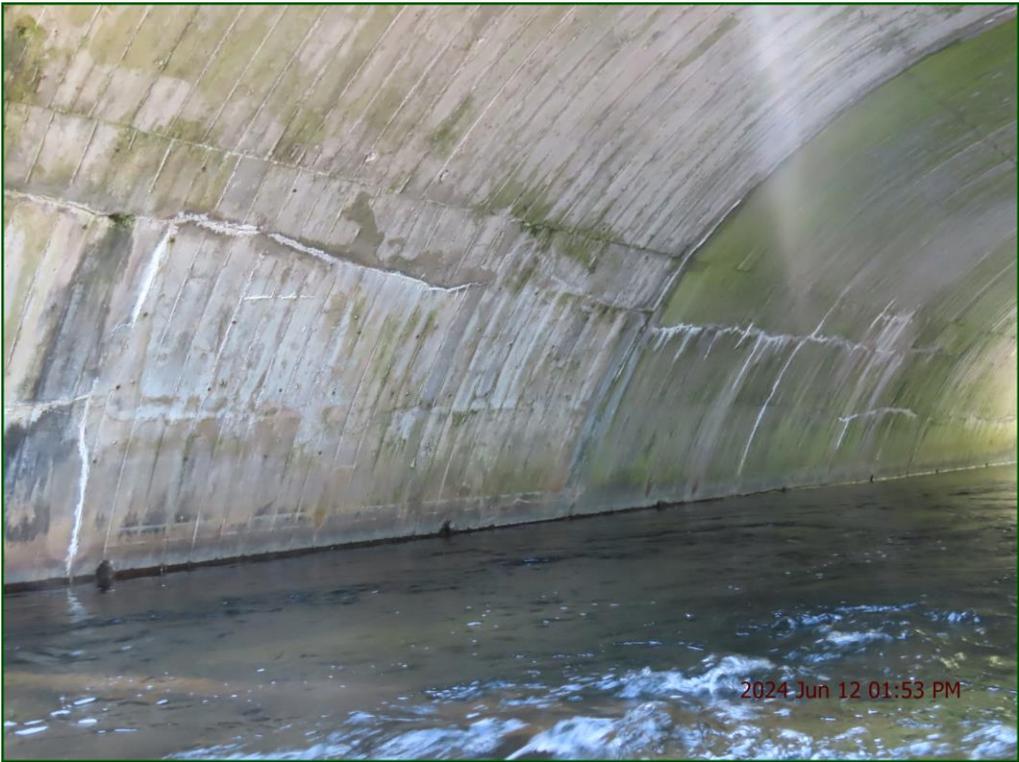
Description: Barrel: Medium to wide transverse cracks with leachate staining (1/2).

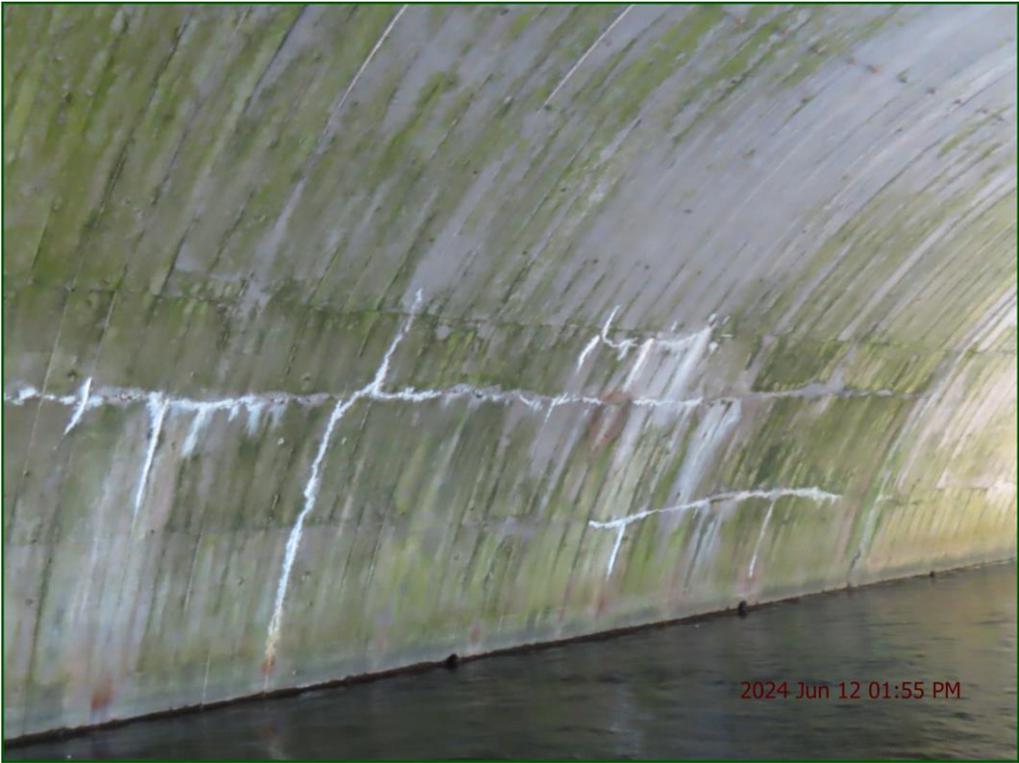
Description: Barrel: Medium to wide transverse cracks with leachate staining (2/2).

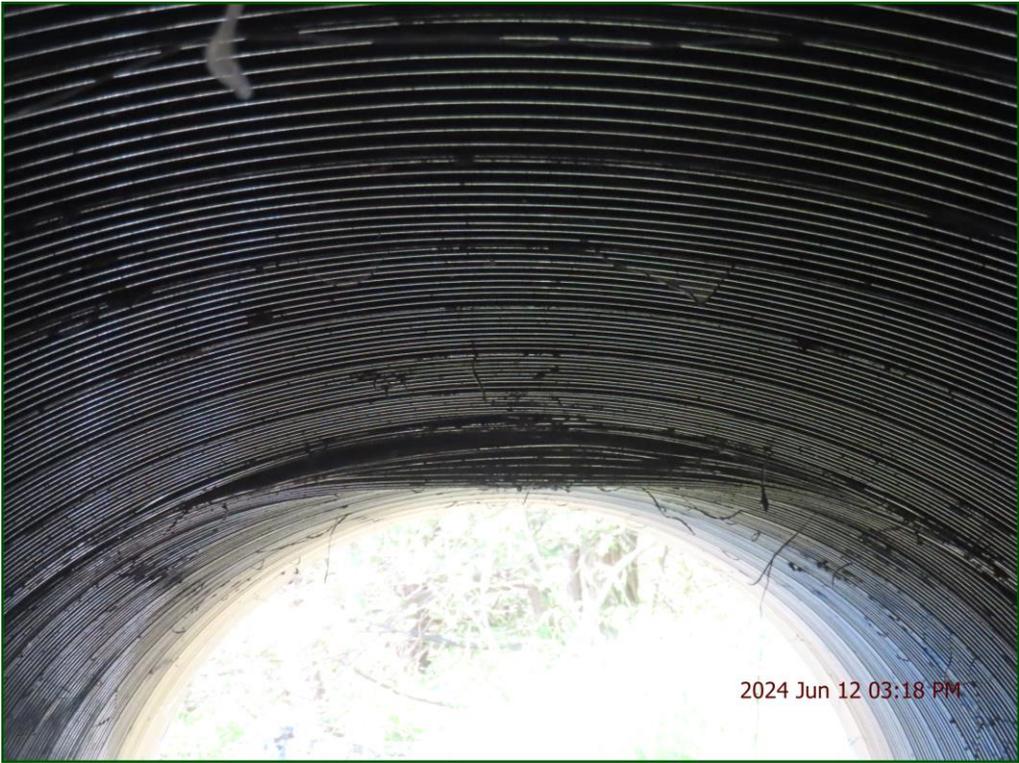
Description: Barrel: Moderate deformation at midspan in east barrel.

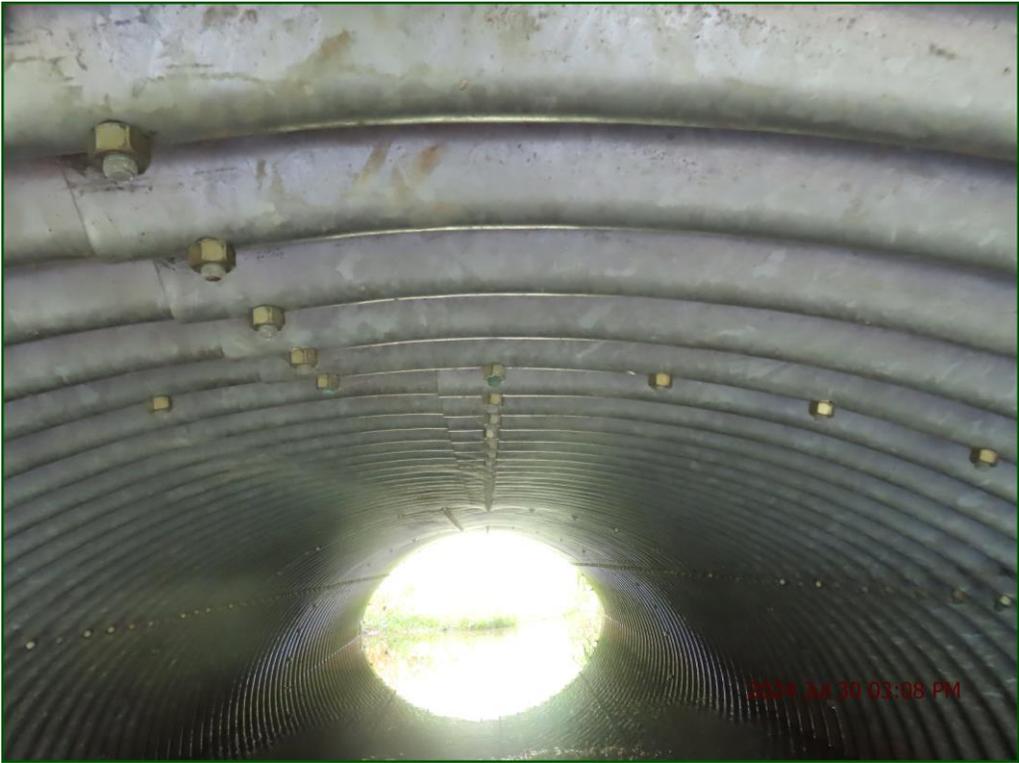
Description: Barrel: Minor deformations throughout.

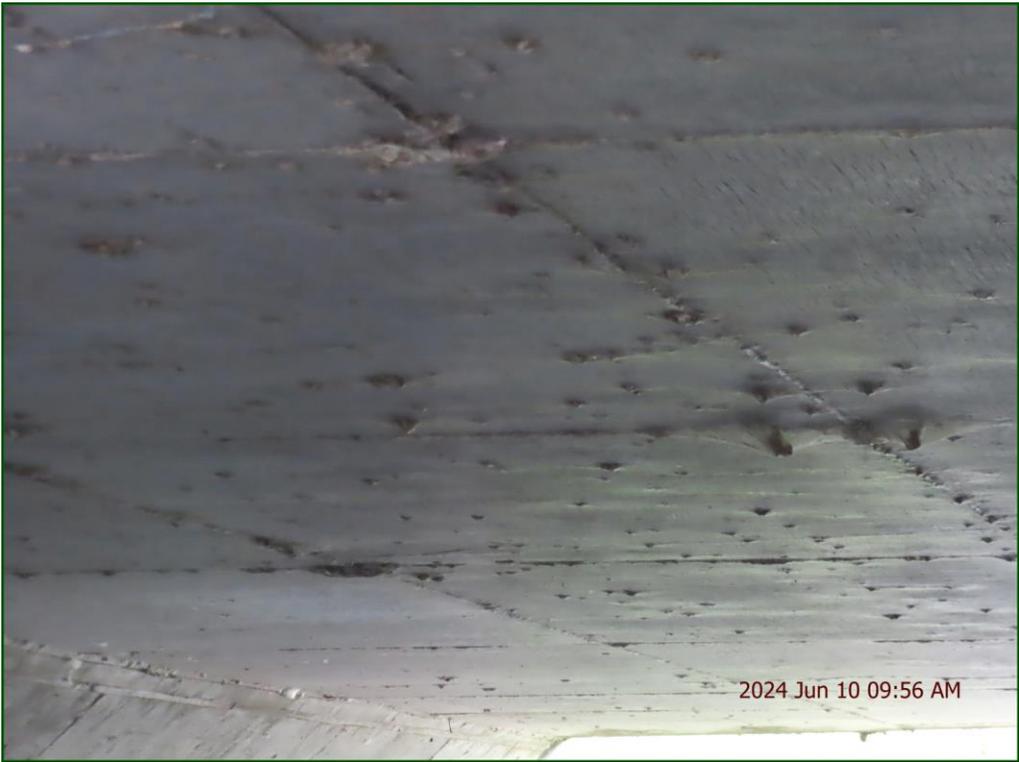
Description: Barrel: Medium longitudinal crack with leachate staining and stalactite (1/2).

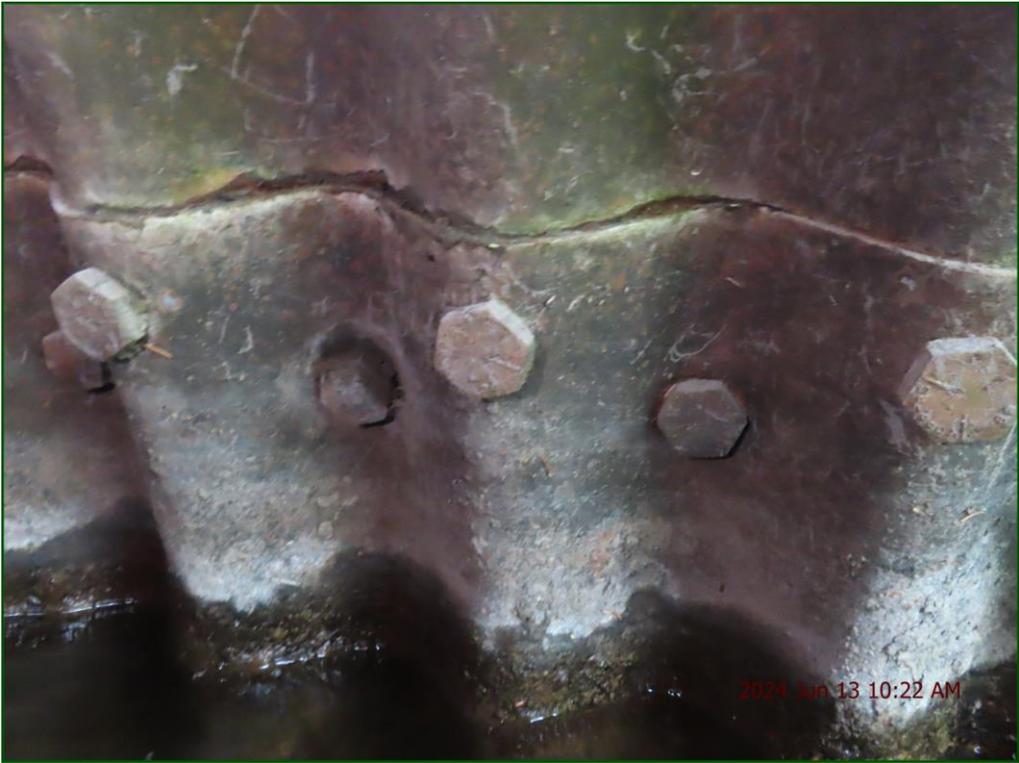
Description: Barrel: Improper splice bolt pattern, no cracking noted.

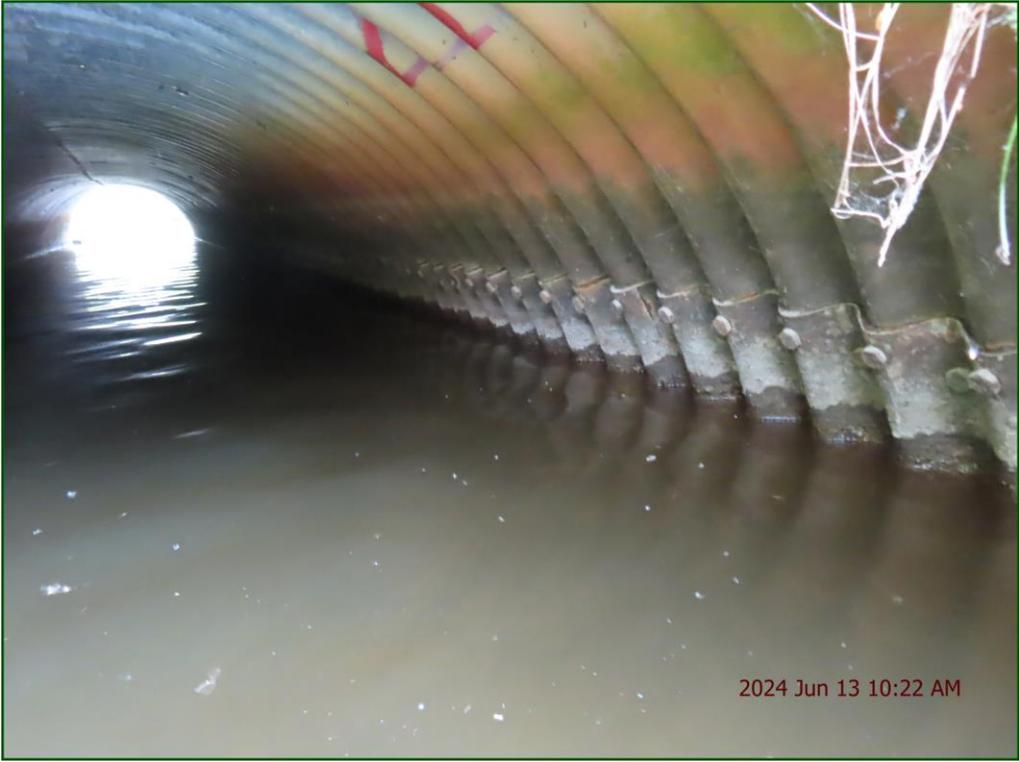
Description: Barrel: Light corrosion at waterline.

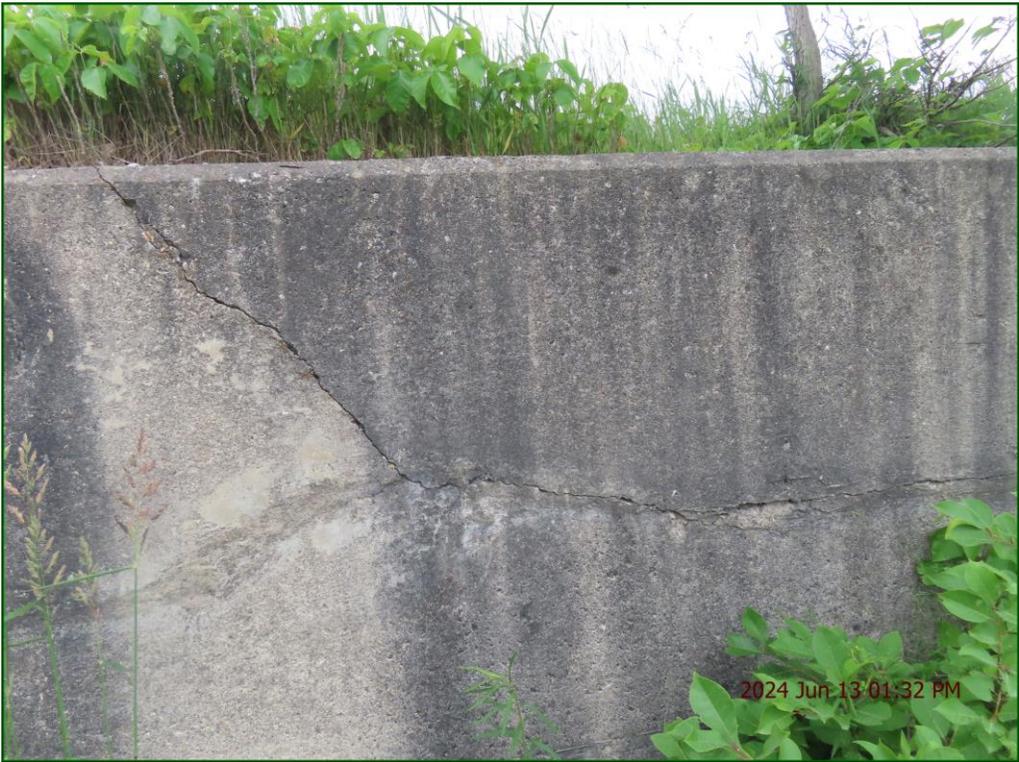
Description: Outlet: Medium to wide crack.

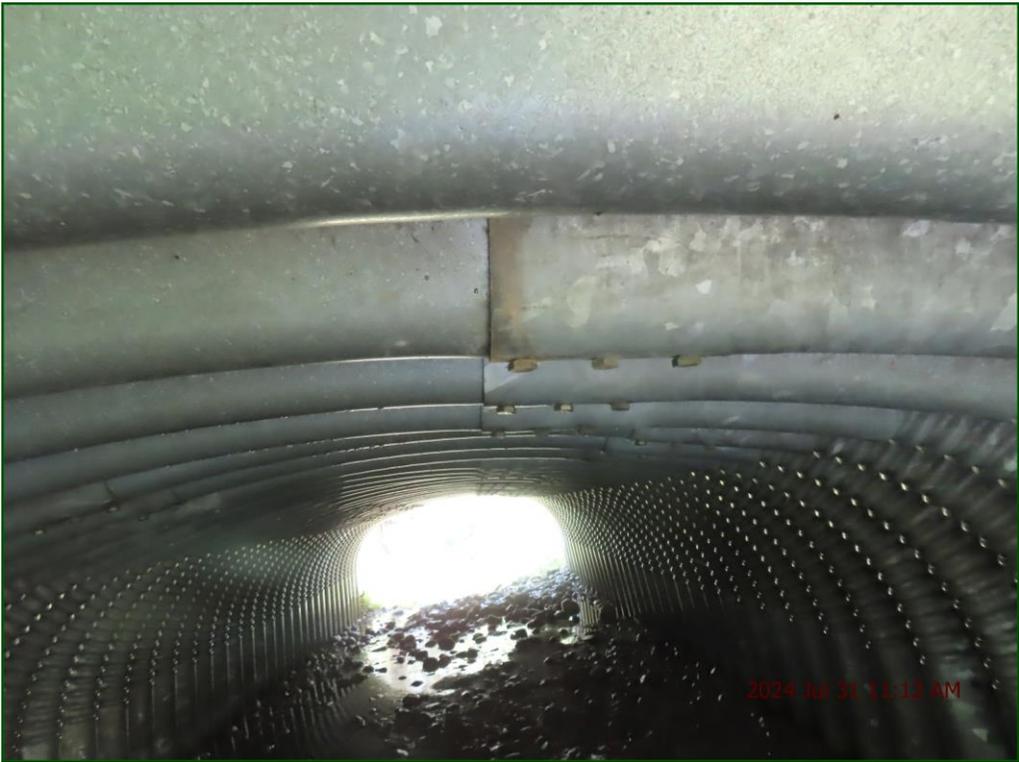
Description: Barrel: Minor deformations in barrel.

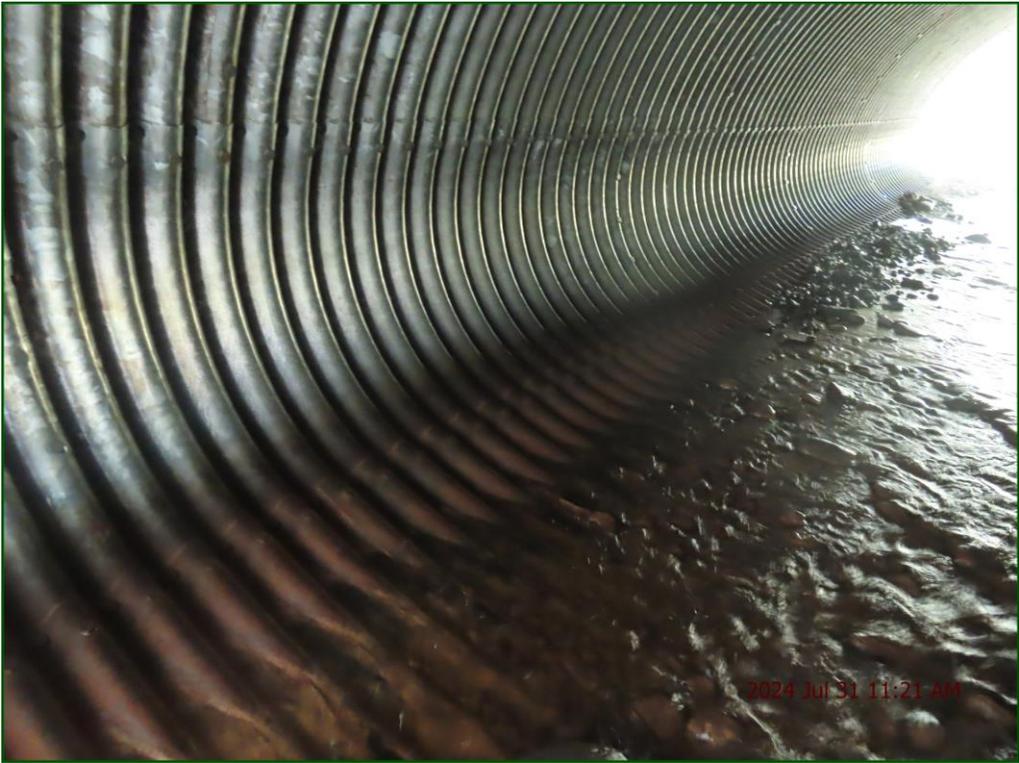
Description: Barrel: Light corrosion along waterline.

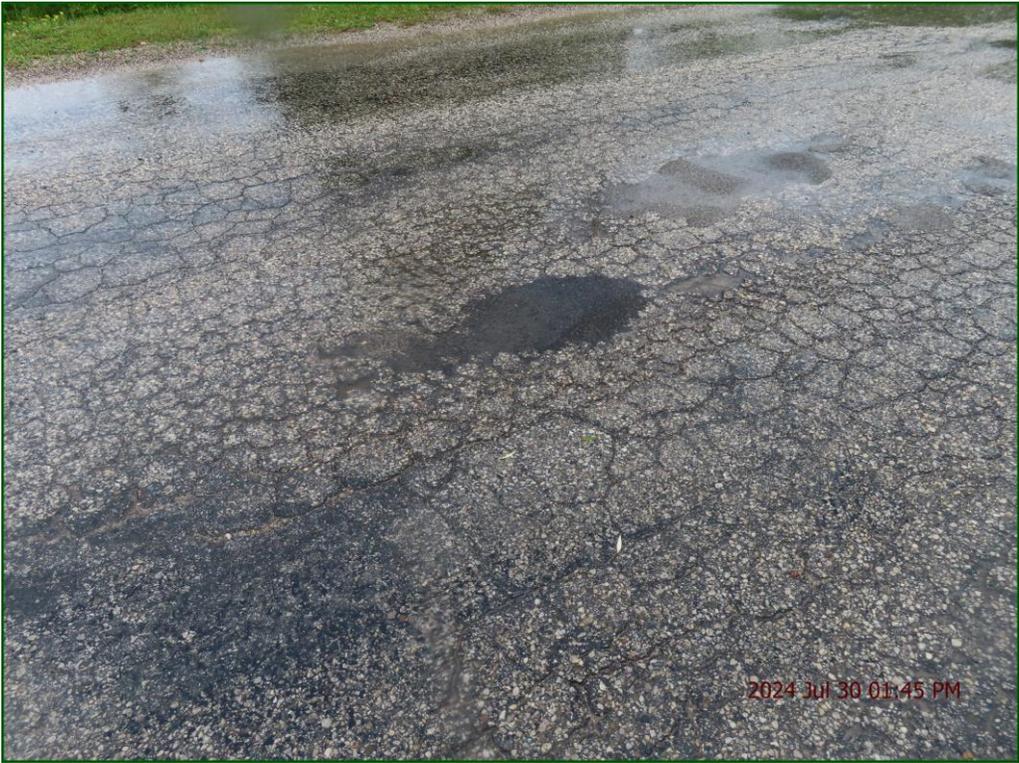
Description: Wearing surface: Severe alligator cracking throughout.

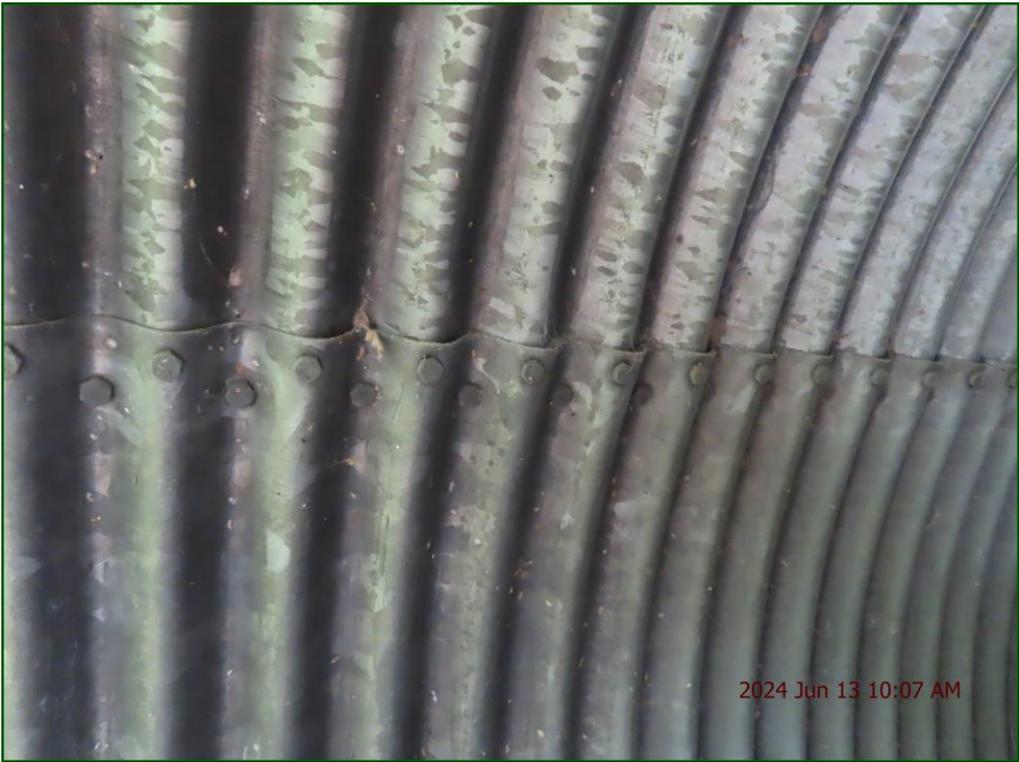
Description: Barrel: Improper splice bolt pattern, no cracking noted.

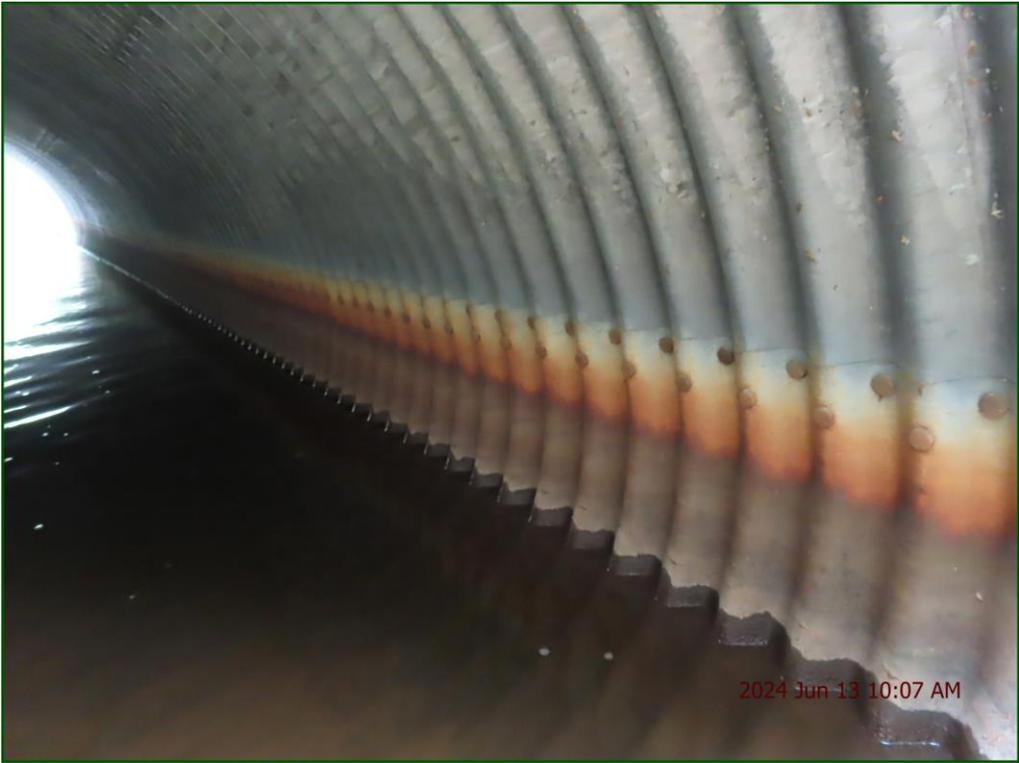
Description: Barrel: Light to medium rust along waterline.

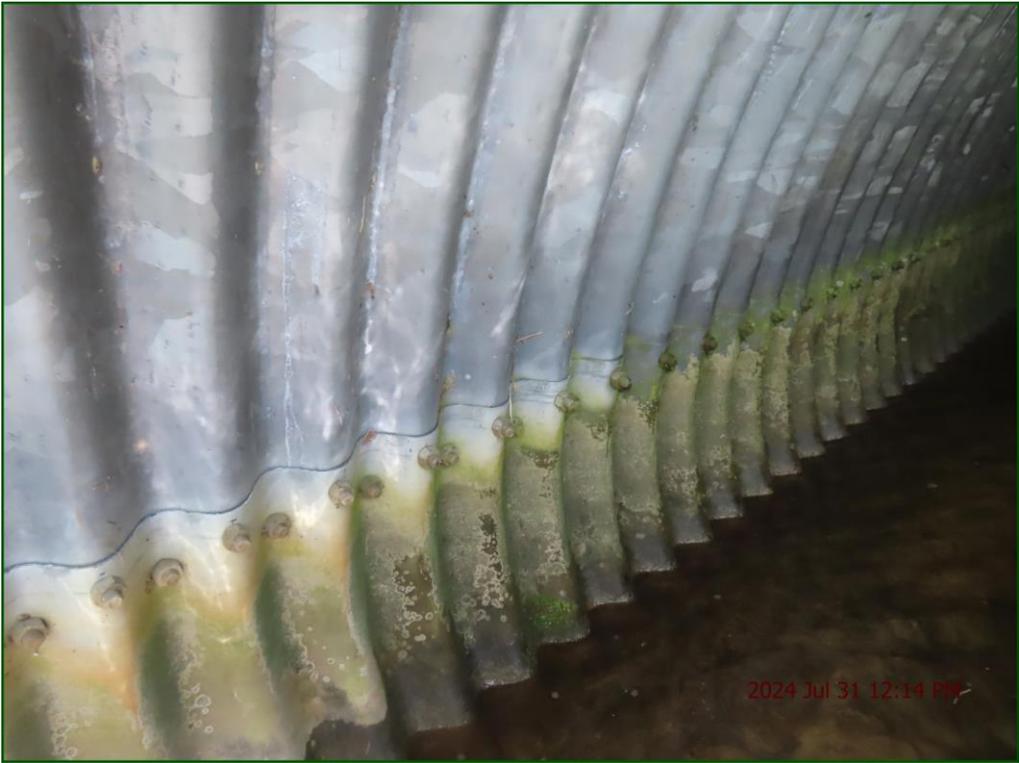
Description: Barrel: Improper splice bolt pattern, no signs of cracking.

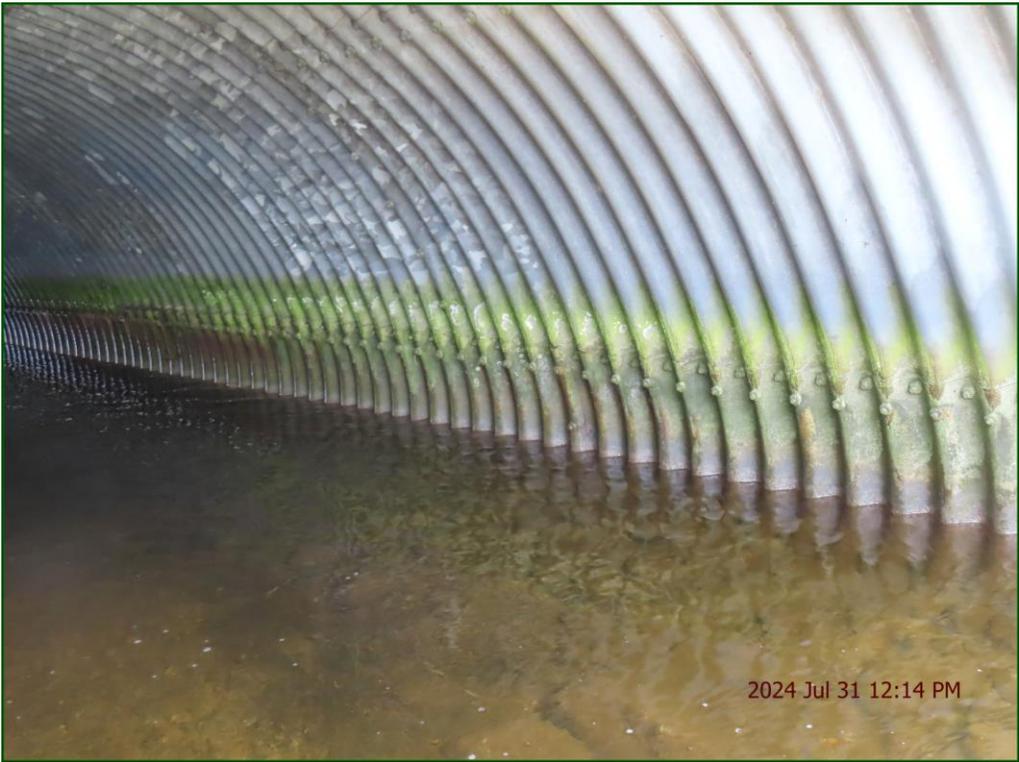
Description: Barrel: Light corrosion along waterline.

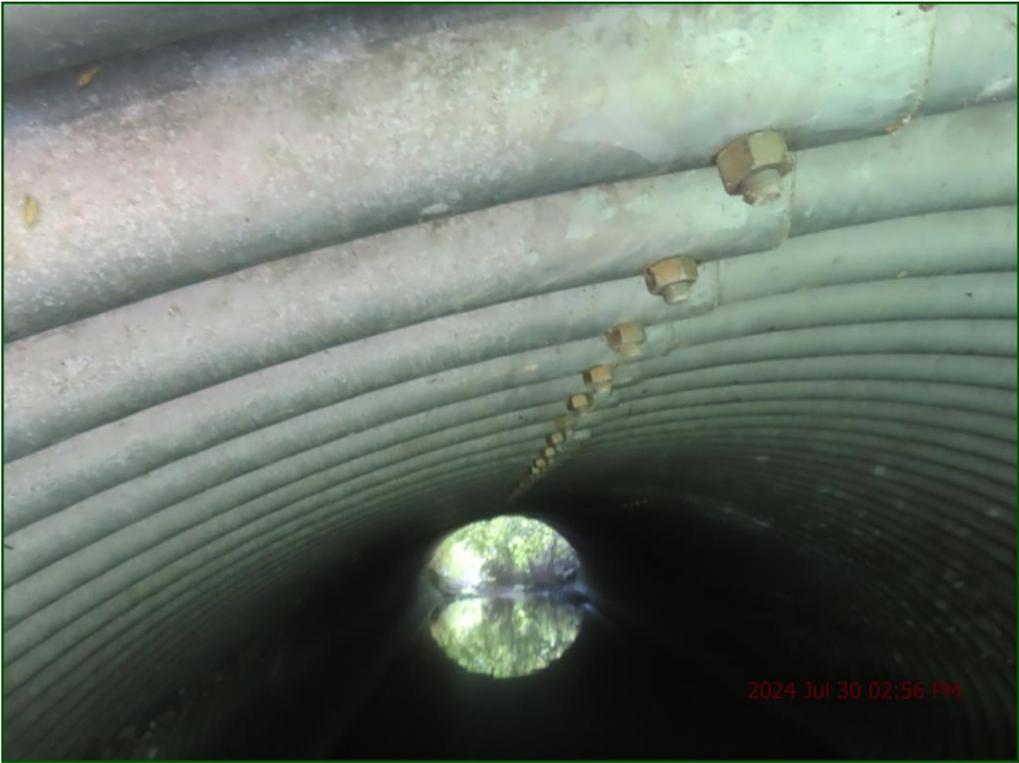
Description: Barrel: Minor deformations.

Minor deformations.

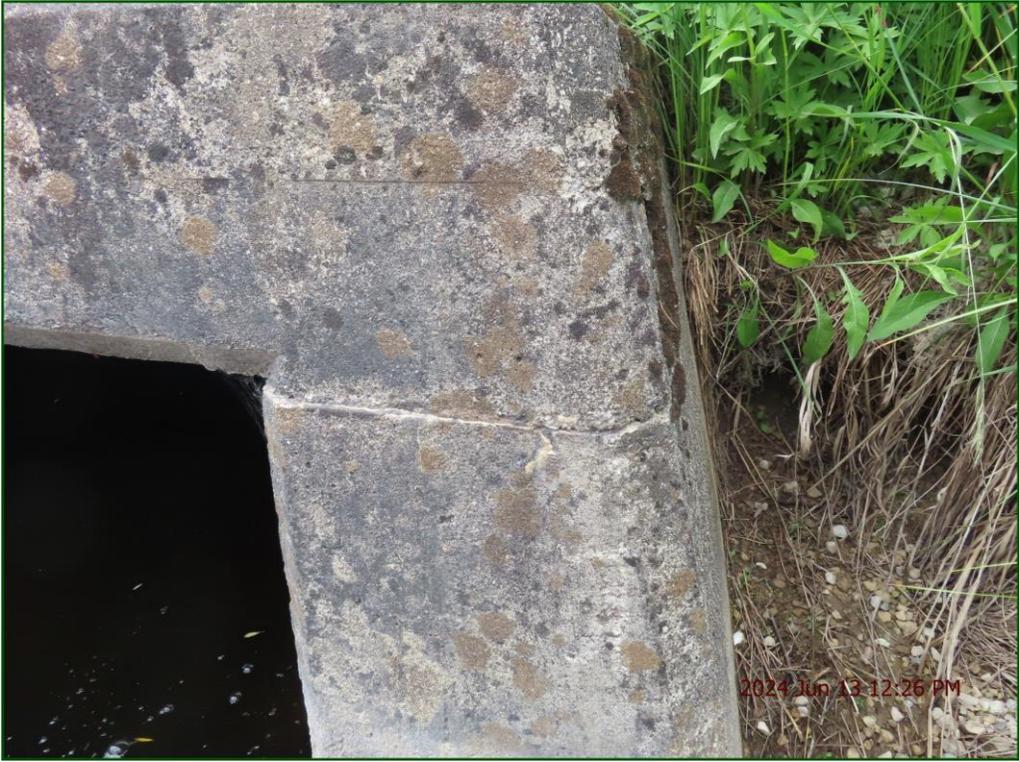
Description: Inlet: Medium cracking at construction joints, possible sign of inward rotation.

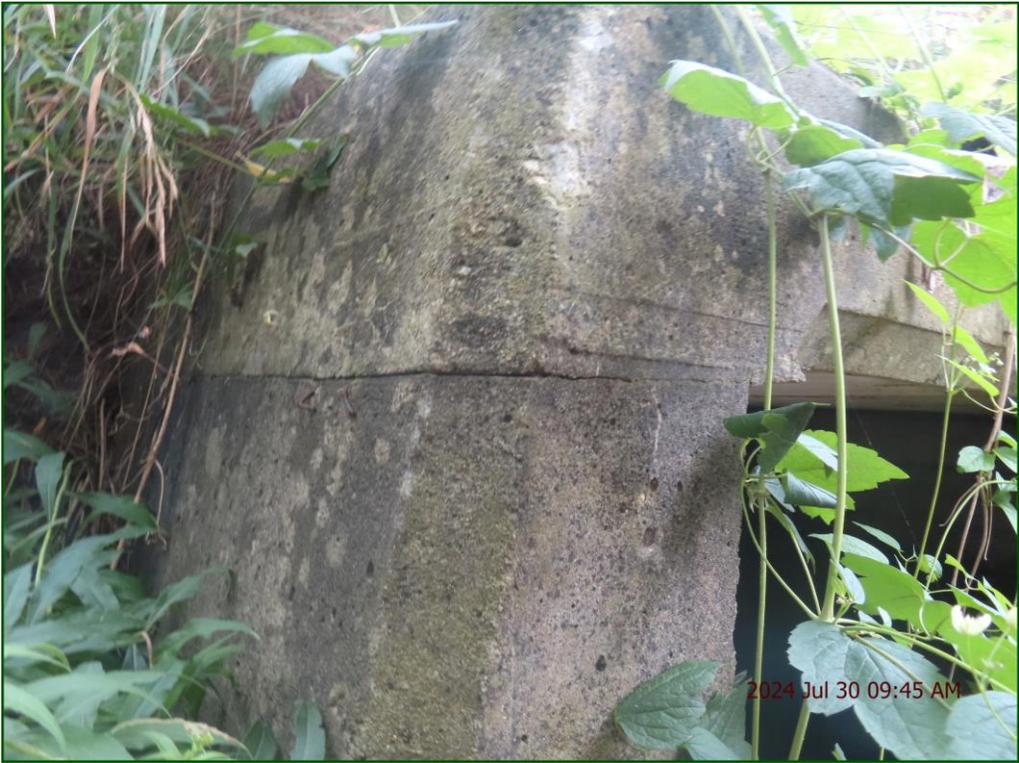
Description: Inlet: Minor separation on outside of construction joint, possible sign of slight wall rotation.

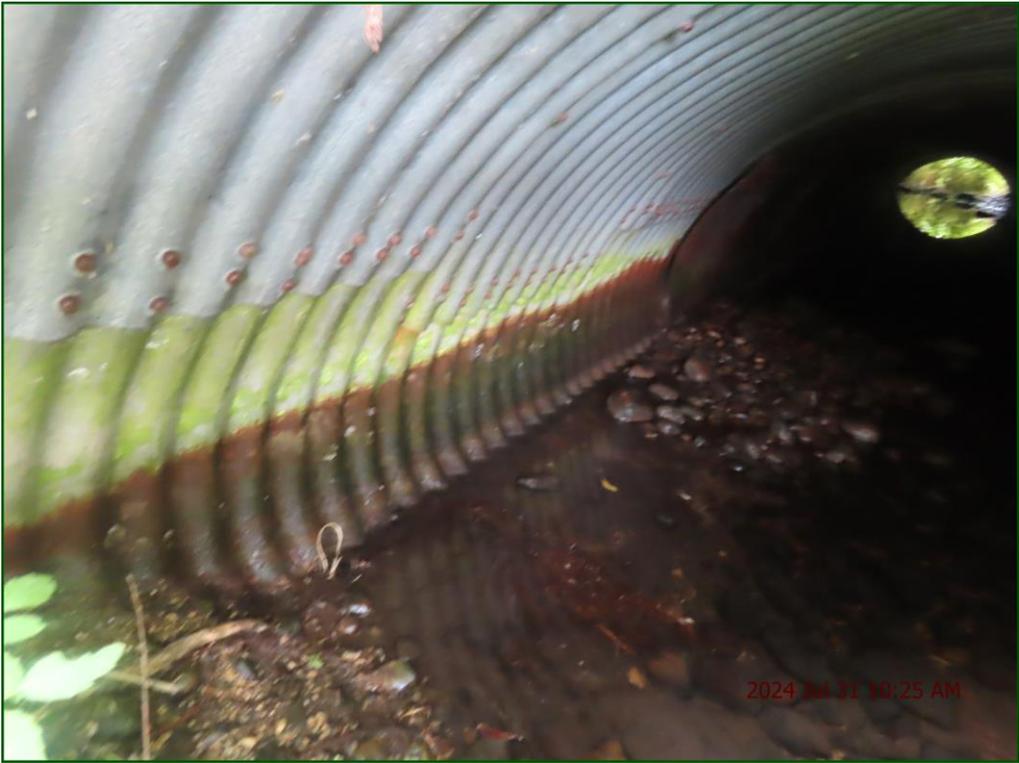
Description: Barrel: Light to medium corrosion in base region.

Only middle barrel functioning properly as other two barrels are filled with sediment. Light to medium corrosion in base region.

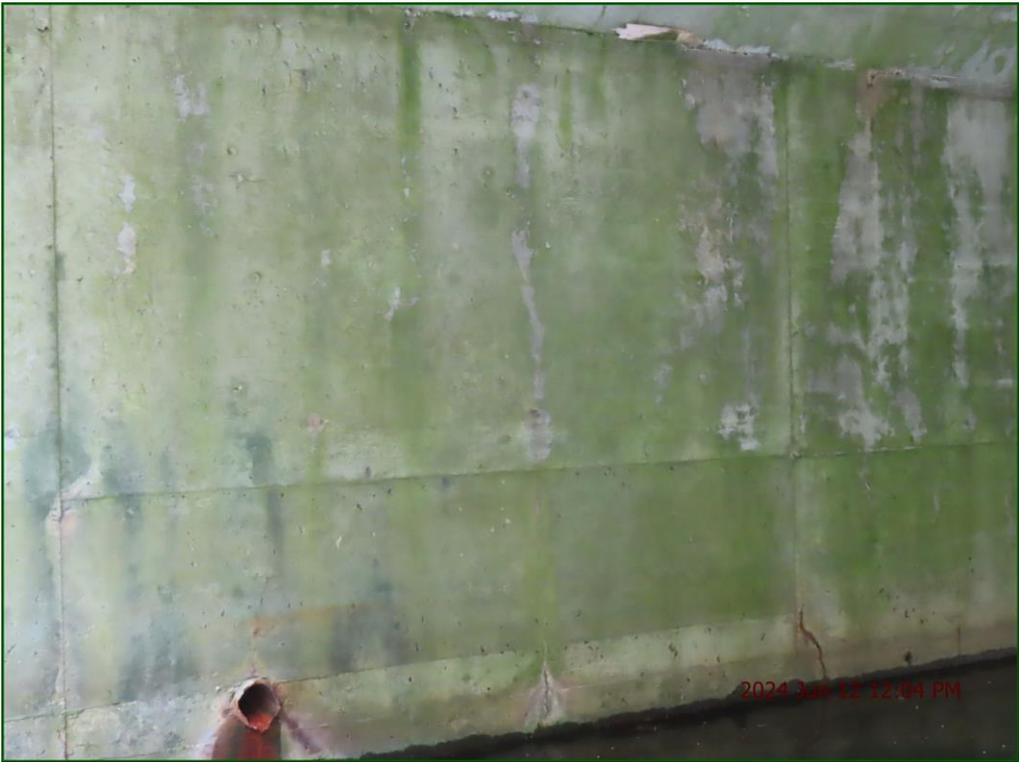
Description: Barrel: Light to medium vertical cracks with leachate staining.

Light to medium vertical cracks with leachate staining.

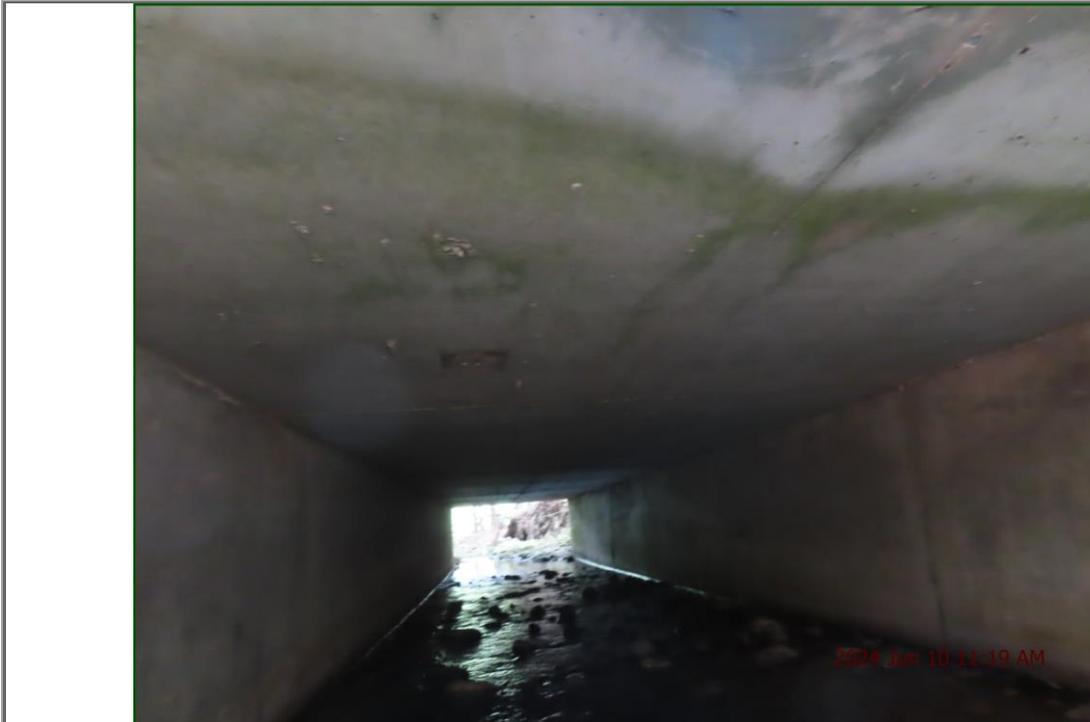
Shallow spalling with exposed reinforcing.
