Final Inspection Report

**Neustadt Flood Control Works
Neustadt Creek**

**Municipality of West Grey,
County of Grey, Ontario**

D.M. Wills Project Number 22-5540

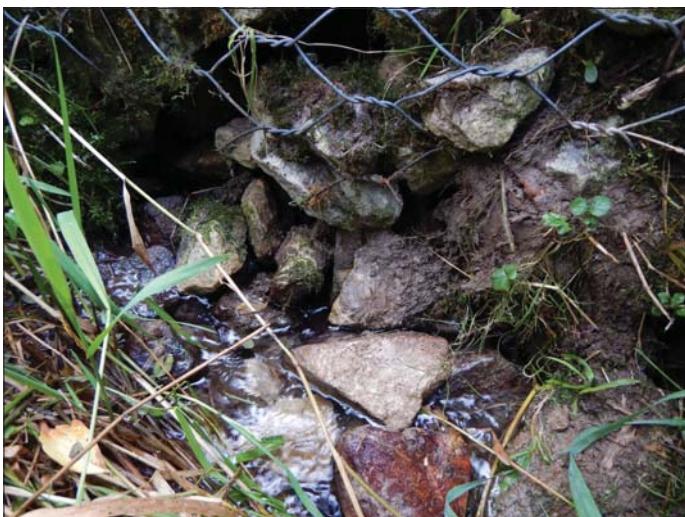
Structure	Location	Deficiency / Description	Condition Rating	Risk Rating
Earth Retaining Structures				
Gabion Baskets	Throughout	Base of many baskets are broken due to corrosion, minimal ballast escaping (Photos: 5, 15, 38, 42)	3	2
Flow Conveyance Systems and Structures				
Box Culvert	William Street	Localized light cracking with efflorescence and medium cracking. Graffiti was noted within the culvert. Grates are missing (Photos: 8, 10, 12, 13)	4	2
CSP Culvert	Adam/Stephana Street	Some point deformations in the barrel, corrosion at and below the waterline and some localized perforations in the bottom of the barrel (Photos: 25-26, 27)	3	2
Upstream Headwall	Adam Street	Grate is open (Photo: 24)	4	1
Downstream Headwall	Stephana Street	Grate is open. Light scaling and moss growth on the energy dissipation blocks. (Photo: 31)	4	1
Concrete Box Culvert	Queen Street	Severe delamination in the soffit. No grate on upstream headwall (Photos: 43, 45)	3	2

Photo 5 - September 20, 2022
Neustadt Flood Control Works - Neustadt Creek
Typical Gabion Baskets

7. Clear sediment and vegetation from in the channel to ensure that is has the hydraulic capacity required to convey the design flood flows. At the same time, undertake repairs to the bottom row of gabion baskets and remove trees and woody debris from near the top of the gabion basket walls.	There is vegetation growth and sediment accumulation within the flood control channel. This has the potential to affect the hydraulic capacity of the system, reducing the flood protection it is intended to provide.	Medium	\$70,000	It is assumed that the SVCA would retain a contractor to carryout this work. Permitting from the DFO and SVCA may be required.

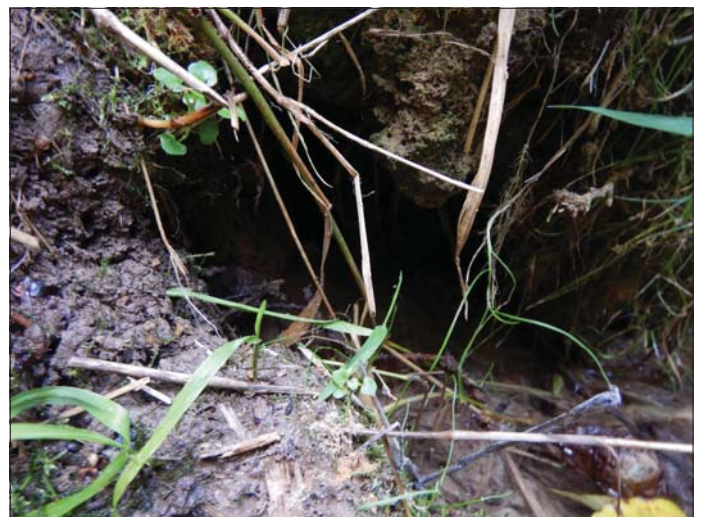
Photo 6 - September 20, 2022
Neustadt Flood Control Works - Neustadt Creek
Erosion at Base of Gabion Baskets

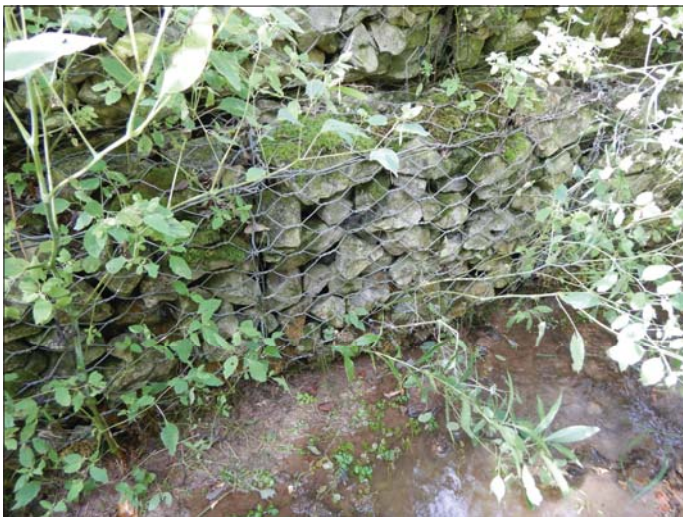
Photo 15 - September 20, 2022
Neustadt Flood Control Works - Neustadt Creek
Typical Base of Gabion Basket

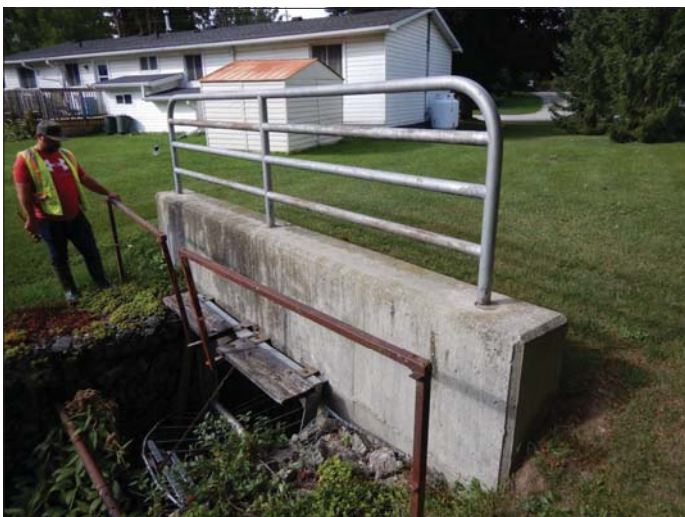
Structure	Location	Deficiency / Description	Condition Rating	Risk Rating
Wooden and Metal Structures				
Steel Railing	Upstream Headwall, Adam Street	Steel cracked at base (Photo: 23)	3	1
Steel Grate	Upstream Headwall, Adam Street	None (Photo: 24)	4	1
Access Platform	Upstream Headwall, Adam Street	Light corrosion of steel and light weathering, rot, and decay of timber components (Photo: 22)	3	2
Steel Railing	Downstream Headwall, Stephana Street	None (Photo: 31)	4	1
Access Platform	Downstream Headwall, Stephana Street	Light corrosion of steel and light weathering, rot, and decay of timber components (Photo: 31)	3	1
Erosion, Seepage and Leakage				
CSP Culvert	Adam Street	Pipe joints misaligned causing seepage (Photo: 25)	3	2
Elliptical Concrete Culvert	Queen Street	Joints are leaking throughout pipe (Photos: 50-51)	3	2

Photo 23 - September 20, 2022
Neustadt Flood Control Works - Neustadt Creek
Upstream End of Adam/Stephana Street Culvert

5. Replace the railings on the various concrete headwalls with railings that meet current Ontario Building Code requirements.	The railings that are in place do not meet the Ontario Building Code Requirements.	High	\$10,000

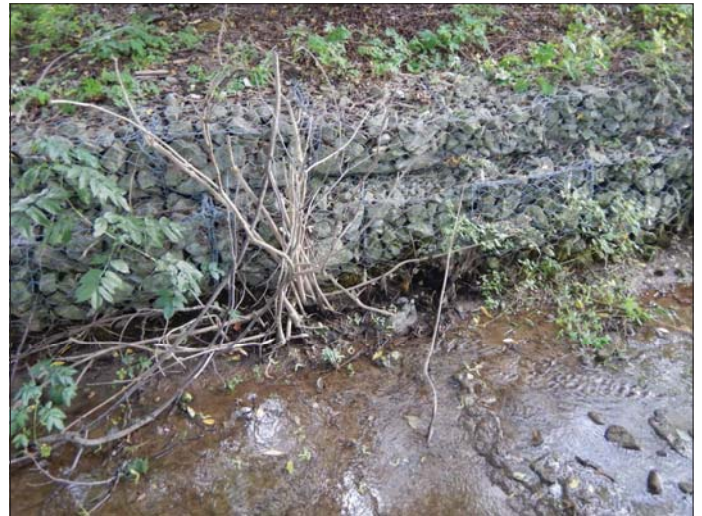
Photo 38 - September 20, 2022
Neustadt Flood Control Works - Neustadt Creek
Typical Gabion Basket

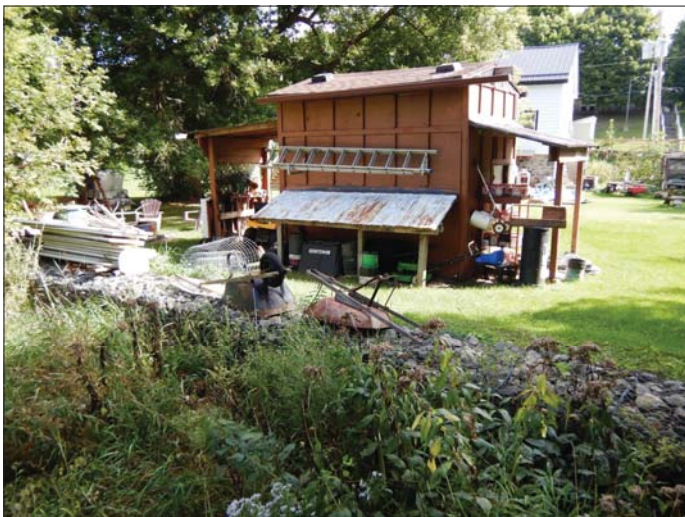
Photo 39 - September 20, 2022
Neustadt Flood Control Works - Neustadt Creek
Materials Stored on Gabion Baskets, Left Bank

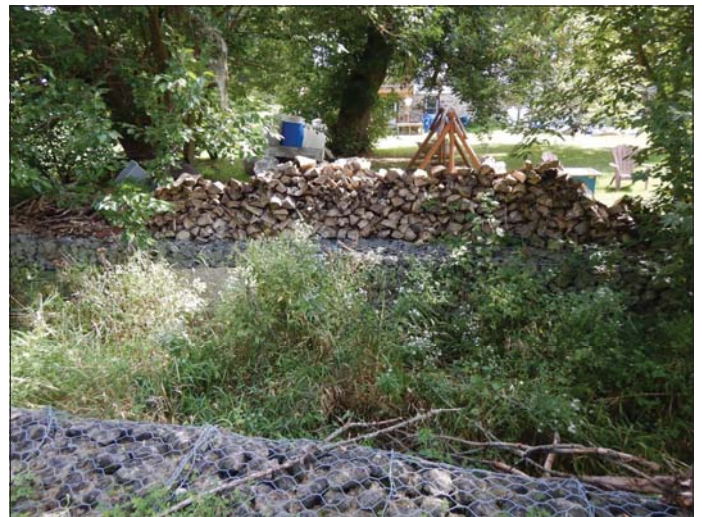
Photo 40 - September 20, 2022
Neustadt Flood Control Works - Neustadt Creek
Wood Pile on Gabion Baskets, Left Bank

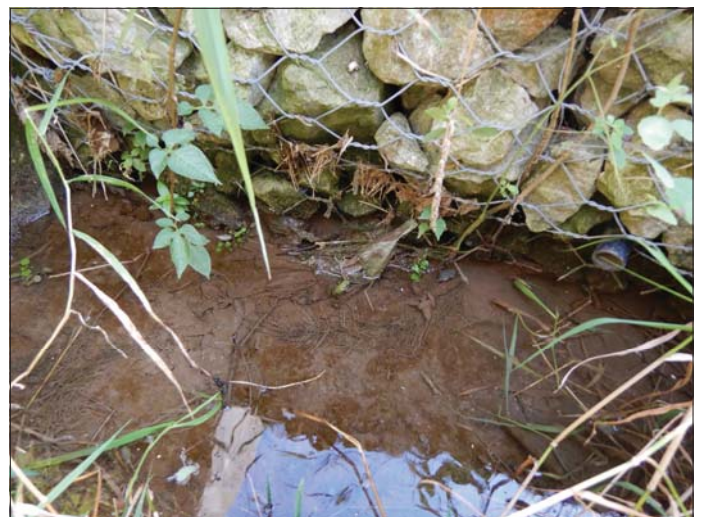
Photo 42 - September 20, 2022
Neustadt Flood Control Works - Neustadt Creek
Base of Gabion Baskets

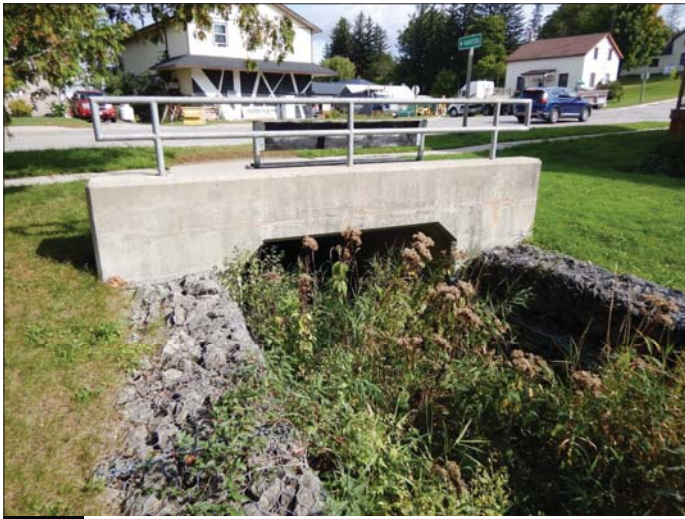
Photo 43 - September 20, 2022
Neustadt Flood Control Works - Neustadt Creek
Upstream End of Queen Street Culvert

Recommendation	Description of Deficiency	Priority	Estimated Cost	Additional Comments
Public Safety				
4. Add public safety signage to each of the culvert headwalls. The signs should read "DANGER KEEP OUT" and the wording should be large enough that it can be seen from outside of the flood control channel.	There are no warning signs at the inlets of the culverts and the culvert grates have been removed.	Immediate	\$2,500	It is assumed that this would be completed by SVCA staff as part of their regular duties using purchased materials.

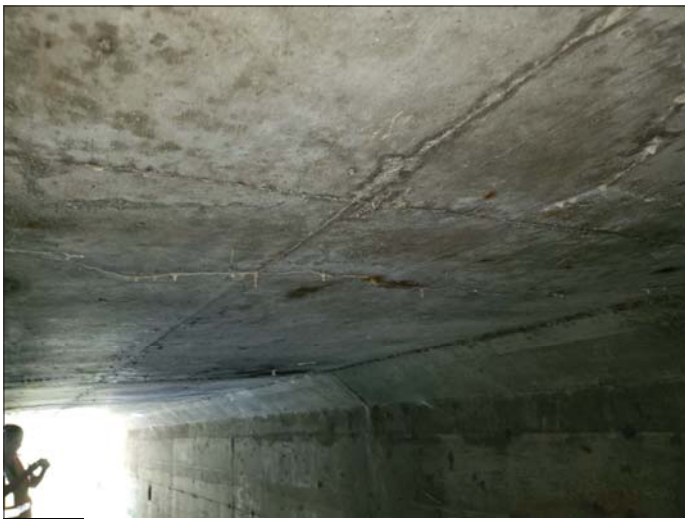
Photo 45 - September 20, 2022
Neustadt Flood Control Works - Neustadt Creek
Interior of Queen Street Culvert, Soffit

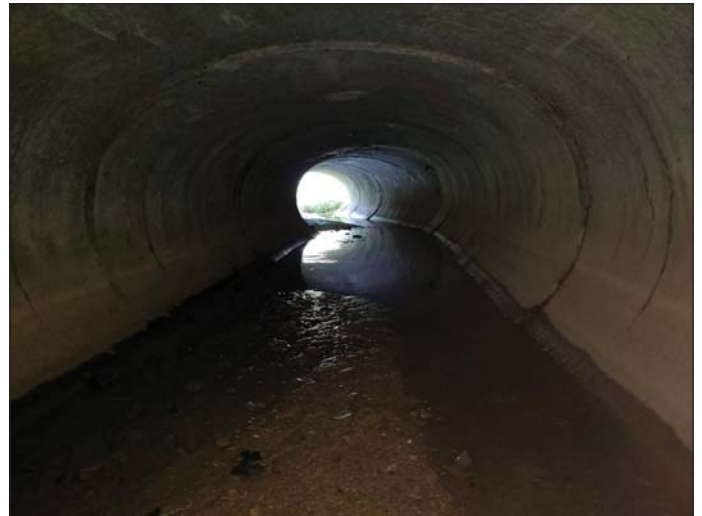
Elliptical Concrete Culvert	Queen Street	Several joints are leaking creating spalling around these areas. Graffiti was noted within the culvert (Photos: 50-51)	3	2
In-Channel Weirs	Between William Street and Adam Street	None	4	1

Photo 50 - September 20, 2022
Neustadt Flood Control Works - Neustadt Creek
Interior of Queen Street Culvert

2. Monitor the condition of the various culvert and gabion basket sections and undertake localized repairs as required.	A number of small deficiencies were identified throughout the gabion basket and culvert structures.	Ongoing	\$0	It is assumed that this would be completed by SVCA staff as part of their regular duties.

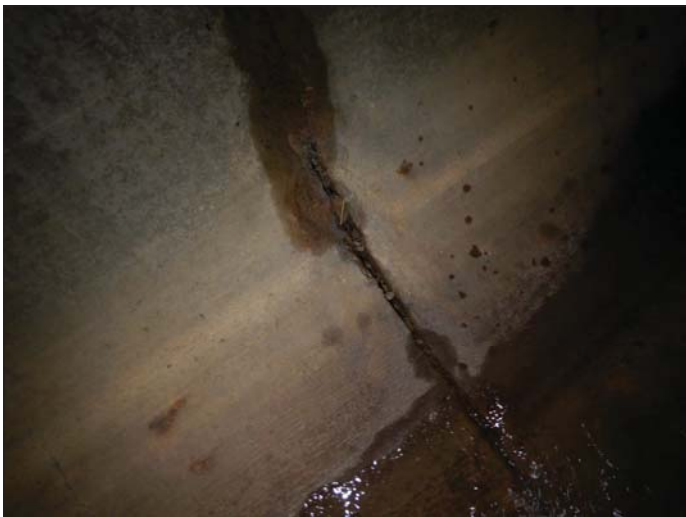
Photo 51 - September 20, 2022
Neustadt Flood Control Works - Neustadt Creek
Joint in Queen Street Culvert

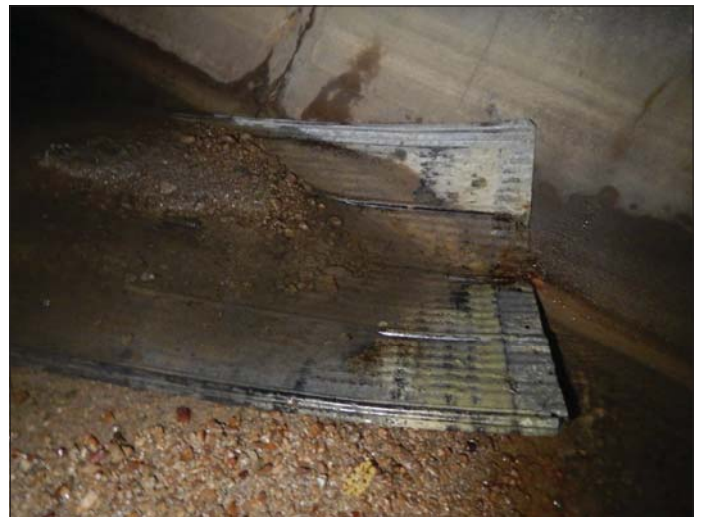
Photo 52 - September 20, 2022
Neustadt Flood Control Works - Neustadt Creek
Debris in Queen Street Culvert
