Final Inspection Report

**Neustadt Flood Control Works
Meux Creek**

**Municipality of West Grey,
Grey County, Ontario**

D.M. Wills Project Number 22-5540

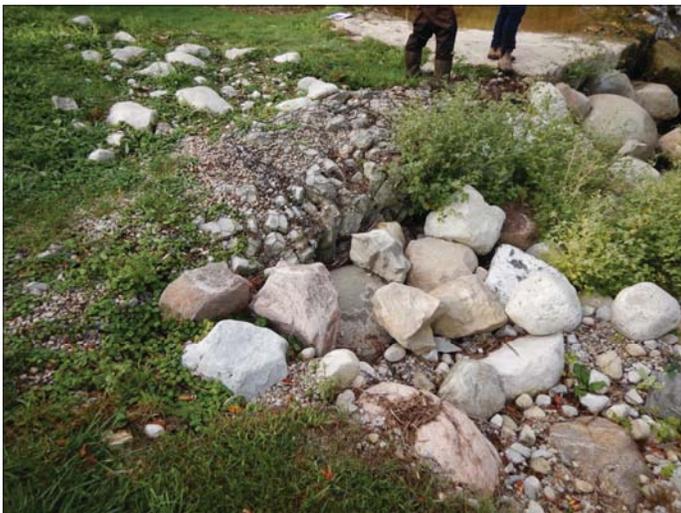
Structure	Location	Deficiency / Description	Condition Rating	Risk Rating
Earth Retaining Structures				
Meux Creek Gabion Flood Control Wall	Upper Section of Baskets	Baskets are slightly bulging but there is little corrosion on the steel wire (Photos: 20, 24, 28)	2	2
	Lower Section of Baskets	The steel has corroded and is broken. Ballast is being displaced to the watercourse causing the baskets to settle and the whole wall to shift (Photos: 24-25)	2	2
	Throughout	Areas where the basket is absent, leaving just embankment and ballast behind (Photo: 27)	2	2
	Back of Gabon Basket Wall	Tree growth near the back of the gabion basket wall. (Photo: 28)	3	1
Flow Conveyance Systems and Structures				
Meux Creek Weir in Neustadt Lions Park	Concrete Weir Structure	Cracking and spalling (Photo: 4)	2	2
	Gabion Baskets	The steel has corroded and is broken. Ballast is being displaced to the watercourse causing the baskets to shift and sag (Photos: 3-7)	2	2

Photo 3 - September 20, 2022
Neustadt Flood Control Works - Meux Creek
Gabion Baskets on Downstream Left Side of Wier

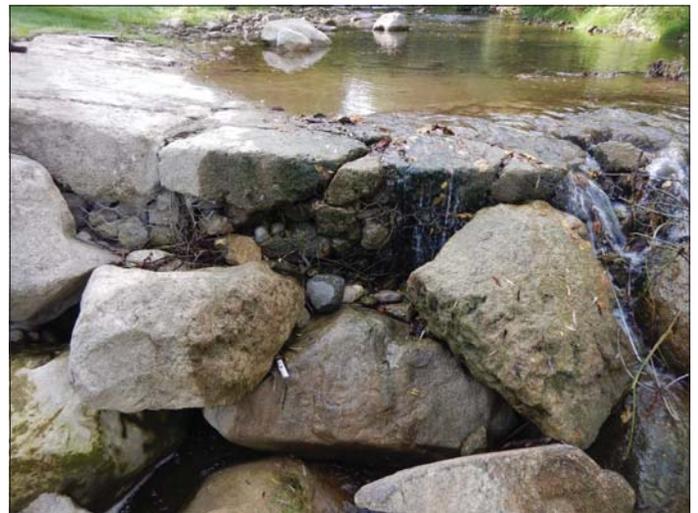
Structure	Location	Deficiency / Description	Condition Rating	Risk Rating
Erosion, Seepage and Leakage				
Meux Creek Weir in Neustadt Lions Park	Gabion Baskets	Seepage between the edge of the embankment and the baskets (Photo: 4)	2	1
	Upstream and Downstream Left and Right Banks	Erosion and slope failure (Photos: 2, 8-9, 11-13)	2	2
	Right Bank Approximately 65 m Downstream of Weir	Severe erosion (Photo: 8)	2	2
Meux Creek Gabion Flood Control Wall	Left Side of the Creek Upstream of Gabion Baskets	Severe erosion (Photos :32-33)	2	2

Photo 4 - September 20, 2022
Neustadt Flood Control Works - Meux Creek
Downstream Side of Wier

13. Replace the Meux Creek Weir in Neustadt Lions Park and provide appropriate erosion protection and stabilization measures within the creek channel and on the upstream and downstream creek banks.	Meux Creek Weir in Neustadt Lions Park is in poor condition with deteriorating concrete and corroded and broken gabion baskets.	Low	\$200,000	This cost estimate is provided for high level budget preparation only. The final cost will depend on the selected design and construction methodology. Estimate includes \$50,000 for engineering, permitting and tendering.

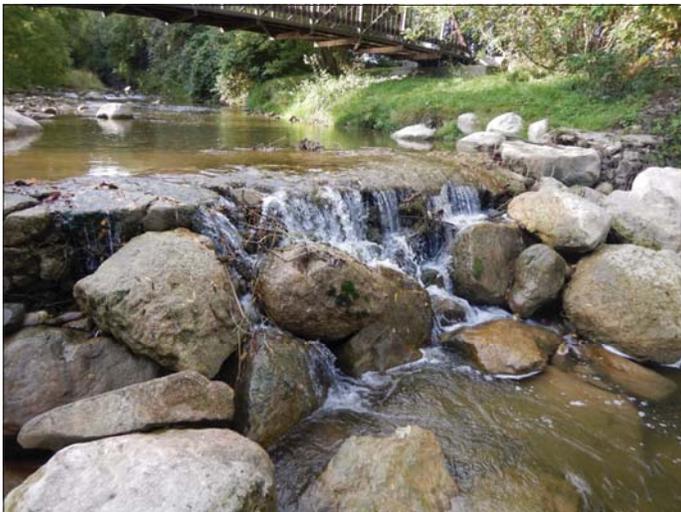
Photo 5 - September 20, 2022
Neustadt Flood Control Works - Meux Creek
Downstream Side of Wier

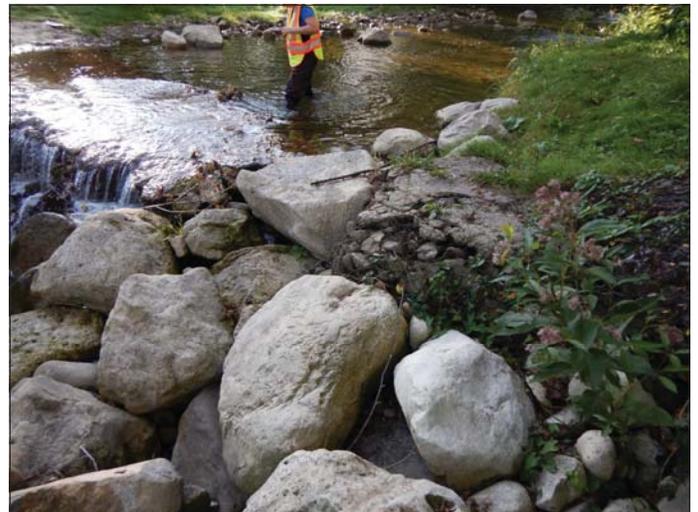
Photo 6 - September 20, 2022
Neustadt Flood Control Works - Meux Creek
Right Side of Wier

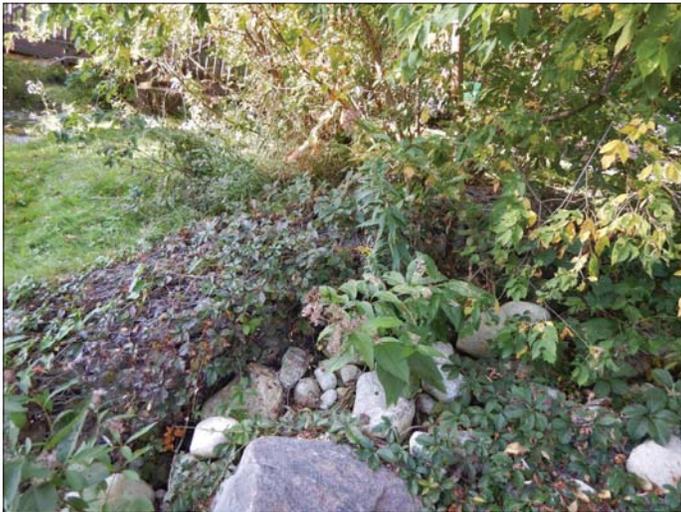
Photo 7 - September 20, 2022
Neustadt Flood Control Works - Meux Creek

Gabion Baskets on Downstream Right Side of Wier

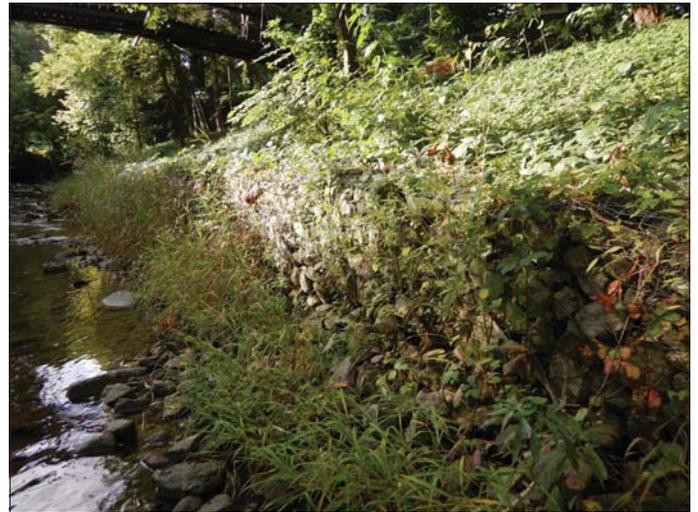
Photo 26 - September 20, 2022
Neustadt Flood Control Works - Meux Creek

Vegetation Growth on Right Bank

10. Remove all trees and other woody vegetation growing within 1 m of the top/back of the gabion basket wall on the right bank of Meux Creek upstream of Queen Street.	There were trees noted growing behind the gabion basket wall on the right bank of Meux Creek upstream of Queen Street. Over time, root growth could contribute to the deterioration and movement of the gabion baskets.	Medium	\$0	It is assumed that this would be completed as part of the routine inspections completed by SVCA staff as part of their regular duties.

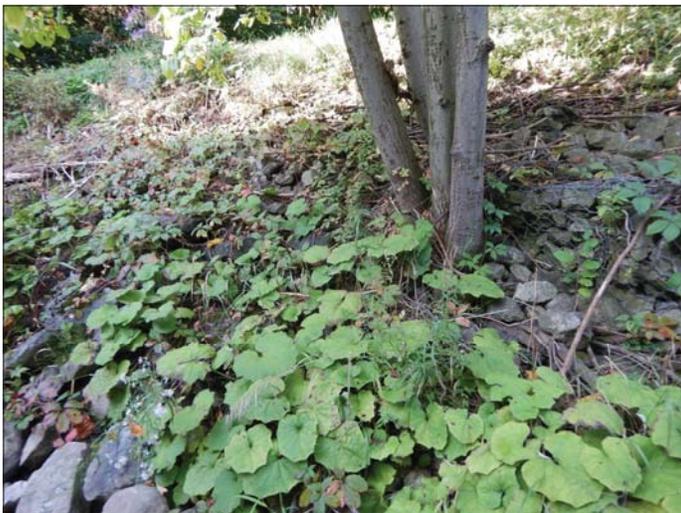
Photo 27 - September 20, 2022
Neustadt Flood Control Works - Meux Creek

Vegetation Growth on Right Bank

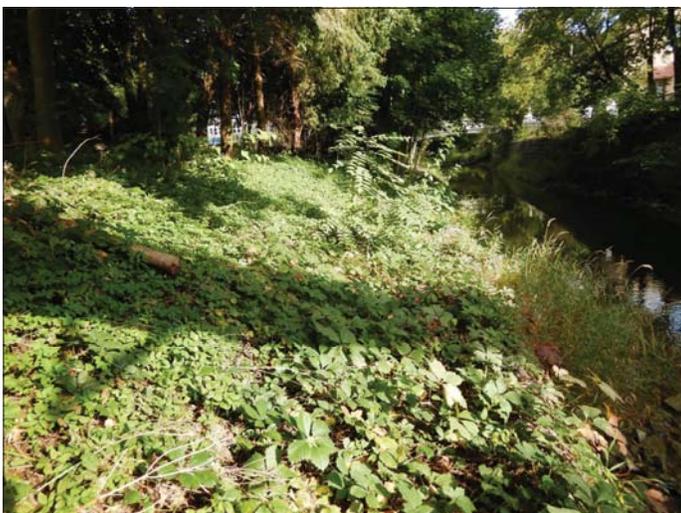
Photo 29 - September 20, 2022
Neustadt Flood Control Works - Meux Creek

Vegetation on Top of Gabion Baskets, Right Bank

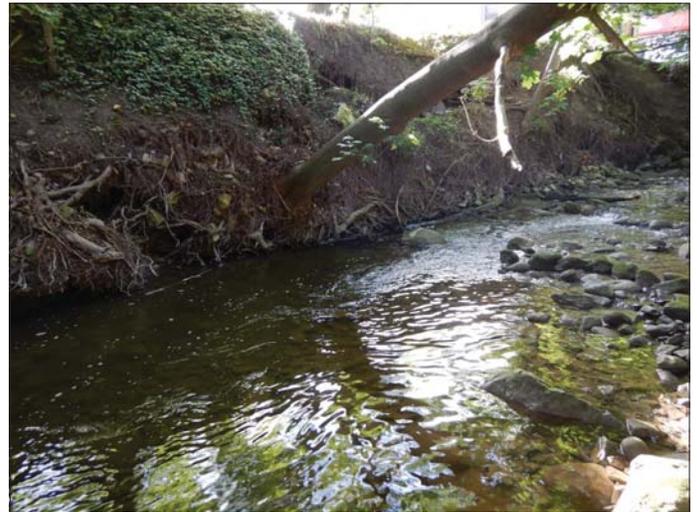
Photo 32 - September 20, 2022
Neustadt Flood Control Works - Meux Creek
Erosion on Left Bank

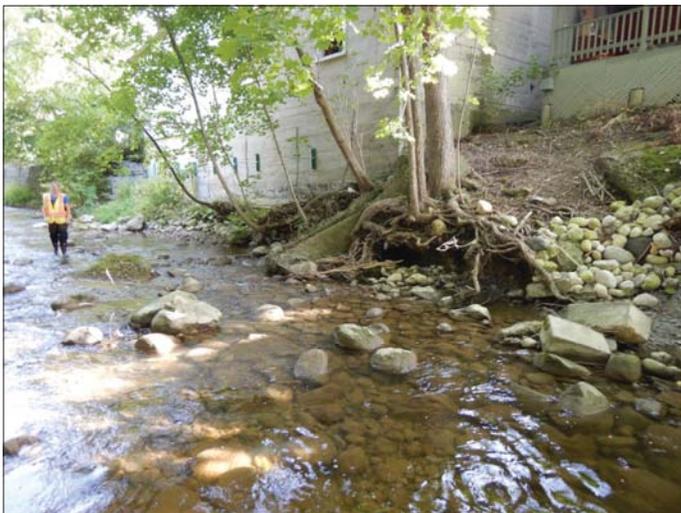
Photo 33 - September 20, 2022
Neustadt Flood Control Works - Meux Creek
Erosion on Left Bank
