Structure Name:	Concession 4 NDR Lot 30 Culvert	Site Number:	B-105
District:		Road Name:	Concession 4
County:	Grey County	Owner:	West Grey
Township:	West Grey	Skew:	0
Bridge or Culvert:	Culvert	AADT:	250
Structure Type:	CSP (arch)	Overall Struct. Width:	25 m
Number of Spans:	2	Roadway Width:	6.6 m
Direction of Structure:	North-South	Total Deck Length:	7.4 m
GPS Coordinates (Degrees)		Span (s):	5.4 m
General	Latitude: 44.211104	Total Deck Area:	185 sq.m
	Longitude: -80.895677	Current Load Limit:	0

Inspection Data

Date of Inspection:	10-Jun-24
Name of Inspector:	A. Burgess P.Eng. & J. Ziegler CET
Equipment Used:	Sounding hammer, measuring equipment, GPS
Weather Conditions:	Cloudy
Temperature:	12
Special Notes:	Culvert is in good condition, recommend railing system repair.

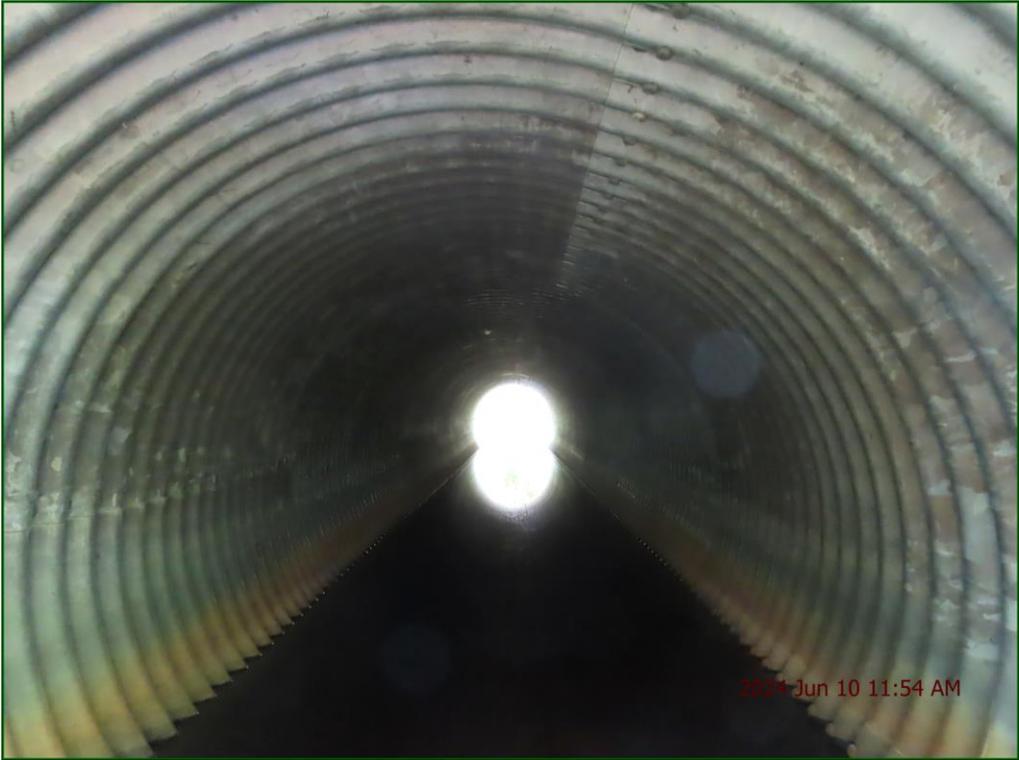
Description: West Barrel: View from south.

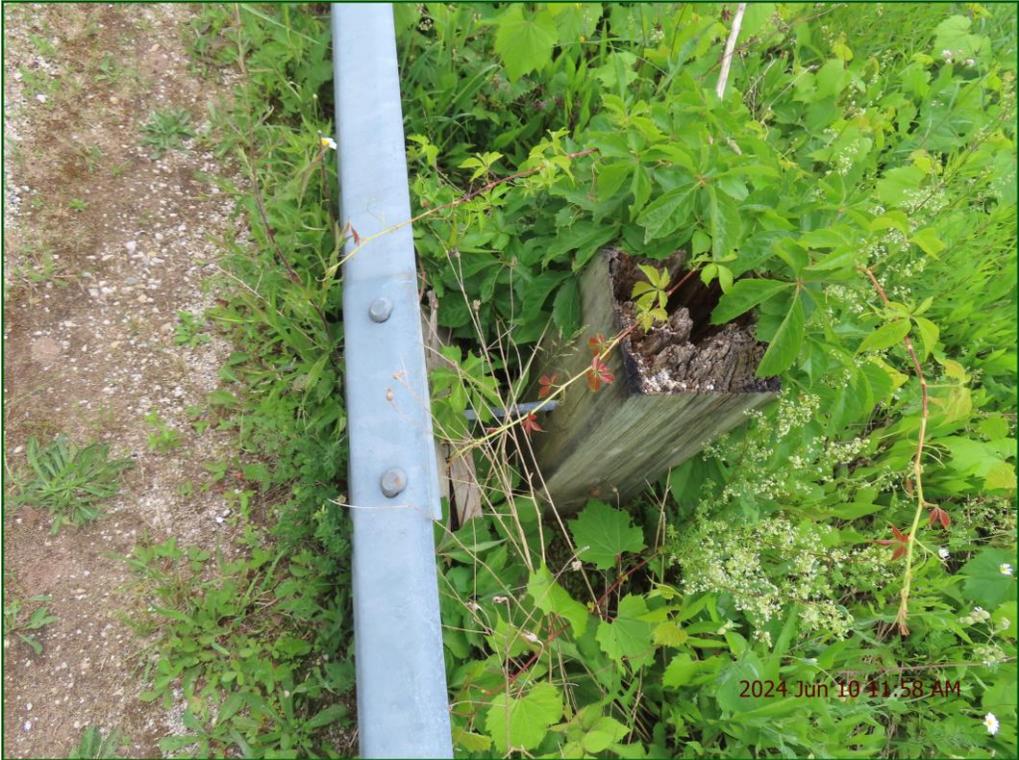
Description: Railing systems: Medium to severe rot throughout with localized 100% section loss.

Medium to severe rot throughout with localized 100% section loss.

Element Group:	Barriers	Site Number:	B-105
Element Name:	Railing systems	Width:	0 m
Element type:	Flexi beam with steel posts	Height:	0.8 m
Sub-element:		Length:	24 m
Material:	Steel	Count:	2
Location:		Total Quantity:	48 m
Environment:	Severe	Not inspected:	<input type="checkbox"/>
Perform. deficiencies:		Maintenance Type:	Structural
Maint needs:	Barrier/railing system repair	Maint. Time Period:	2 Year

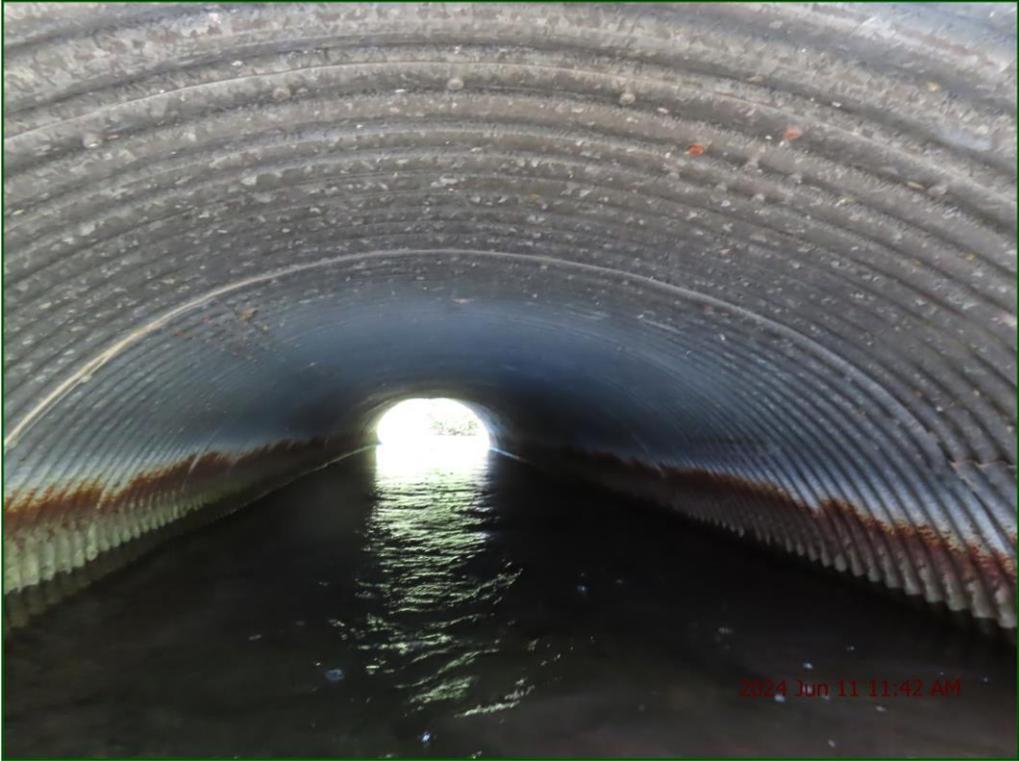
Description: North barrel: View from east.

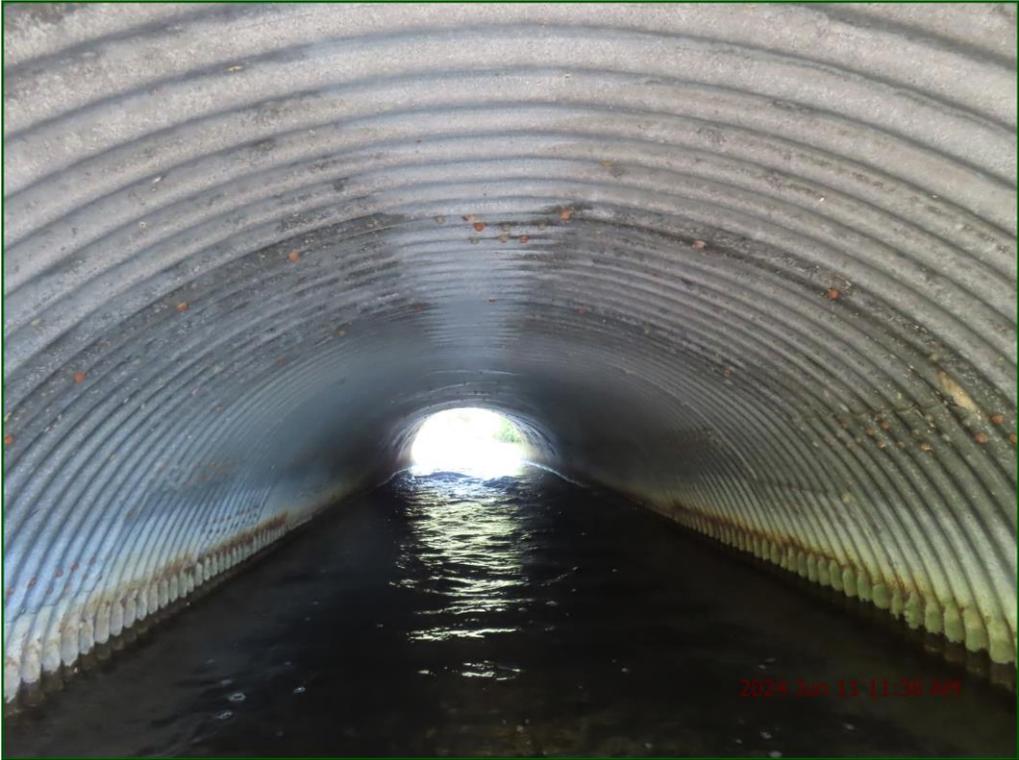
Description: South barrel: View from west.

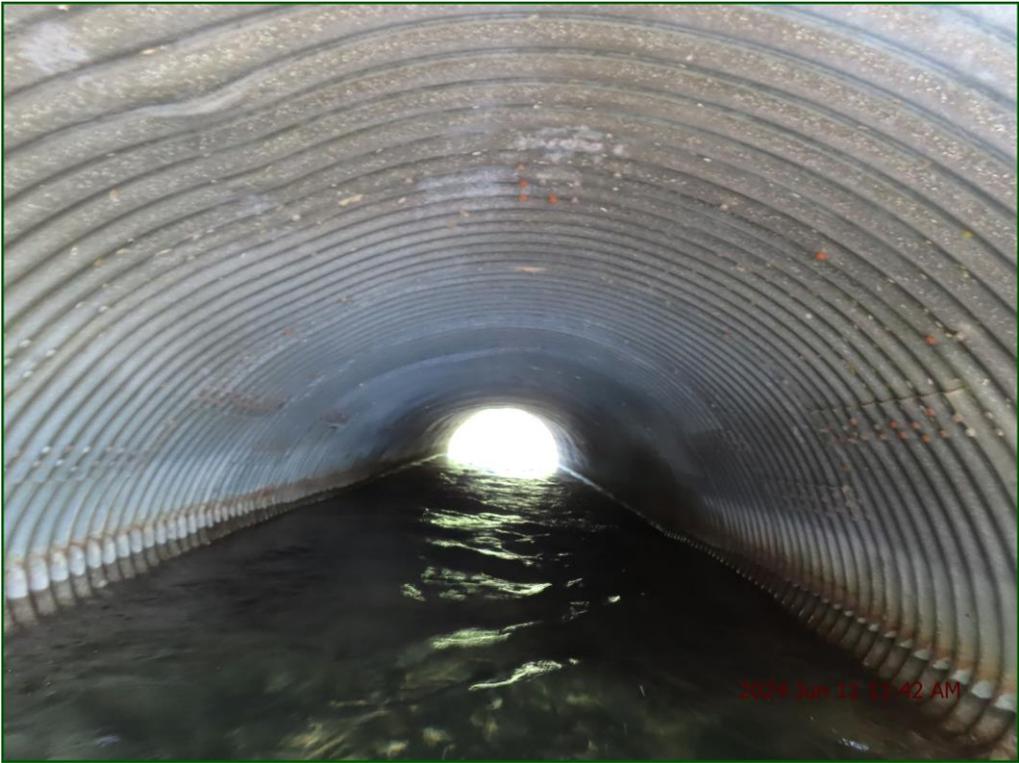
Description: South barrel: View from east.

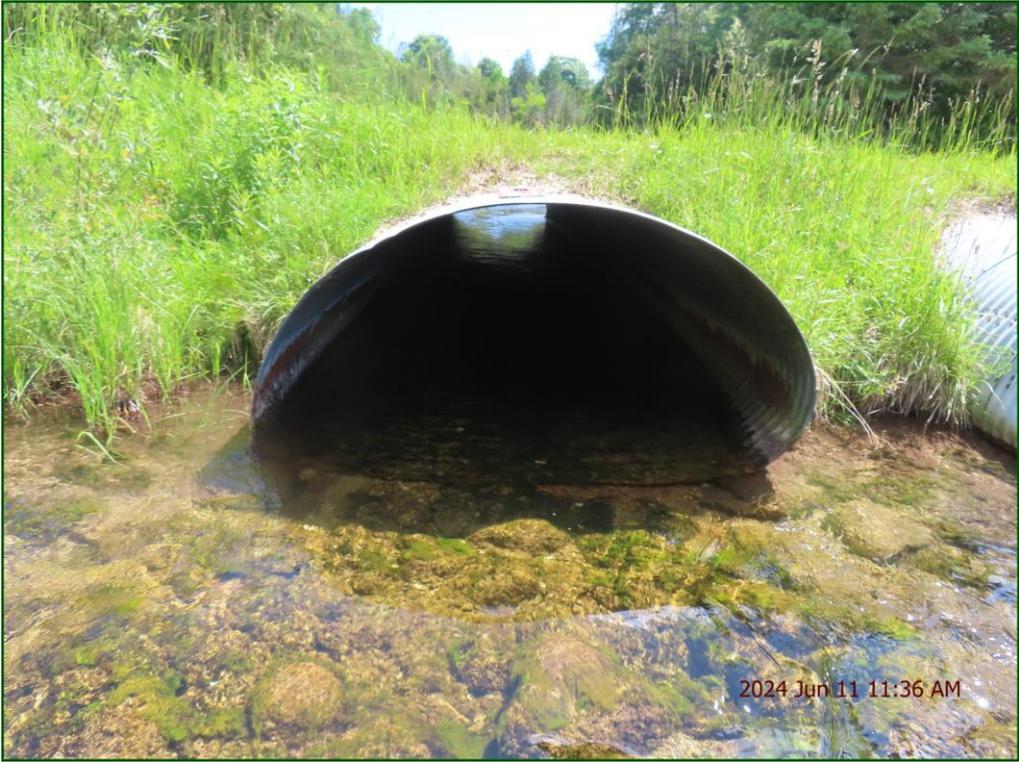
Description: Barrel: Bottom appears to be flattening.

Bottom appears to be flattening. Moderate deformation mid barrel. North barrel at time of inspection: Height - 1.07m, Width: 1.85m. South barrel at time of inspection: Height - 1.24m, Width: 1.83m. Both measured from West end.

Barrel has advanced deformations recommend monitor further deformations until replacement.

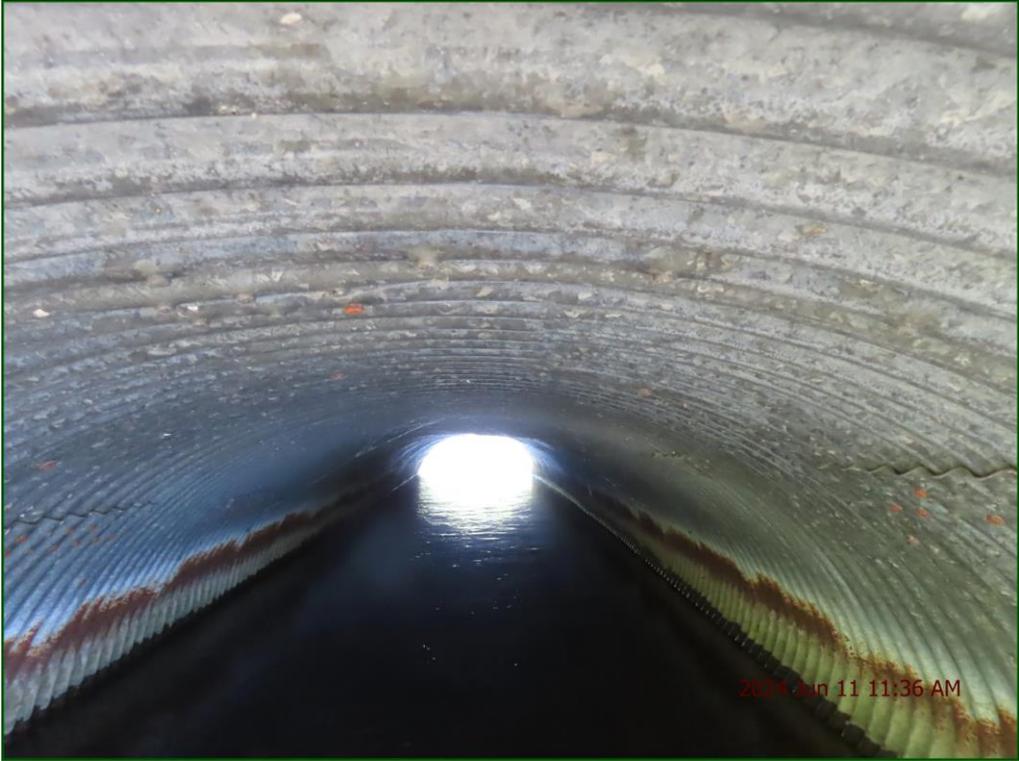
Description: Barrel: Moderate deformation mid barrel.

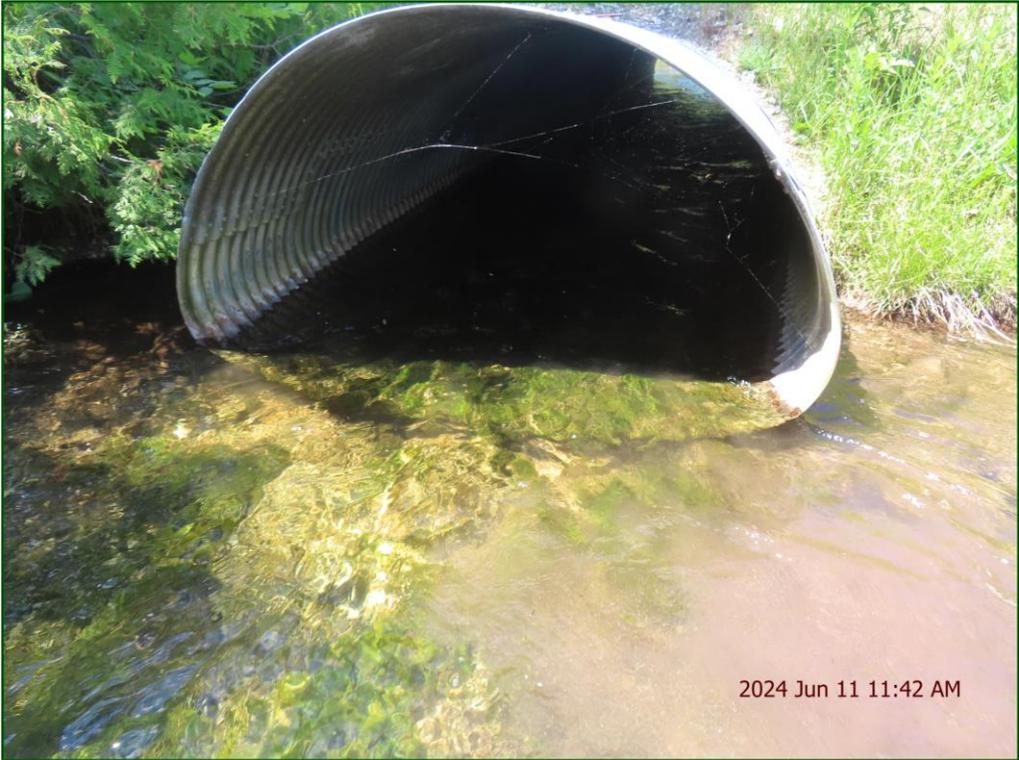
Description: Inlet: Severe scouring of south barrel.

Severe scouring of south barrel.

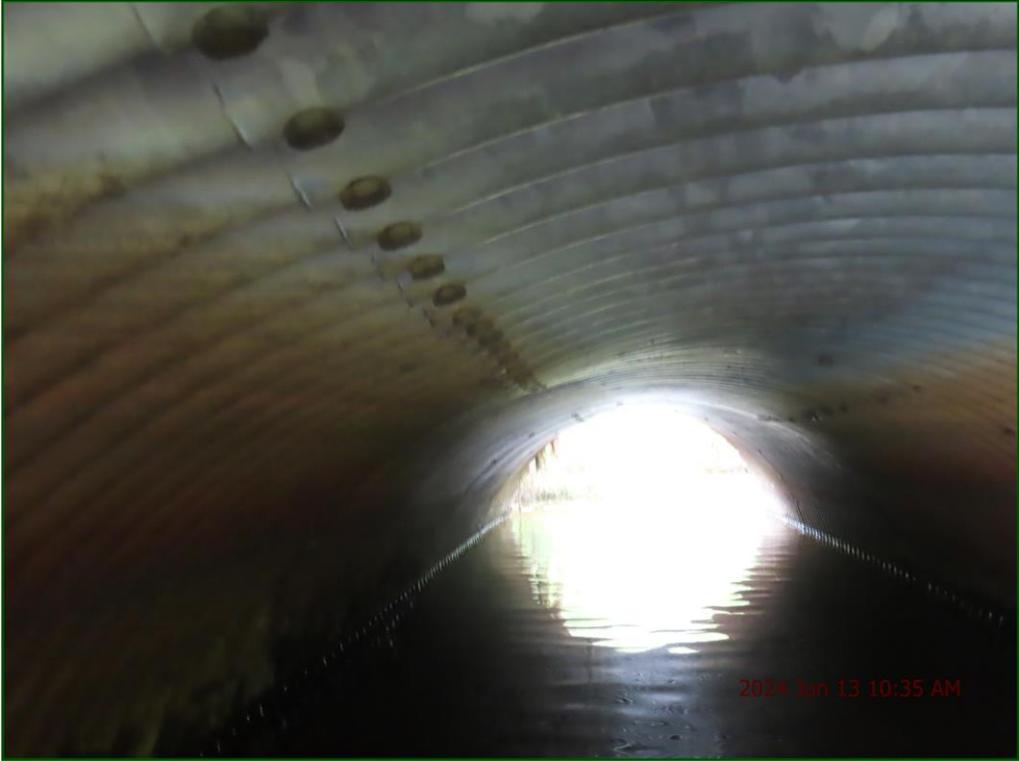
Description: Barrel: Moderate deformation mid barrel.

Improper splice bolt pattern, no cracking noted. Light corrosion along waterline. Moderate deformation mid barrel.

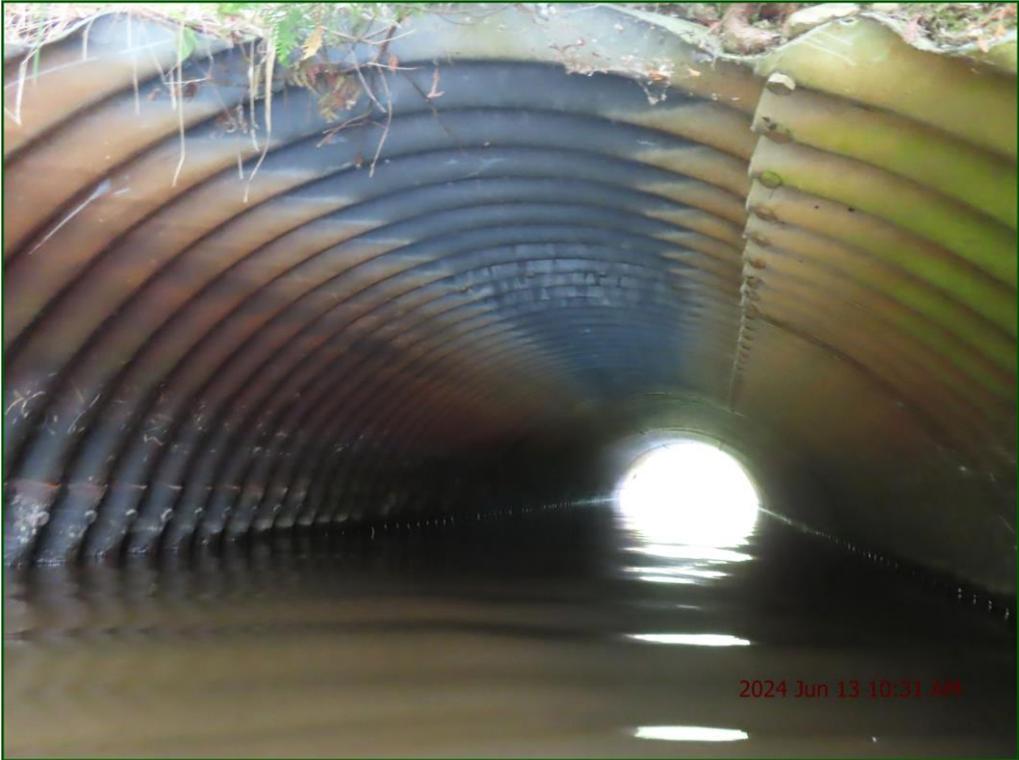
Description: West barrel: View from south.

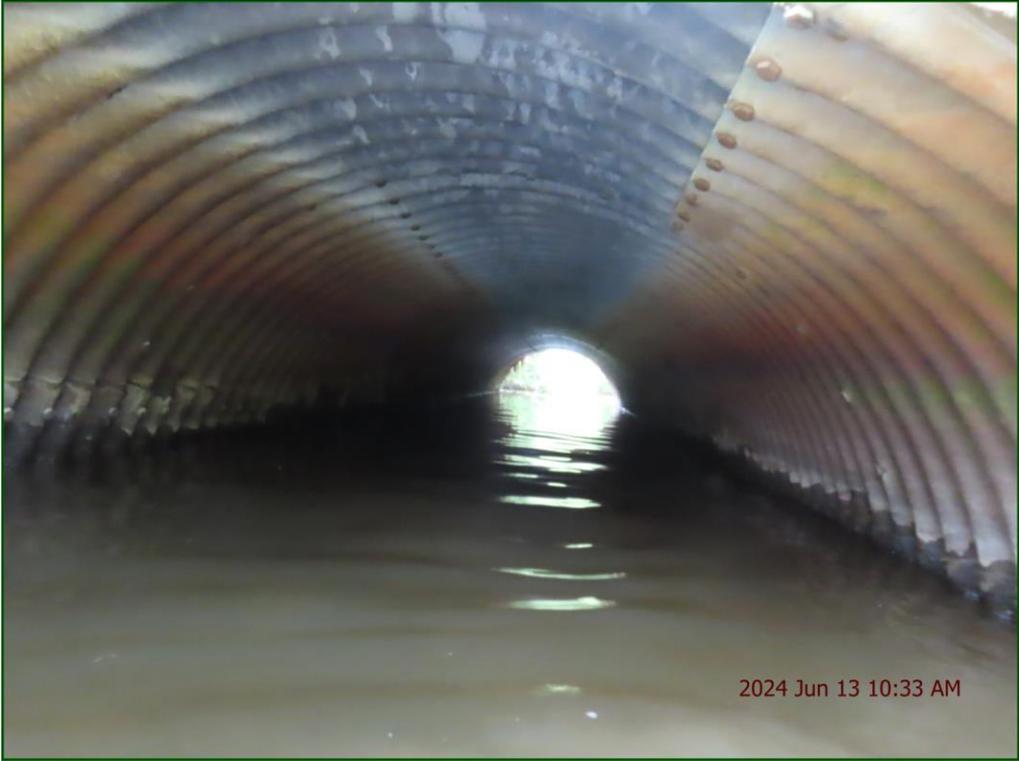
Description: East barrel: View from north.

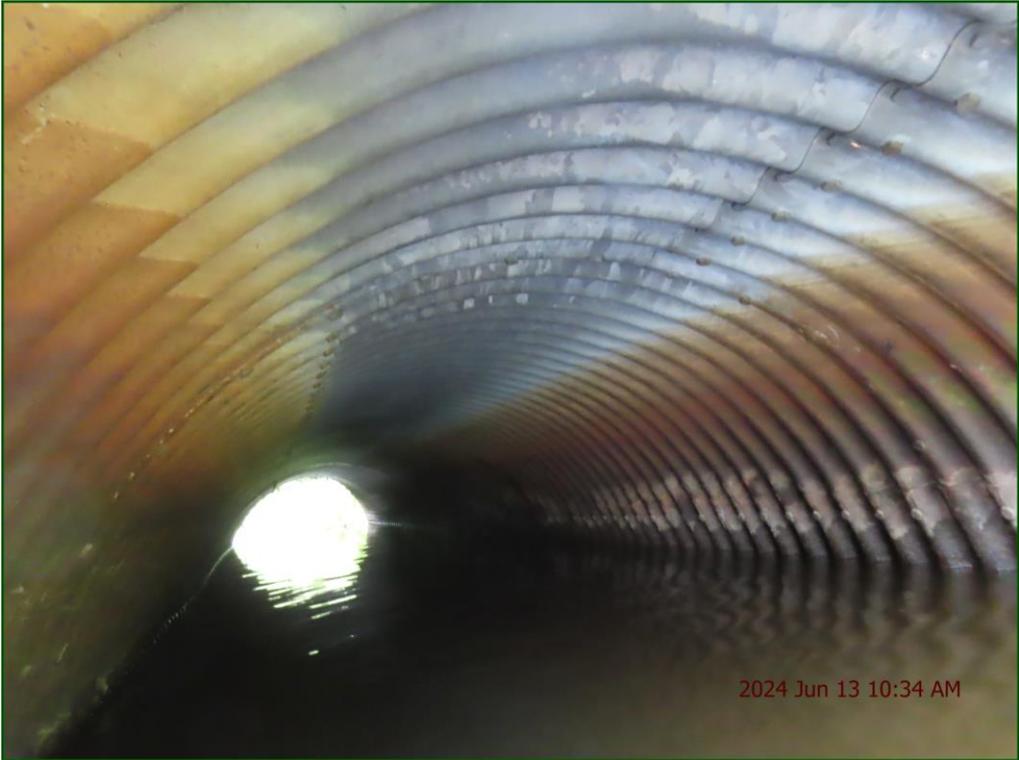
Description: West barrel: View from north.

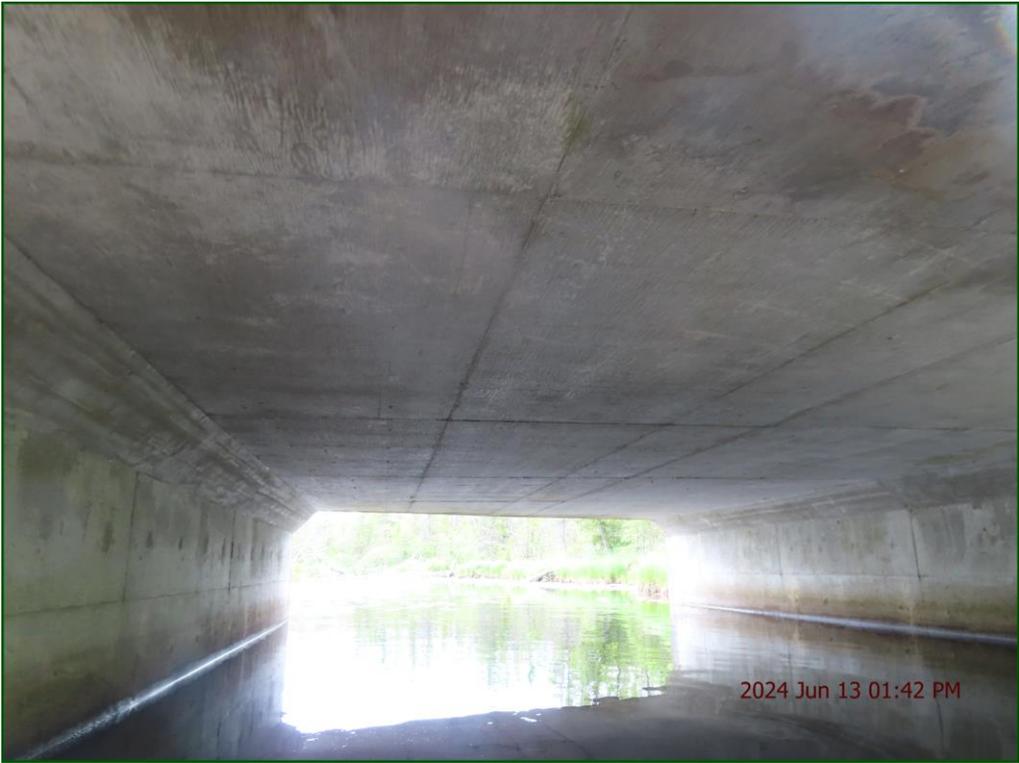
Description: Barrel: View from west.

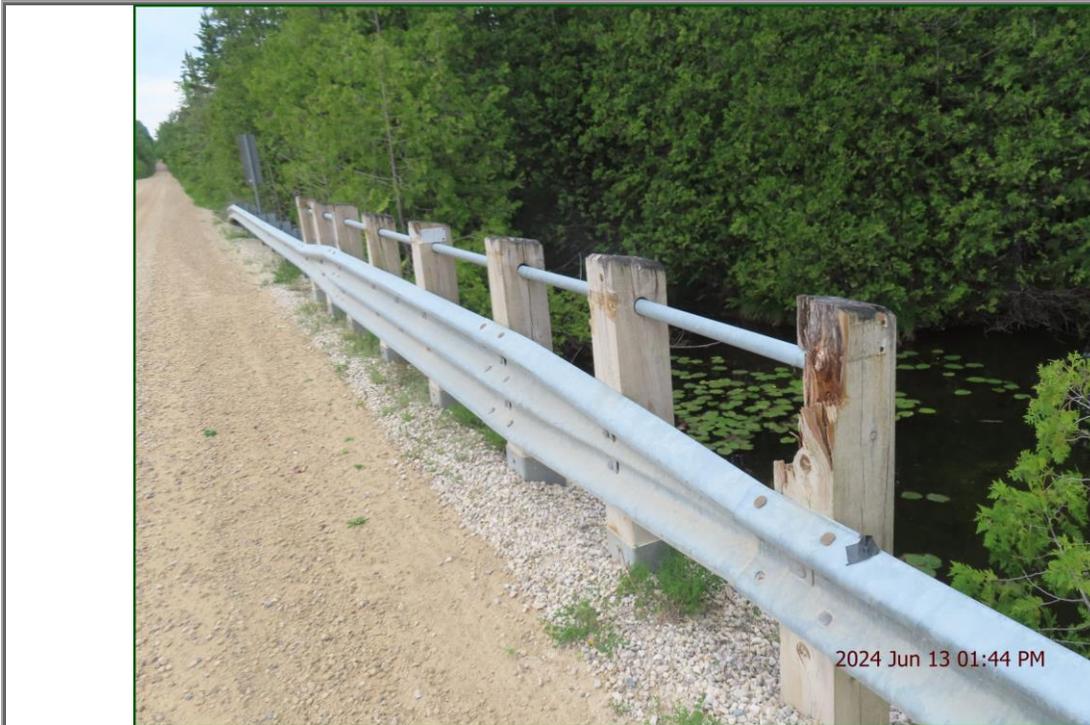
Minor localized damage.

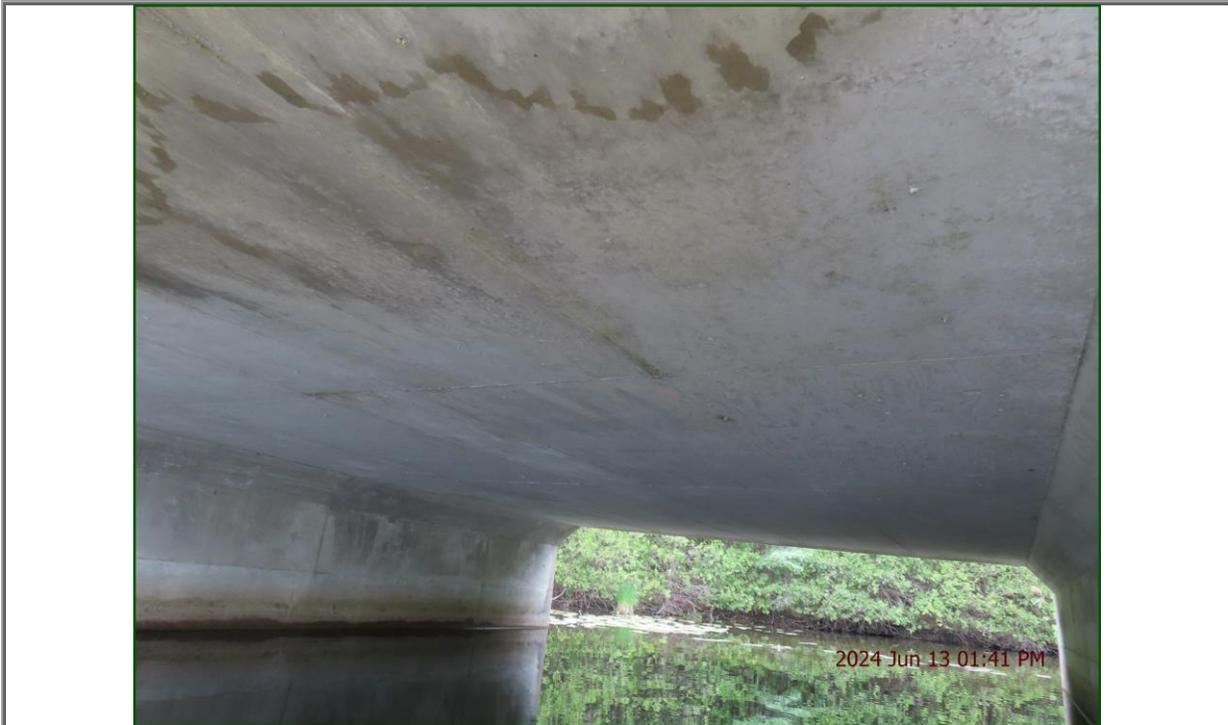
Medium vertical crack with wetness staining.

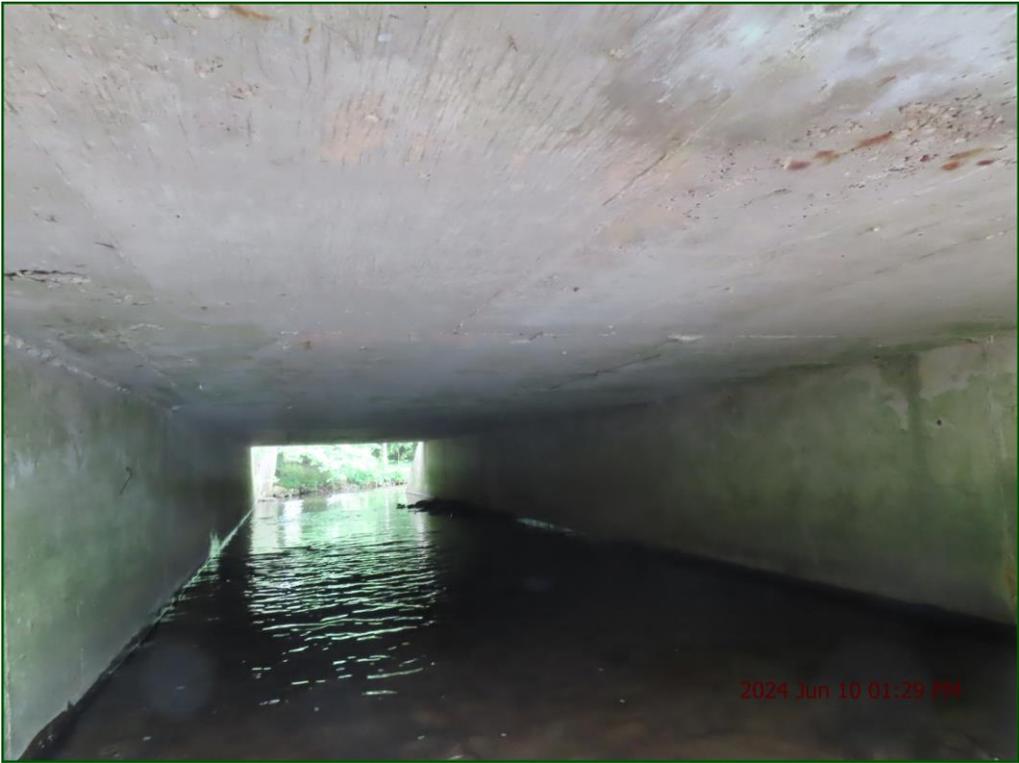
Description: Barrel: View from west.

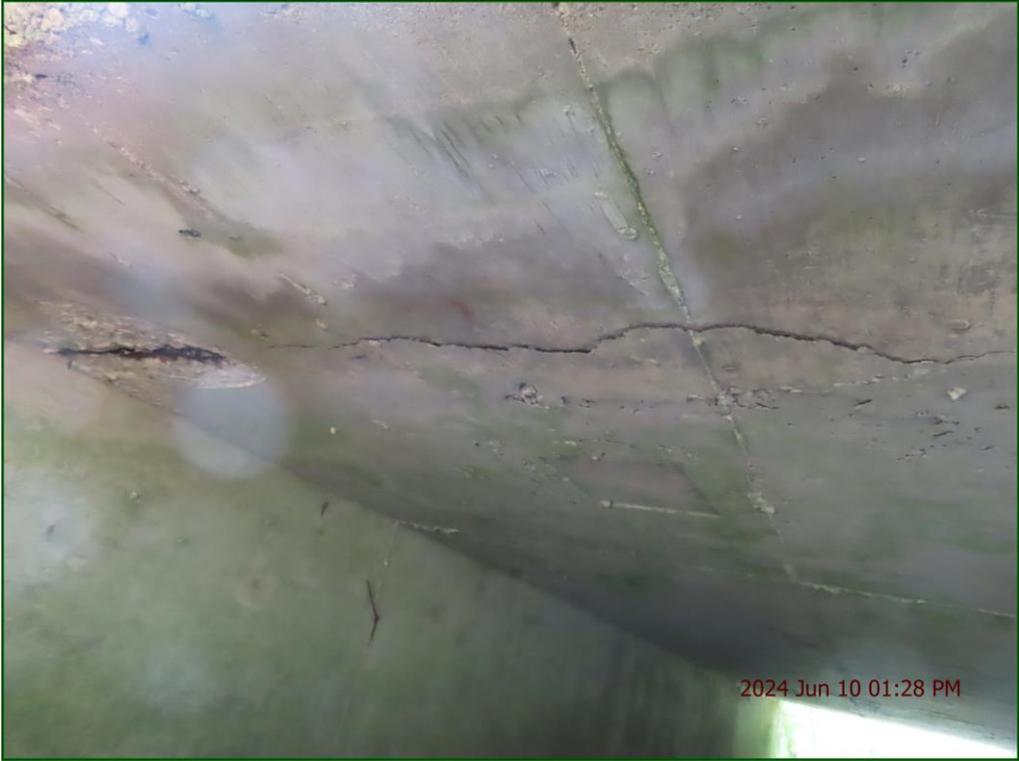
Description: Barrel: Shallow delamination throughout.

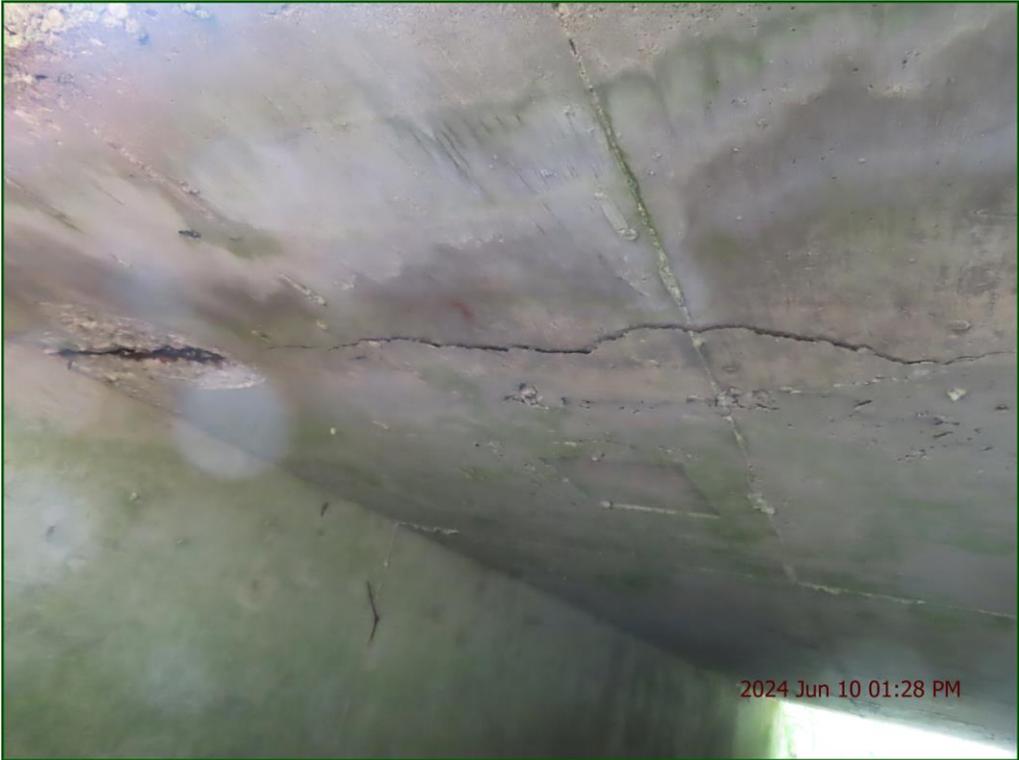
Description: Barrel: Shallow localized spall with exposed reinforcing.

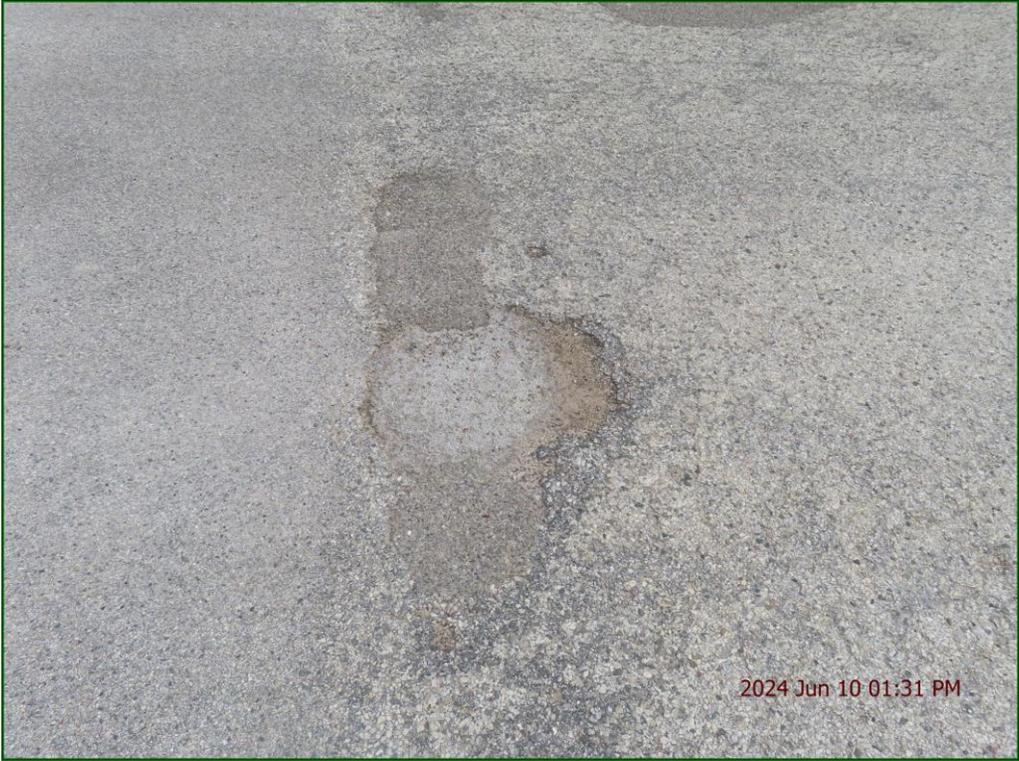
Description: Wearing surface: Moderate potholes throughout.

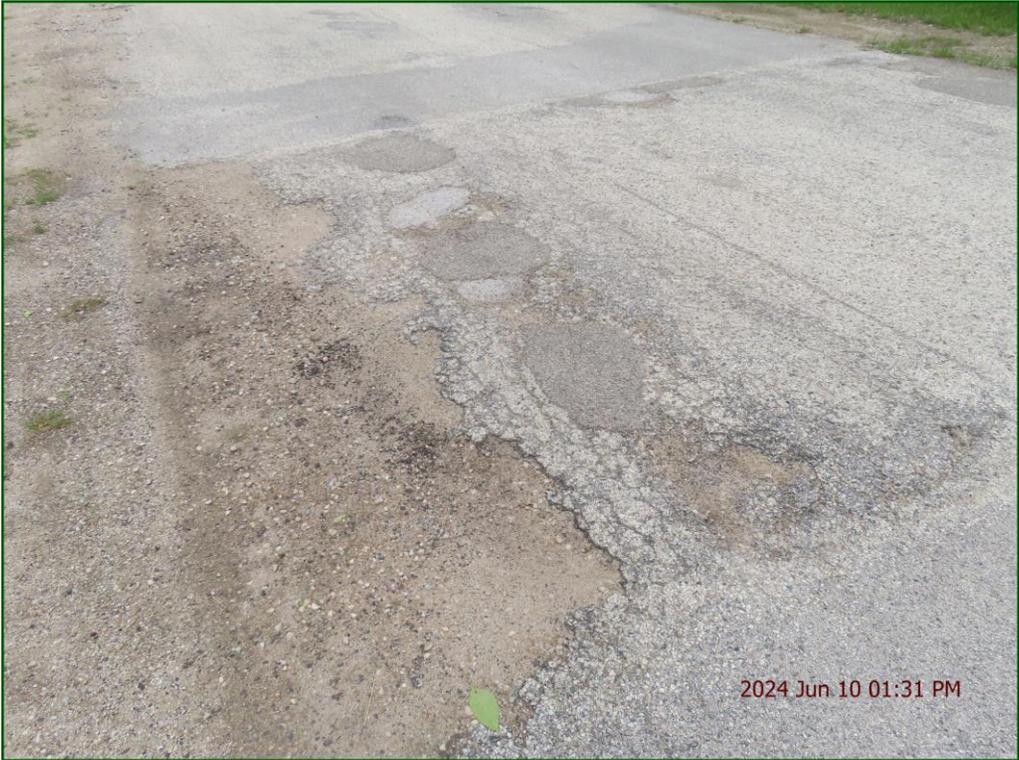
Description: Wearing surface: Severe alligator cracking at shoulders.

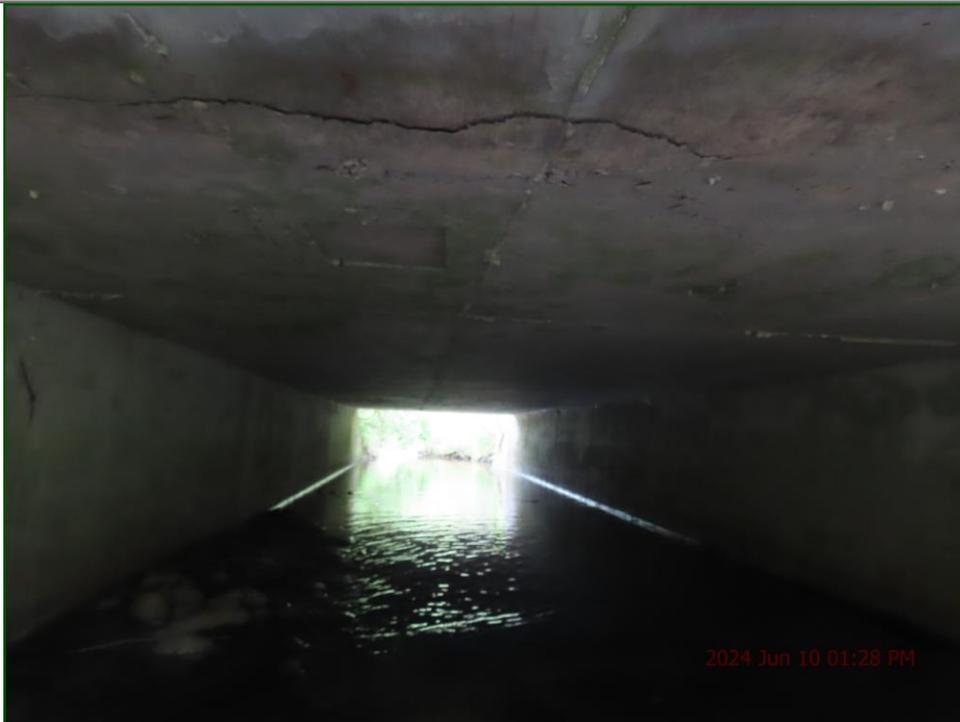
Light vertical cracks with wetness and leachate staining. Shallow delamination throughout. Shallow localized spall with exposed reinforcing.

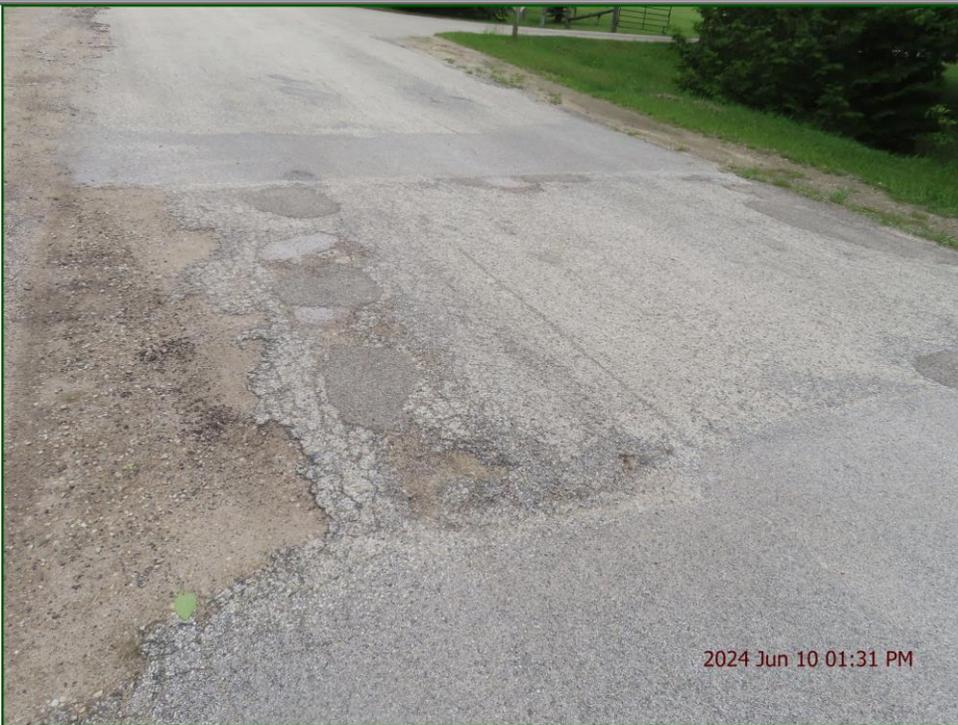
Moderate potholes throughout. Severe alligator cracking at shoulders.

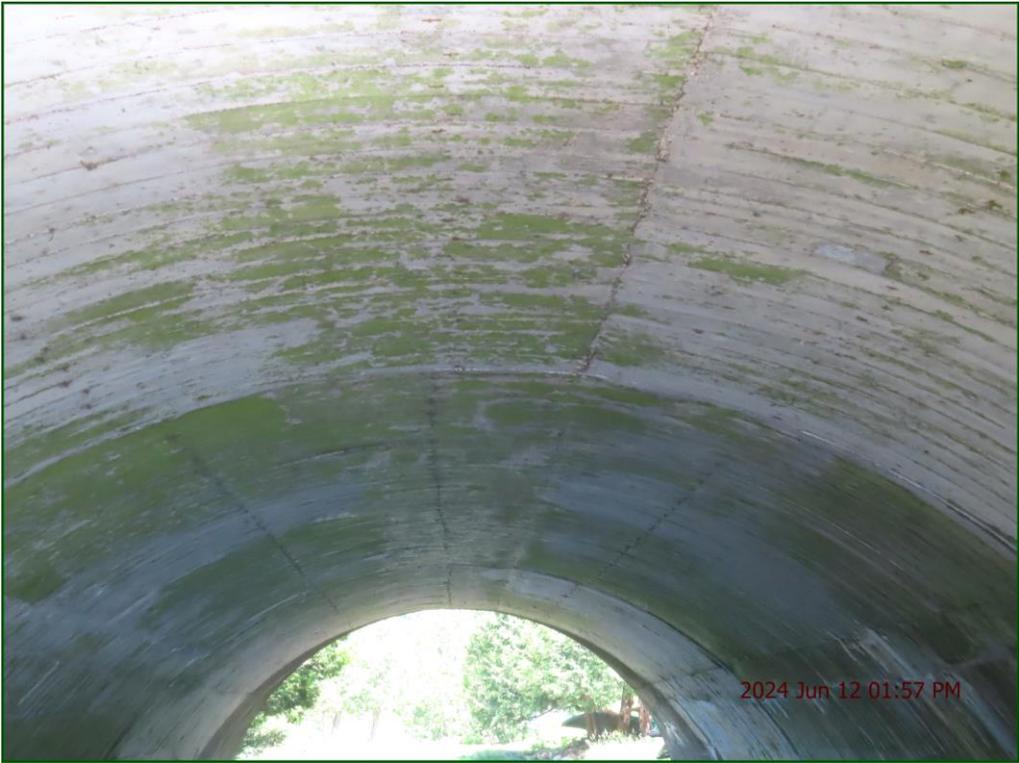
Description: Barrel: View from west.

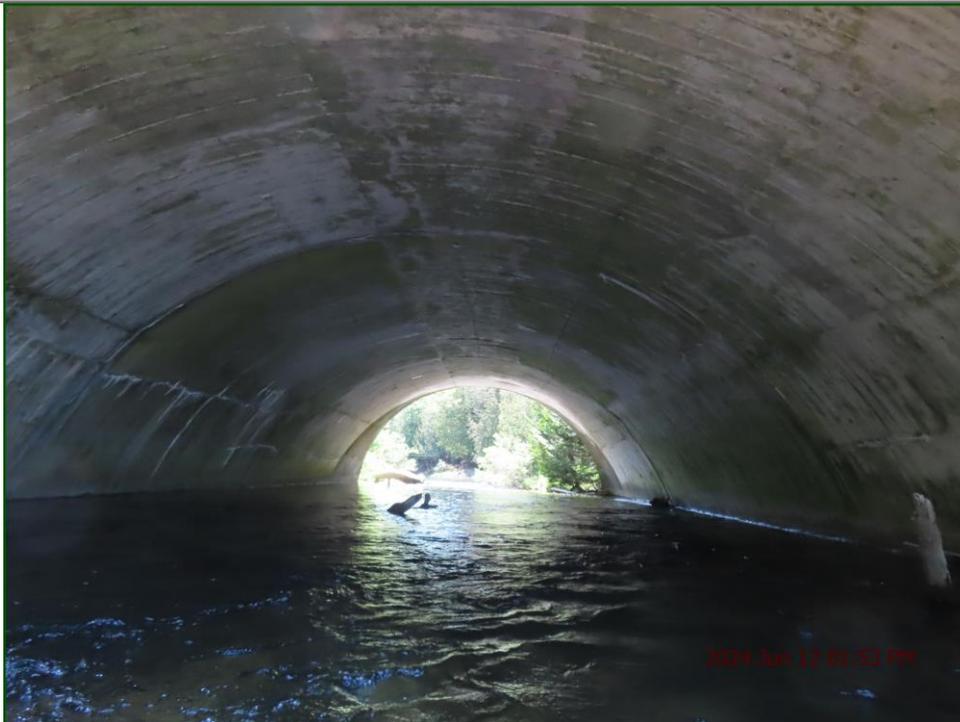
Medium to wide transverse cracks with leachate staining.

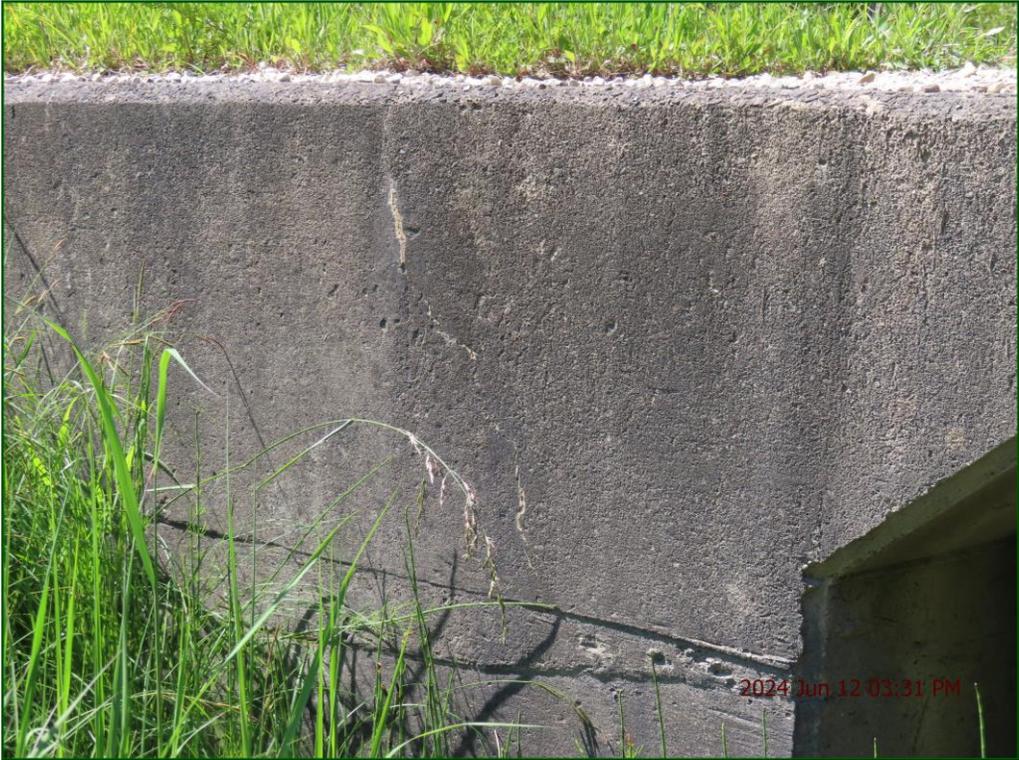
Description: Inlet: Light to medium cracking with leachate staining.

Light to medium cracking with leachate staining.

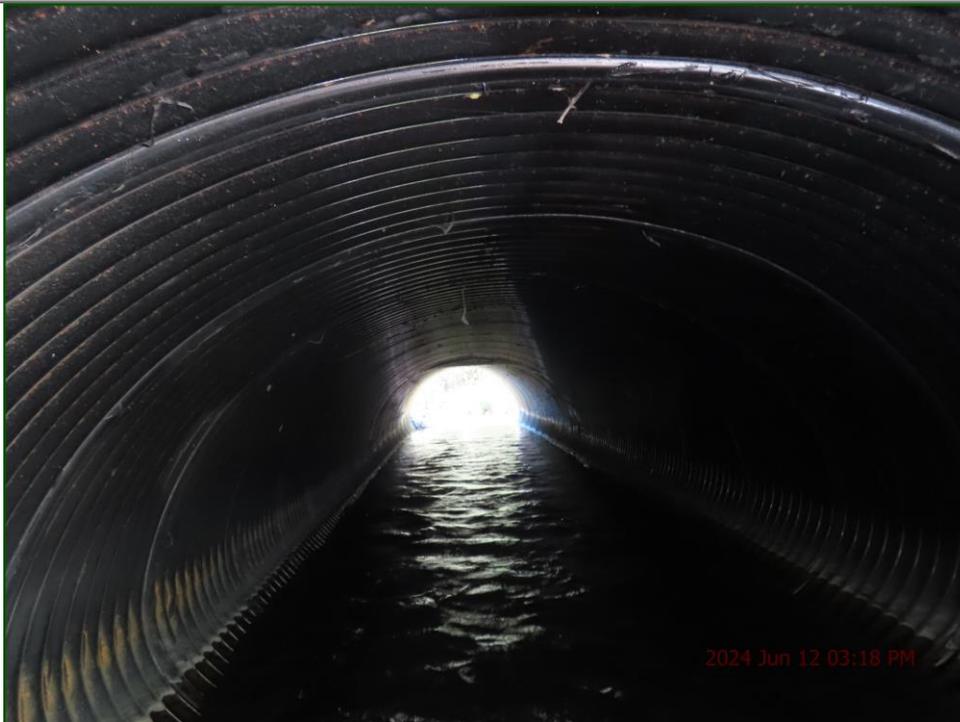
Moderate deformation at midspan in east barrel. Recommend monitoring deformation at next inspection.

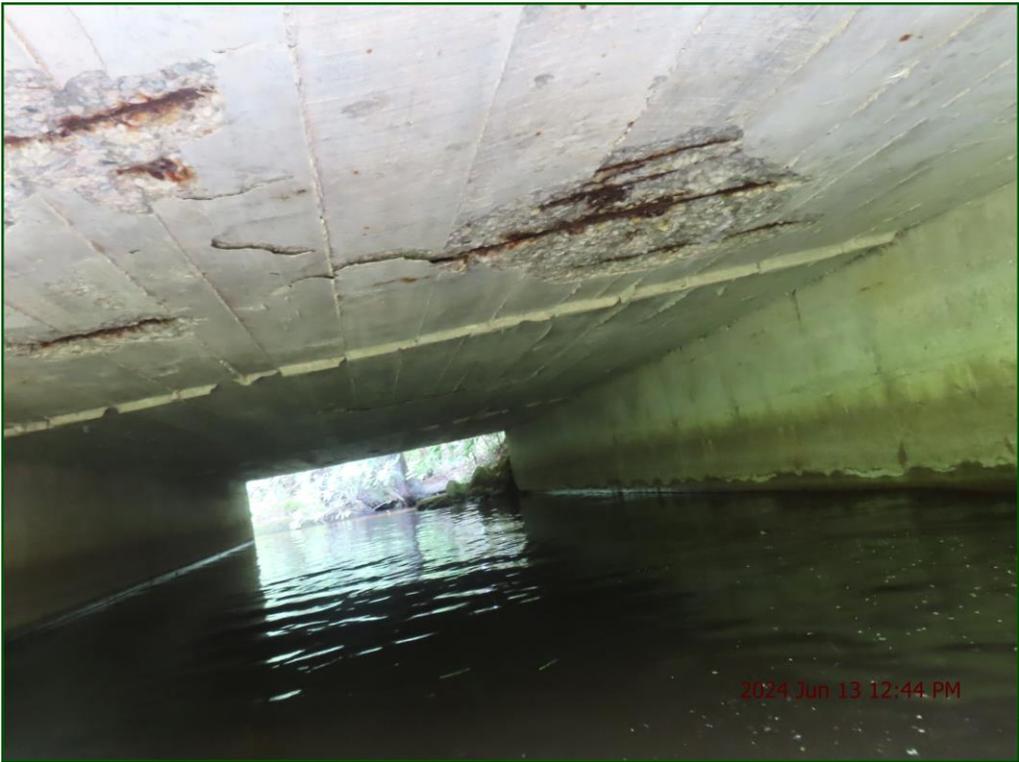
Description: Barrel: Shallow to severe delaminations with exposed reinforcing throughout.

Shallow to severe delaminations with exposed reinforcing throughout.

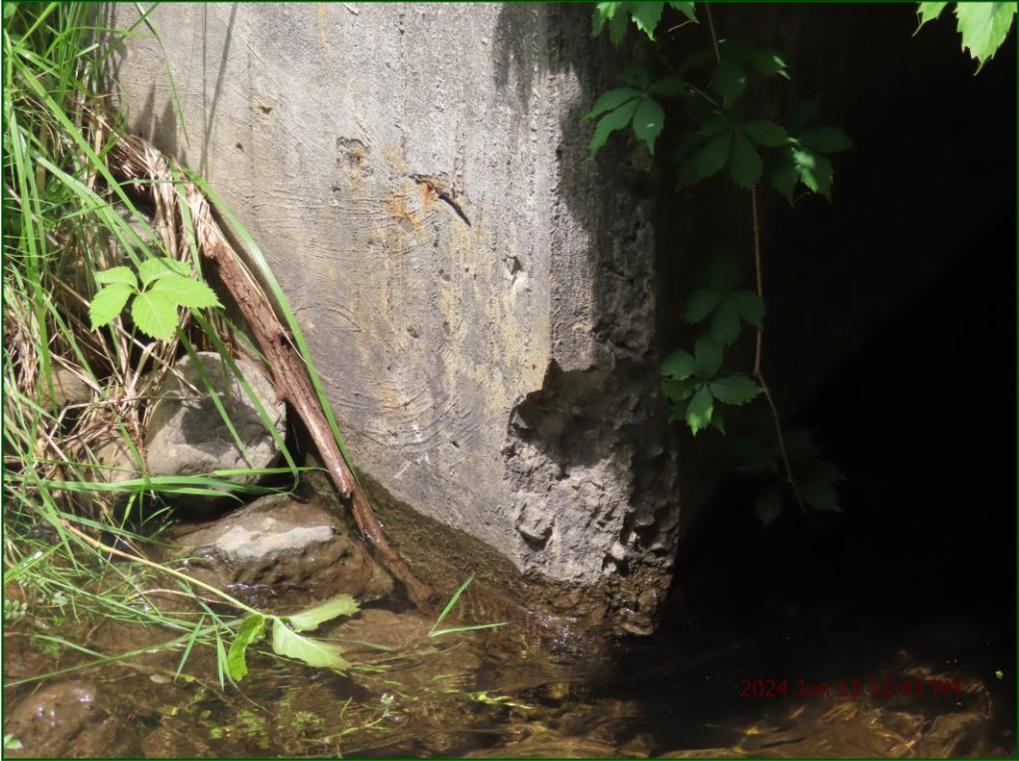
Description: Inlet: Shallow spill.

Shallow spall. Light horizontal cracking with leachate staining.

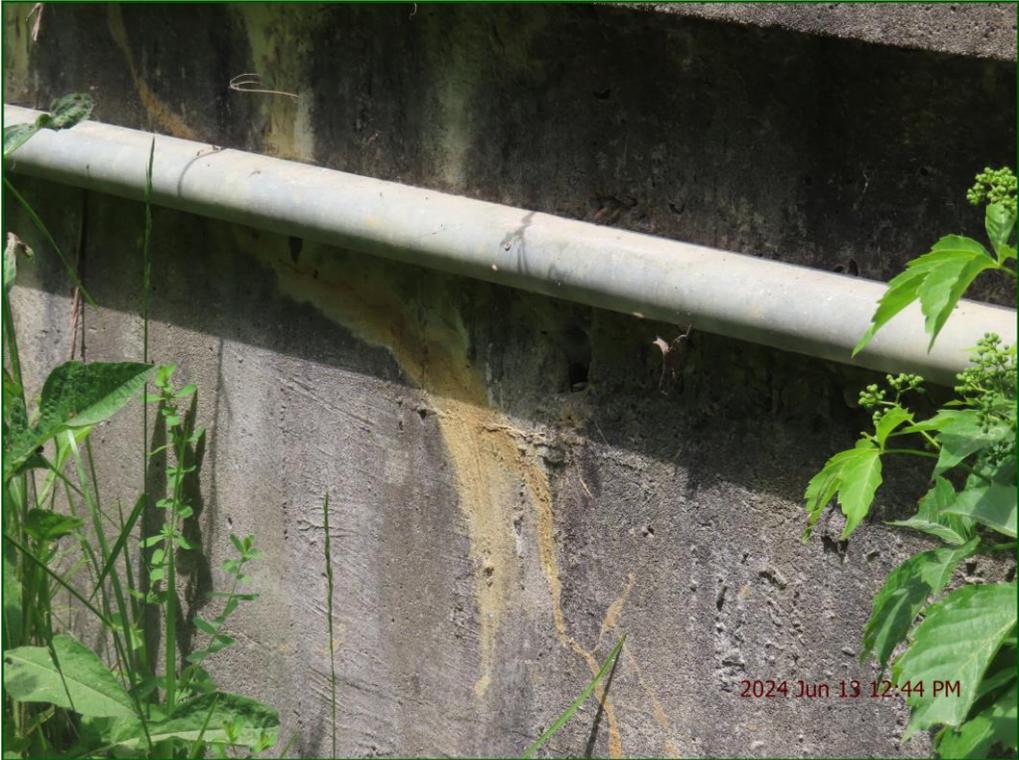
Description: Inlet: Light horizontal cracking with leachate staining.
