Structure Name:	Concession 4 NDR Lot 30 Culvert	Site Number:	B-105
District:		Road Name:	Concession 4
County:	Grey County	Owner:	West Grey
Township:	West Grey	Skew:	0
Bridge or Culvert:	Culvert	AADT:	250
Structure Type:	CSP (arch)	Overall Struct. Width:	25 m
Number of Spans:	2	Roadway Width:	6.6 m
Direction of Structure:	North-South	Total Deck Length:	7.4 m
GPS Coordinates (Degrees)		Span (s):	5.4 m
General	Latitude: 44.211104	Total Deck Area:	185 sq.m
	Longitude: -80.895677	Current Load Limit:	0

Inspection Data

Date of Inspection:	10-Jun-24
Name of Inspector:	A. Burgess P.Eng. & J. Ziegler CET
Equipment Used:	Sounding hammer, measuring equipment, GPS
Weather Conditions:	Cloudy
Temperature:	12
Special Notes:	Culvert is in good condition, recommend railing system repair.

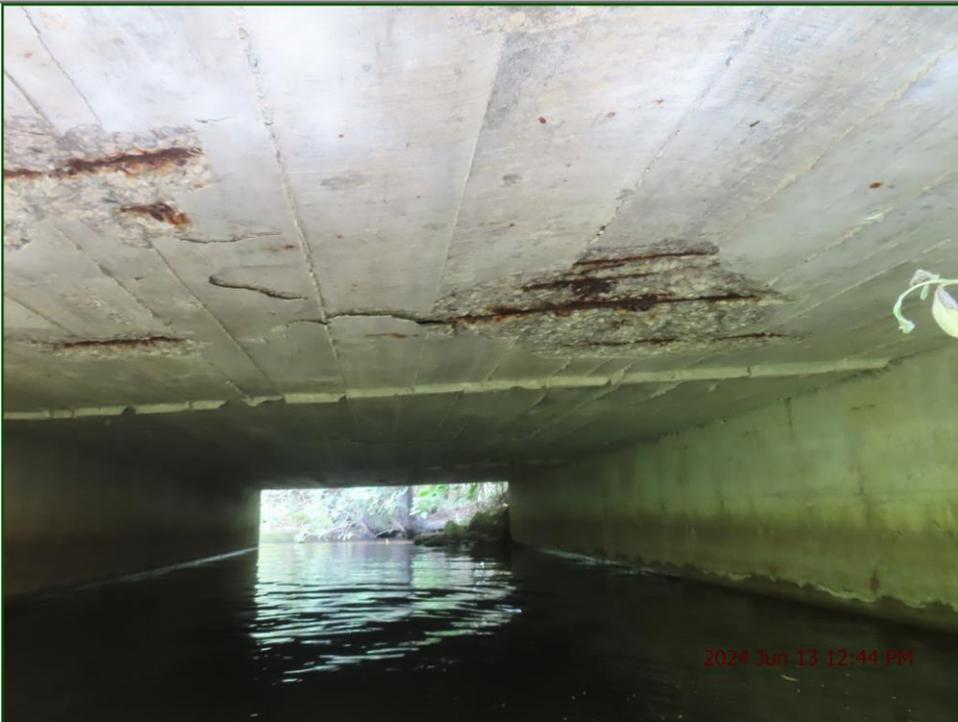
Shallow to severe delaminations with exposed reinforcing throughout.

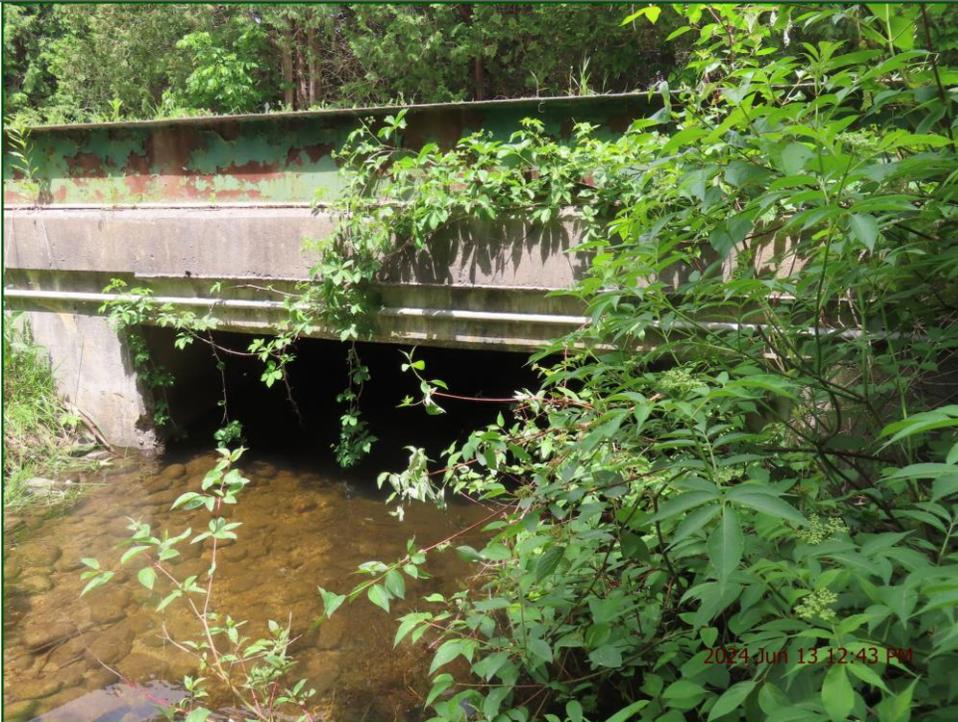
Shallow spall. Light horizontal cracking with leachate staining.

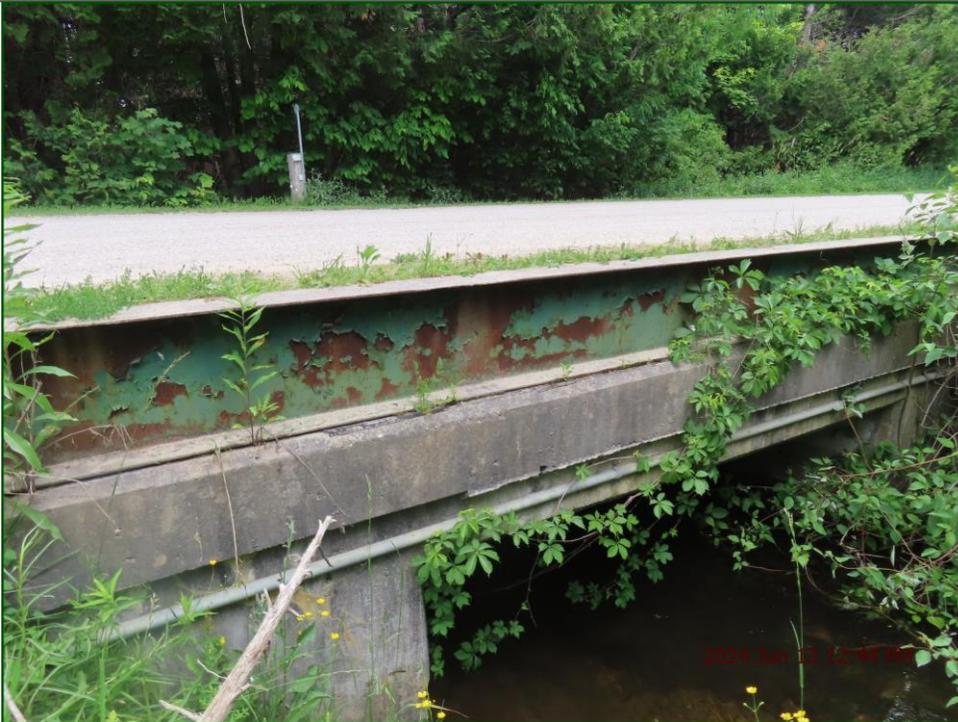
Light corrosion throughout.

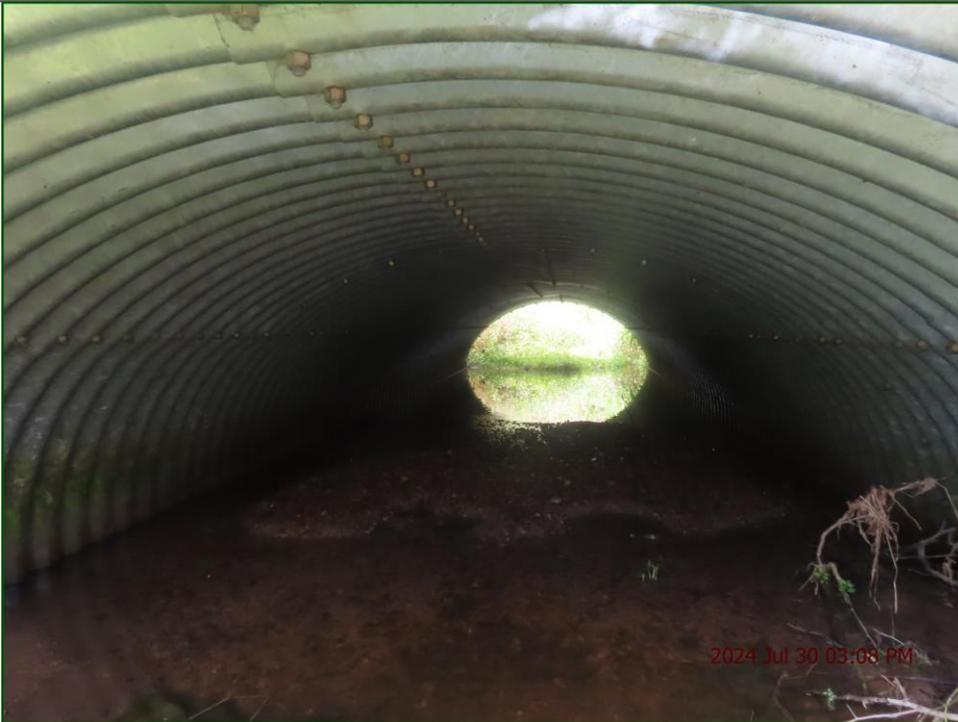
Minor deformations throughout.

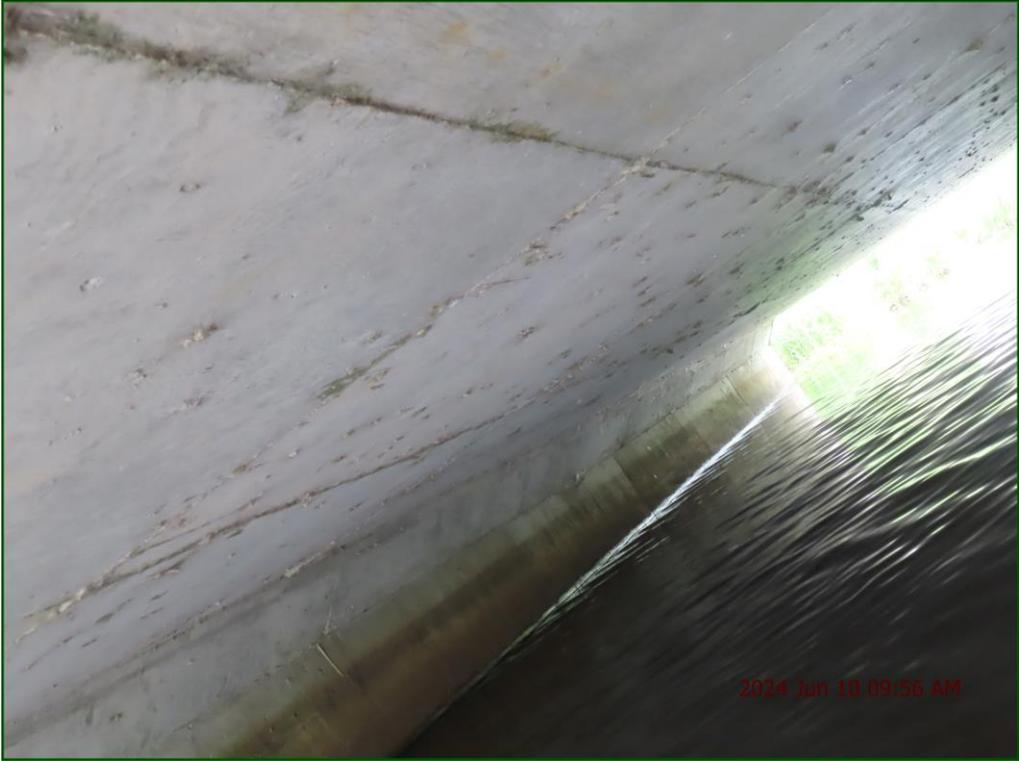
Description: Barrel: Medium longitudinal crack with leachate staining and stalactite (2/2).

Medium longitudinal crack with leachate staining and stalactite mid barrel.

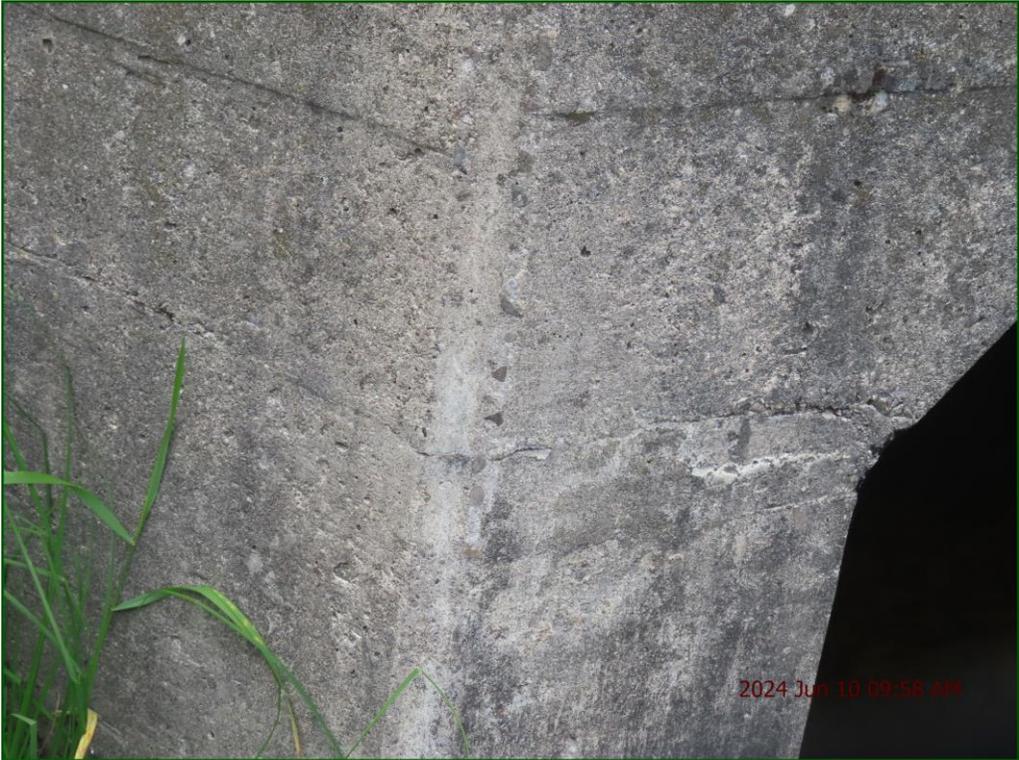
Description: Inlet: Medium horizontal crack.

Medium horizontal crack.

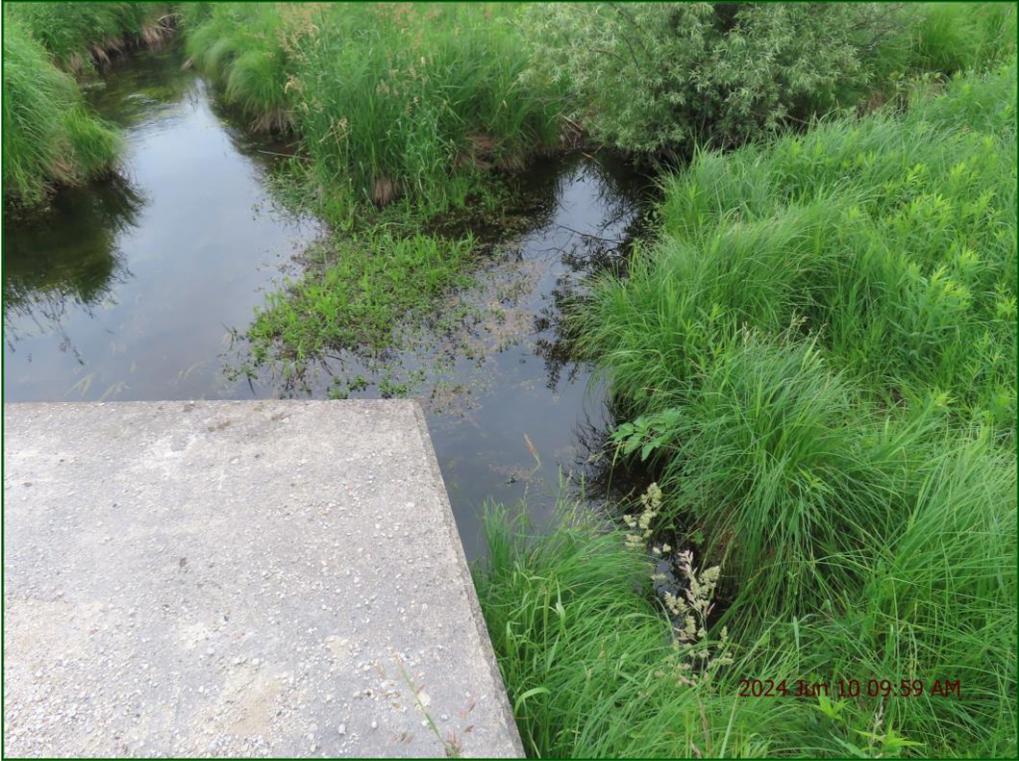
Description: S&W: Heavy flow at time of inspection causing stream to be wider than culvert.

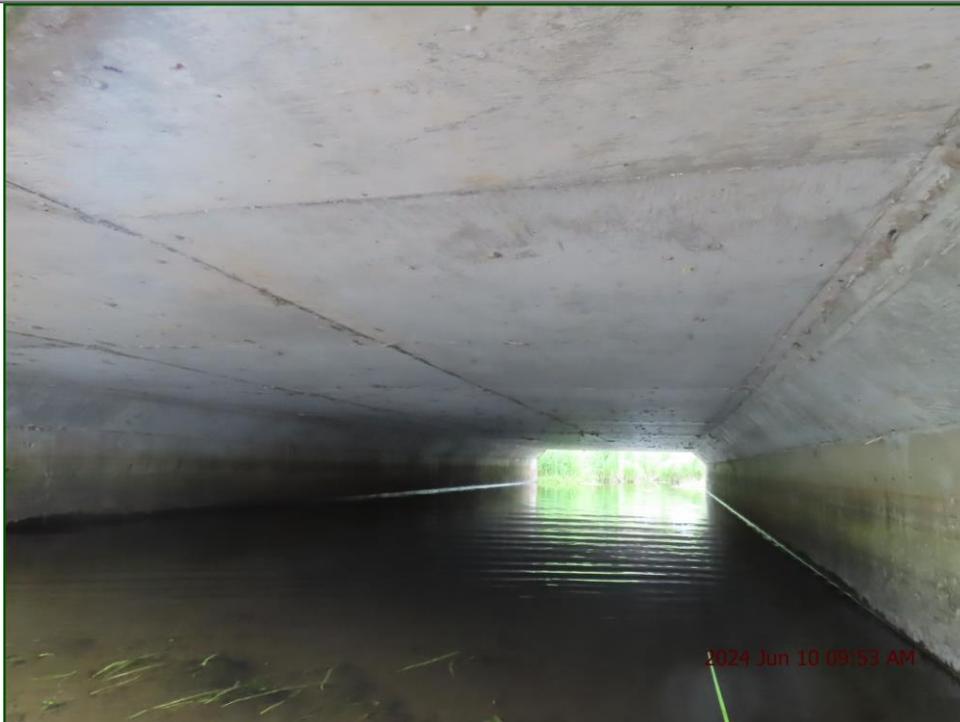
Description: Barrel: Medium longitudinal crack with leachate staining and stalactite (1/2).

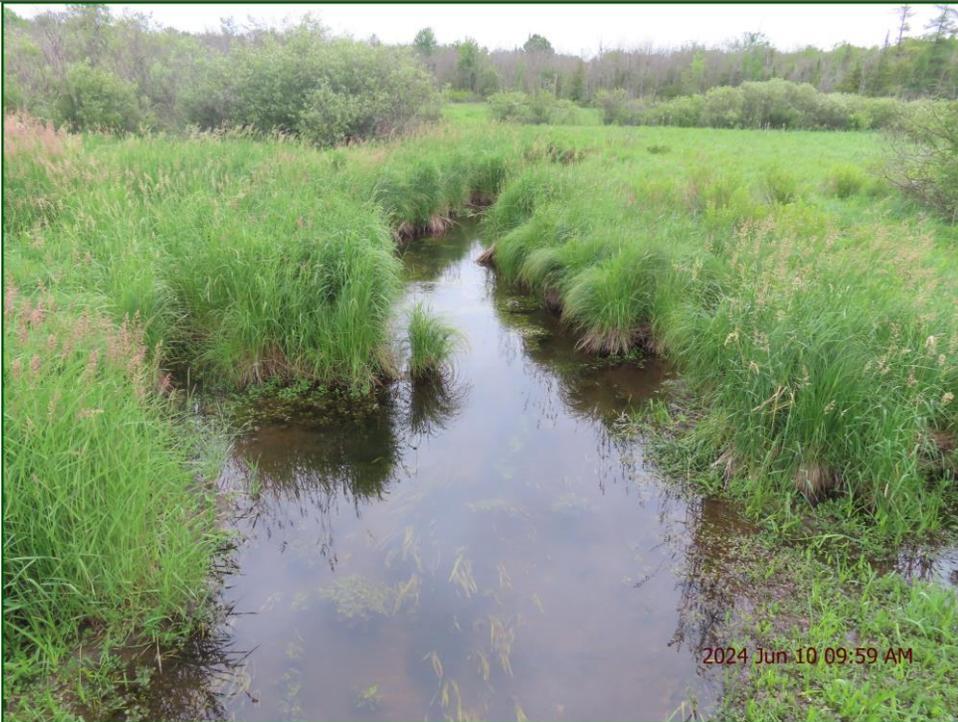
Heavy flow at time of inspection causing stream to be wider than culvert. Heavy sedemant build up causing difficult to inspect thouroughly.

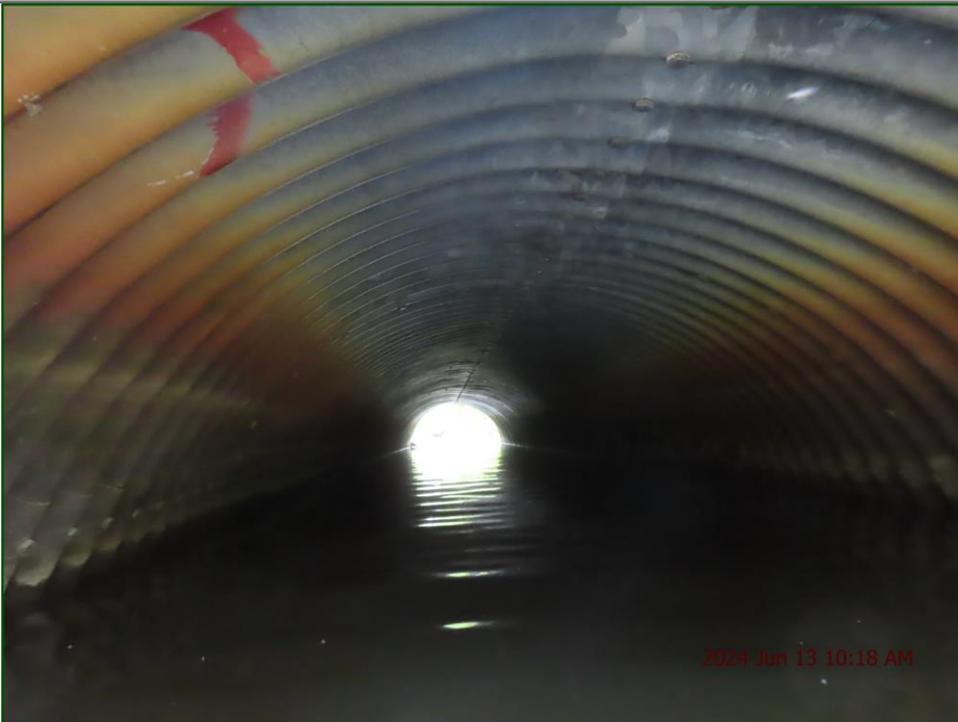
Improper splice bolt pattern, no cracking noted. Light corrosion at waterline.

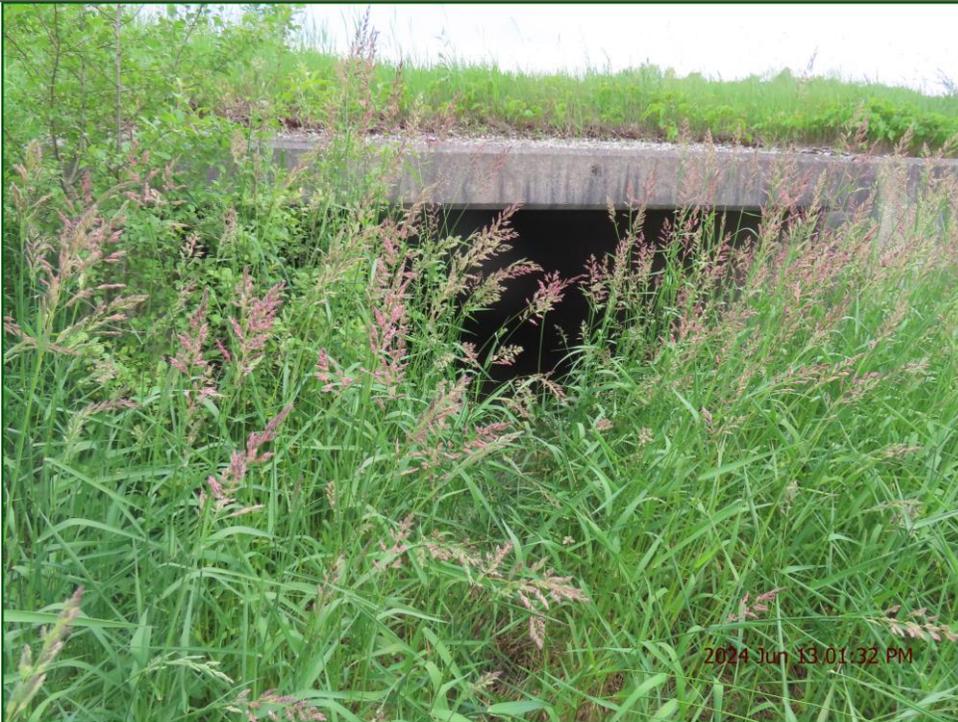
Description: Outlet: Medium to wide crack.

Medium to wide crack.

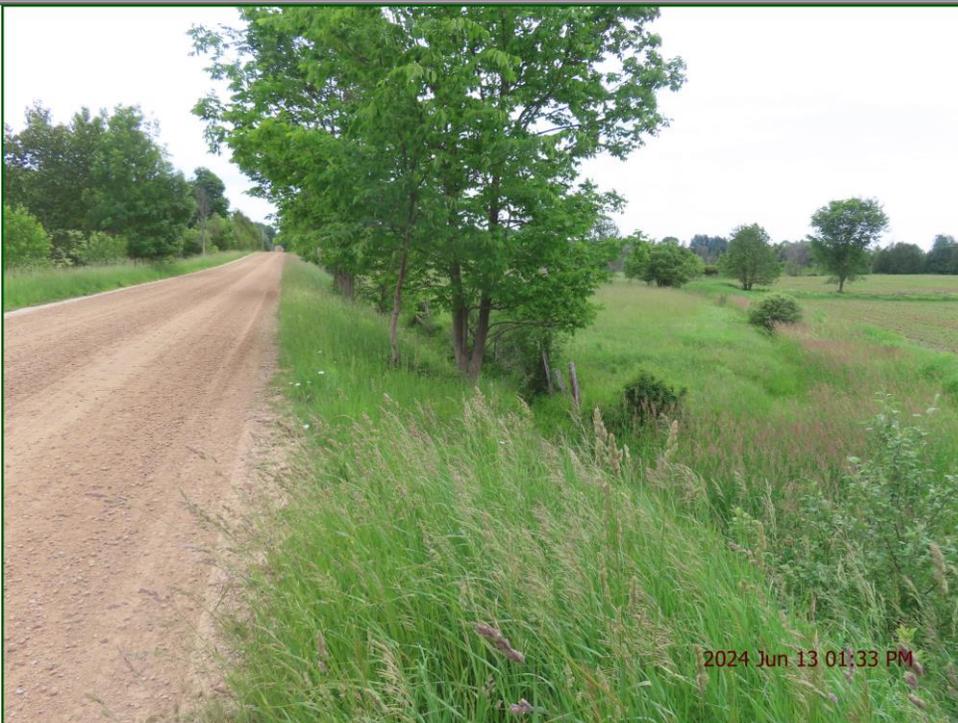
Steep embankments.

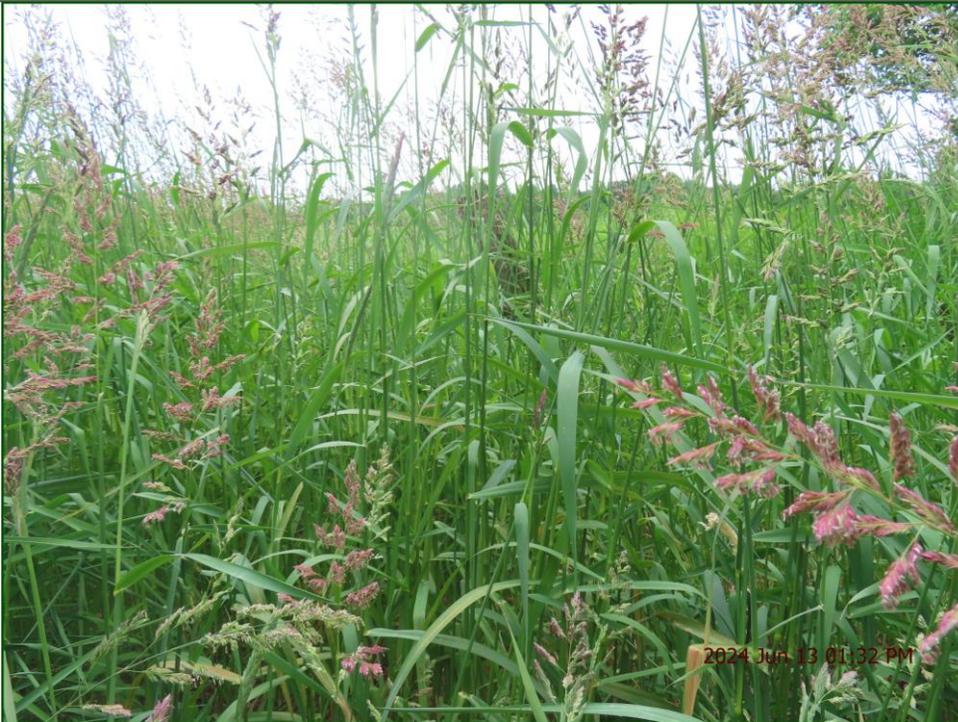
Stream dry at time of inspection.

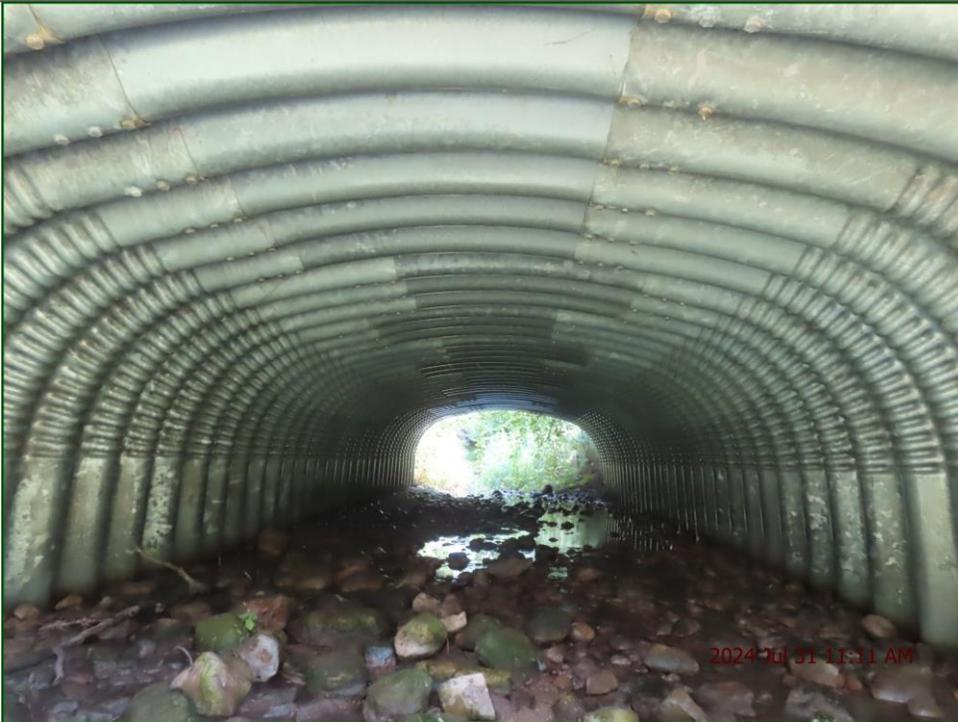
Minor deformations in barrel.

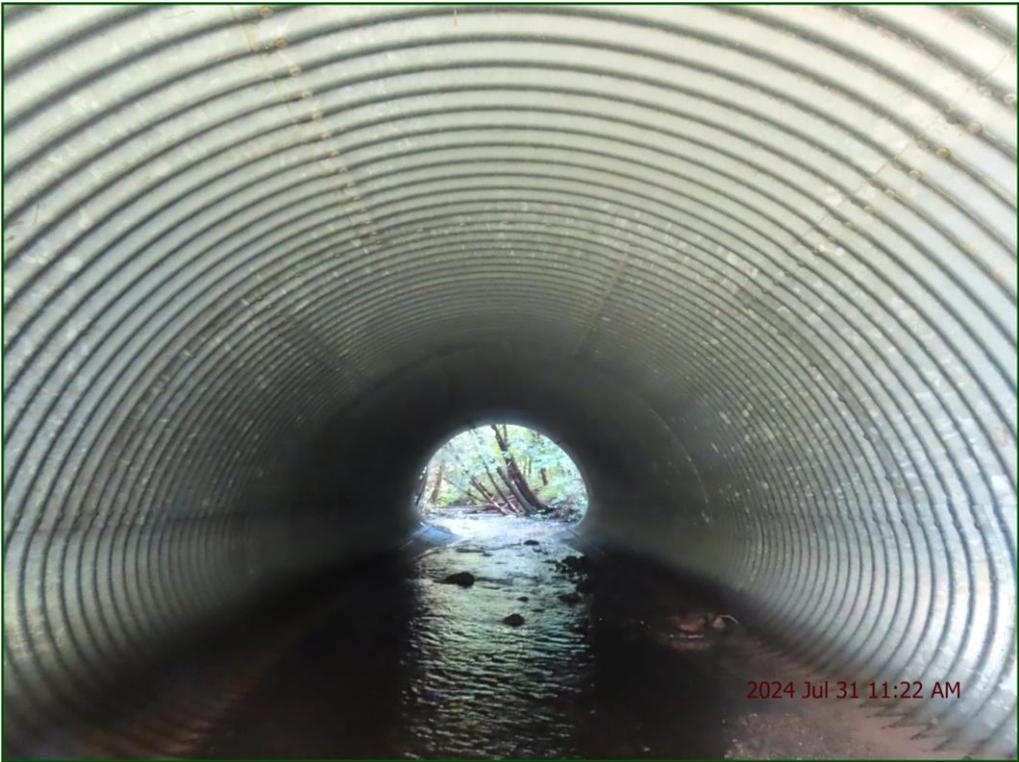
Description: Barrel: View from west.

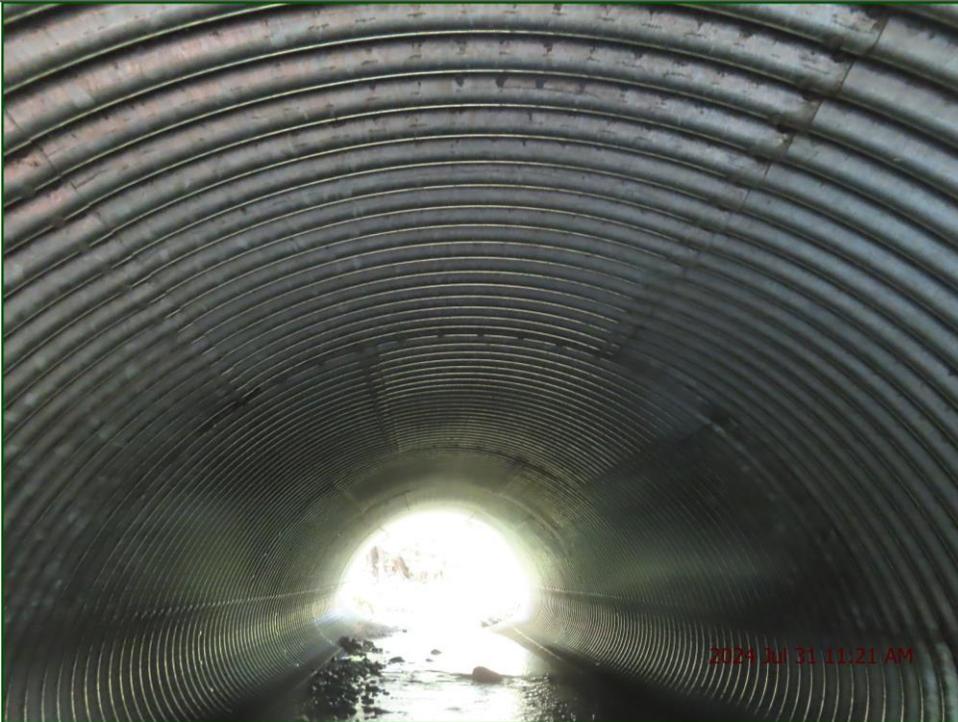
Light corrosion along waterline.

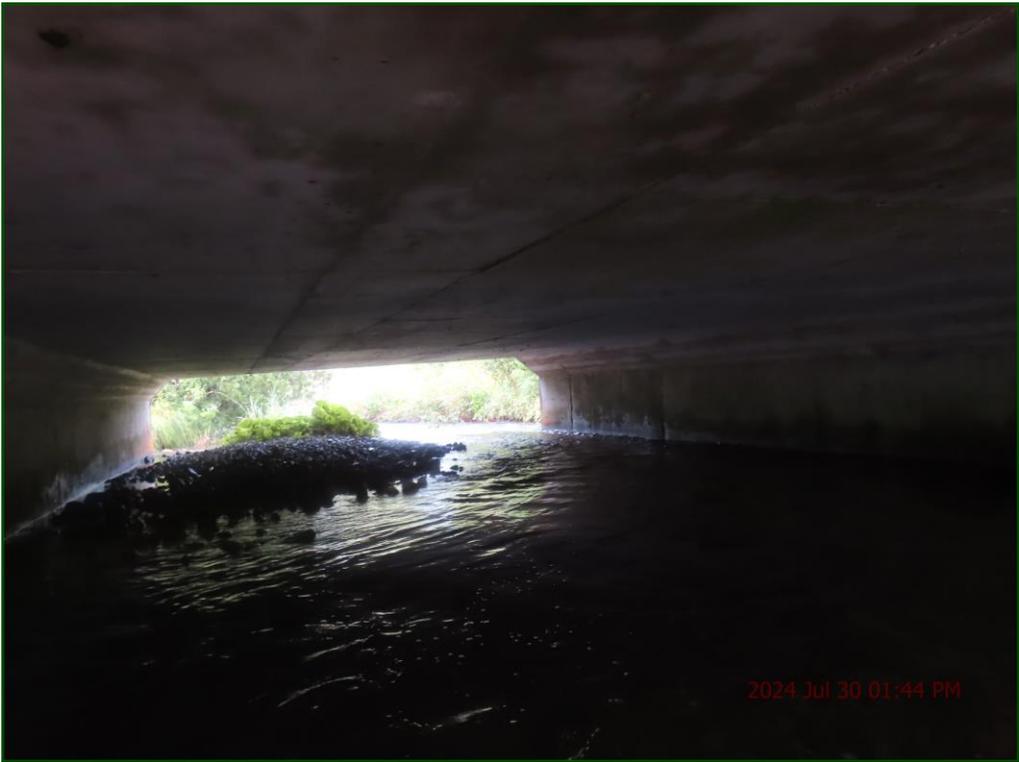
Description: Barrel: View from south.

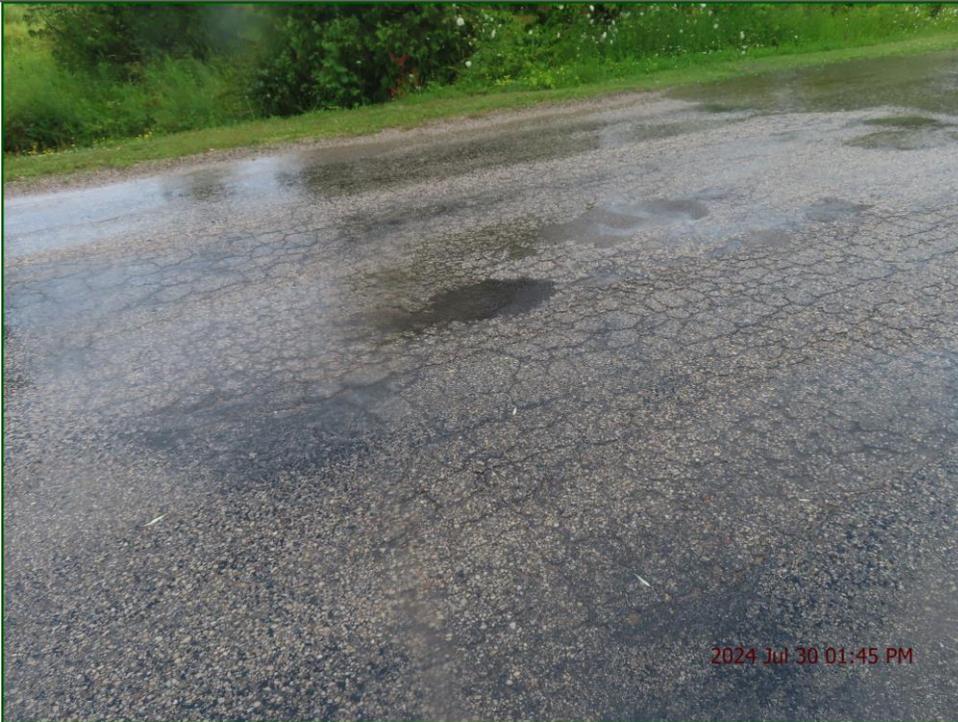
Severe alligator cracking throughout. Road should be resurfaced.

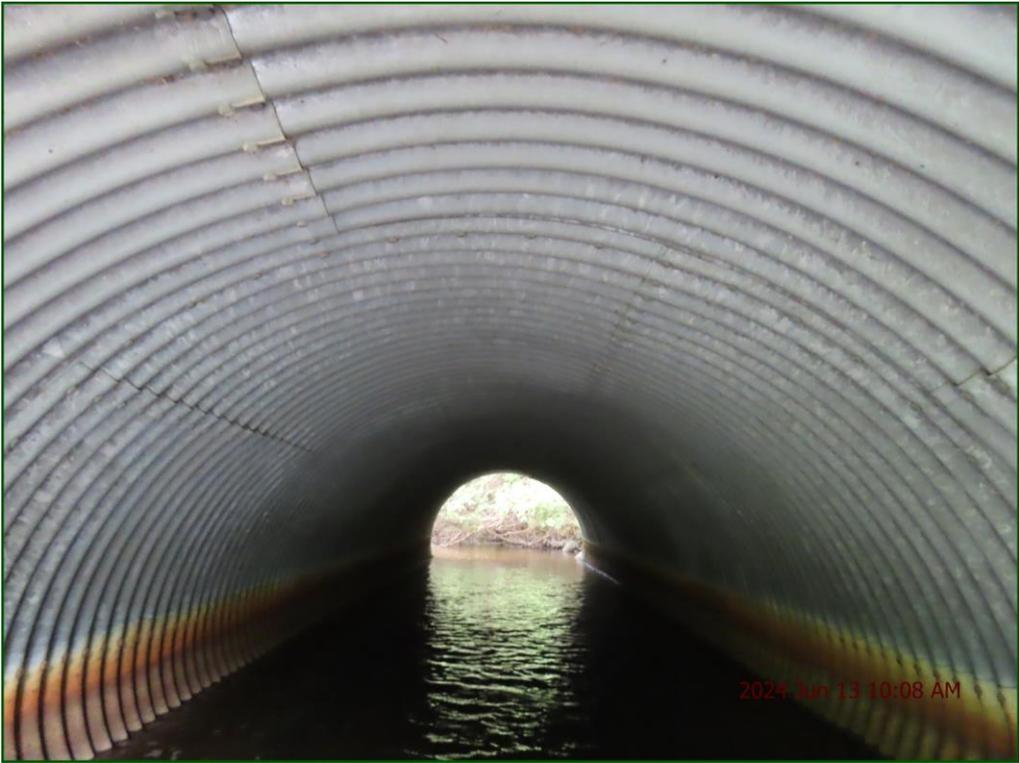
Description: Barrel: View from east.

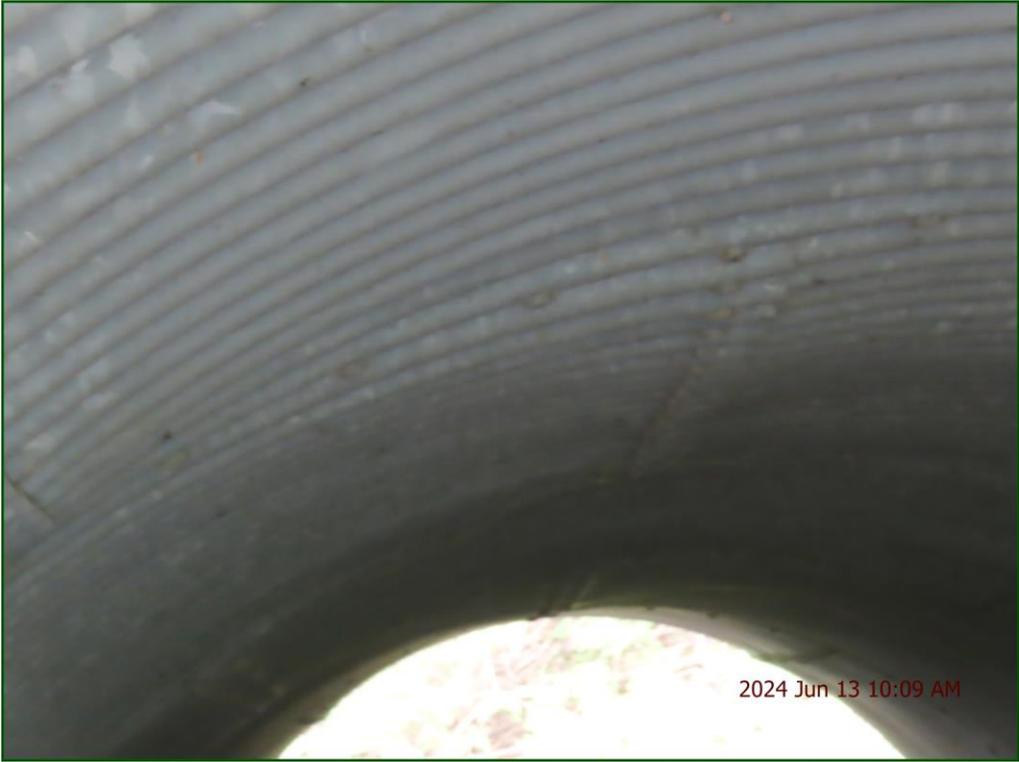
Description: Barrel: Minor sag in mid barrel.

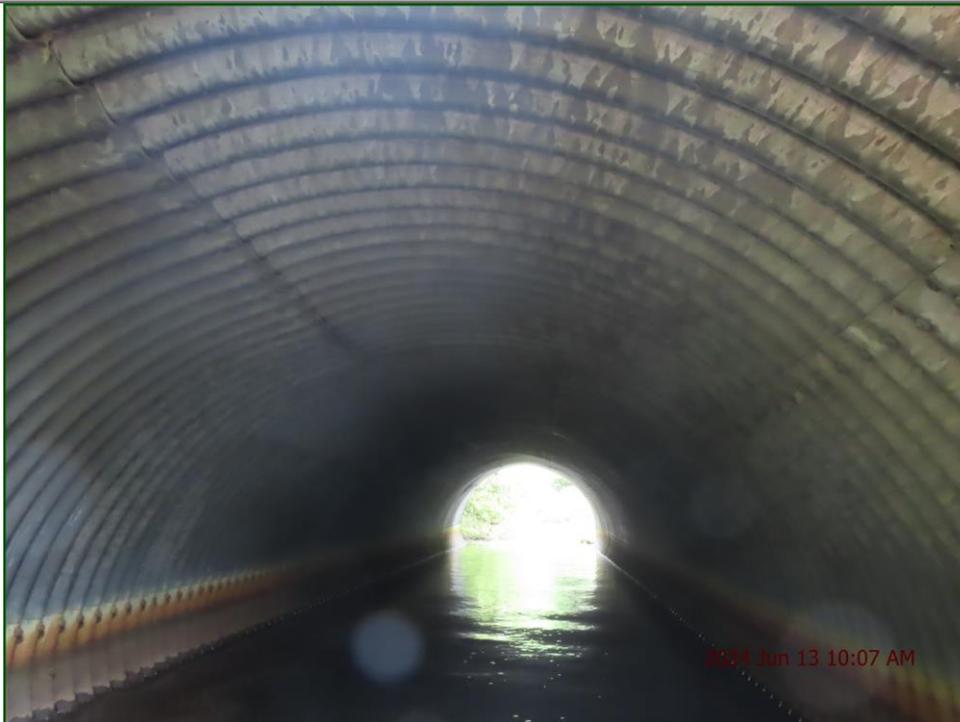
Improper splice bolt pattern, no cracking noted. Light to medium rust along waterline. Minor sag in mid barrel.

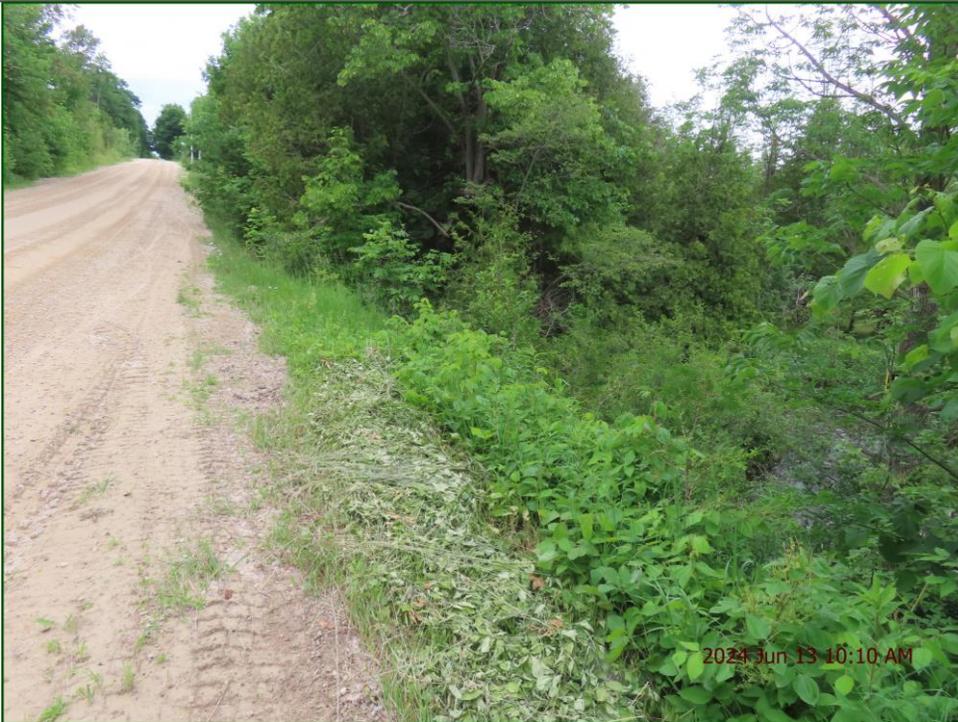
Steep embankments recommend protection.

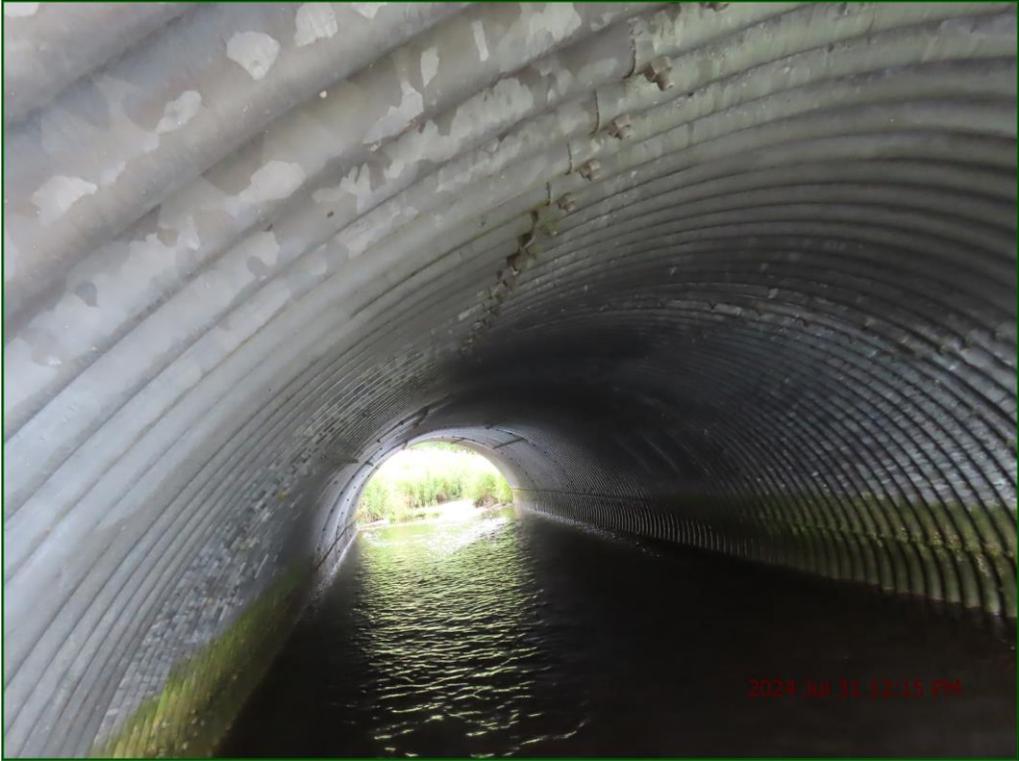
Description: Barrel: View from north.

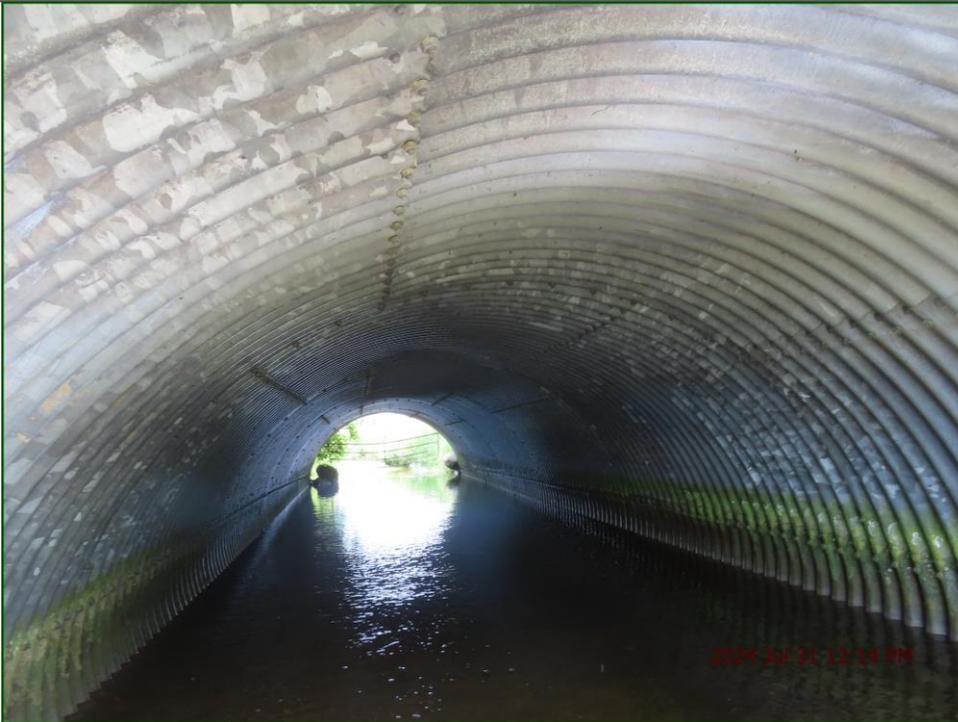
Improper splice bolt pattern, no signs of cracking. Light corrosion along waterline.

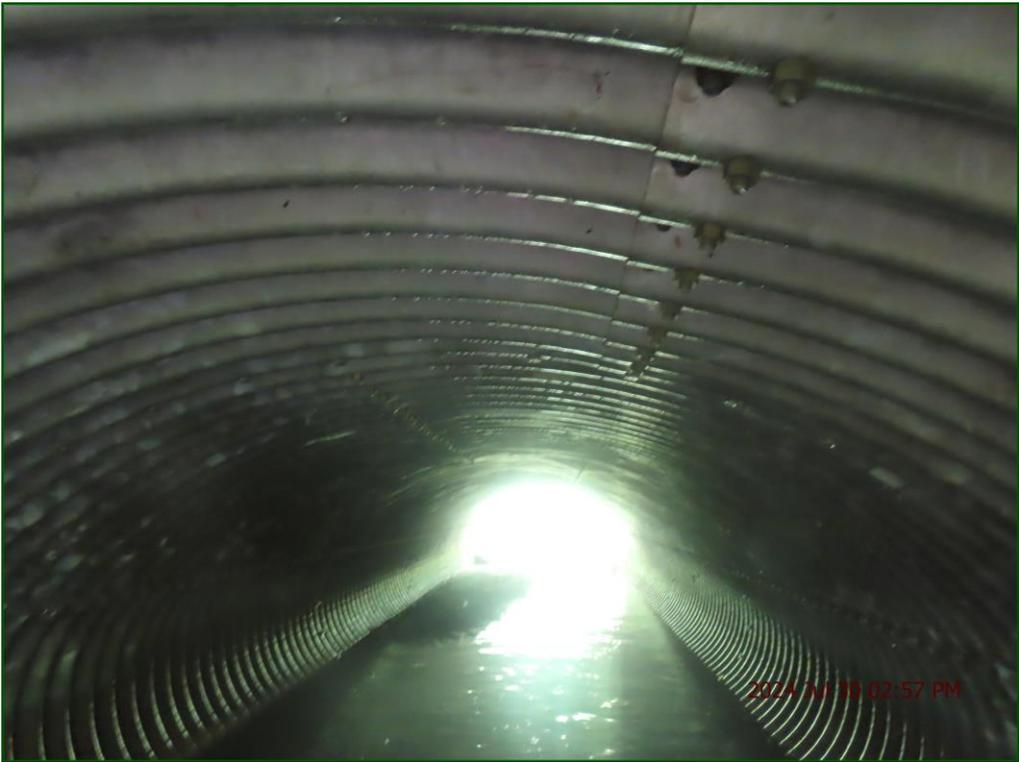
Description: Barrel: View from west.

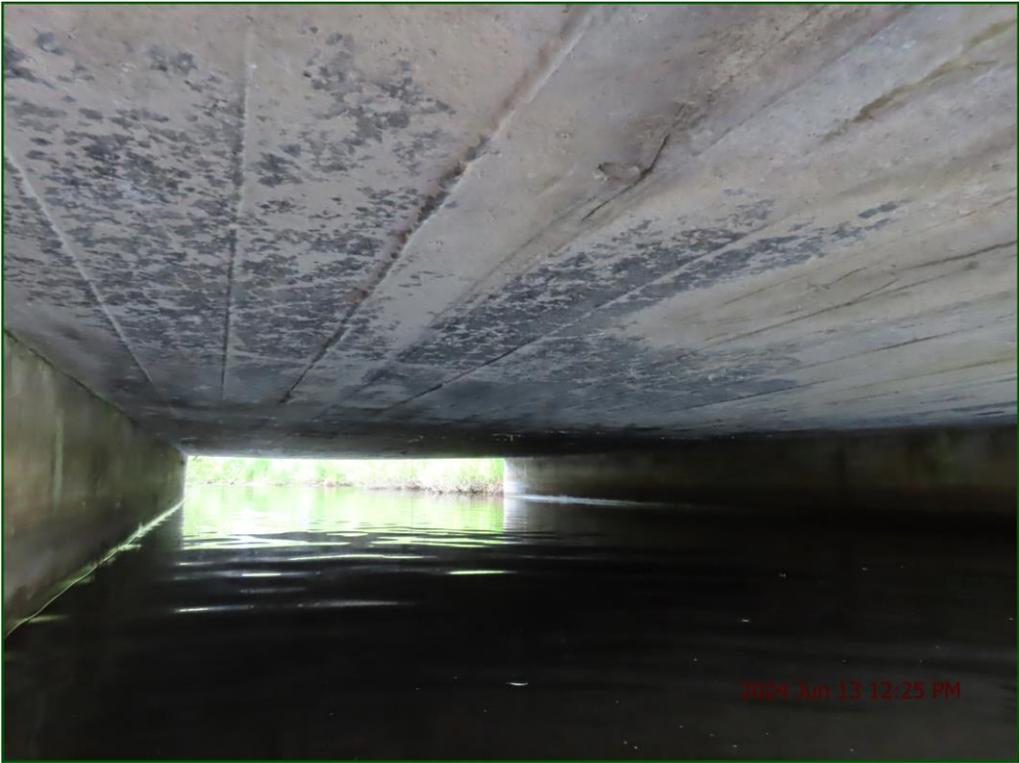
Description: Barrel: View from north.

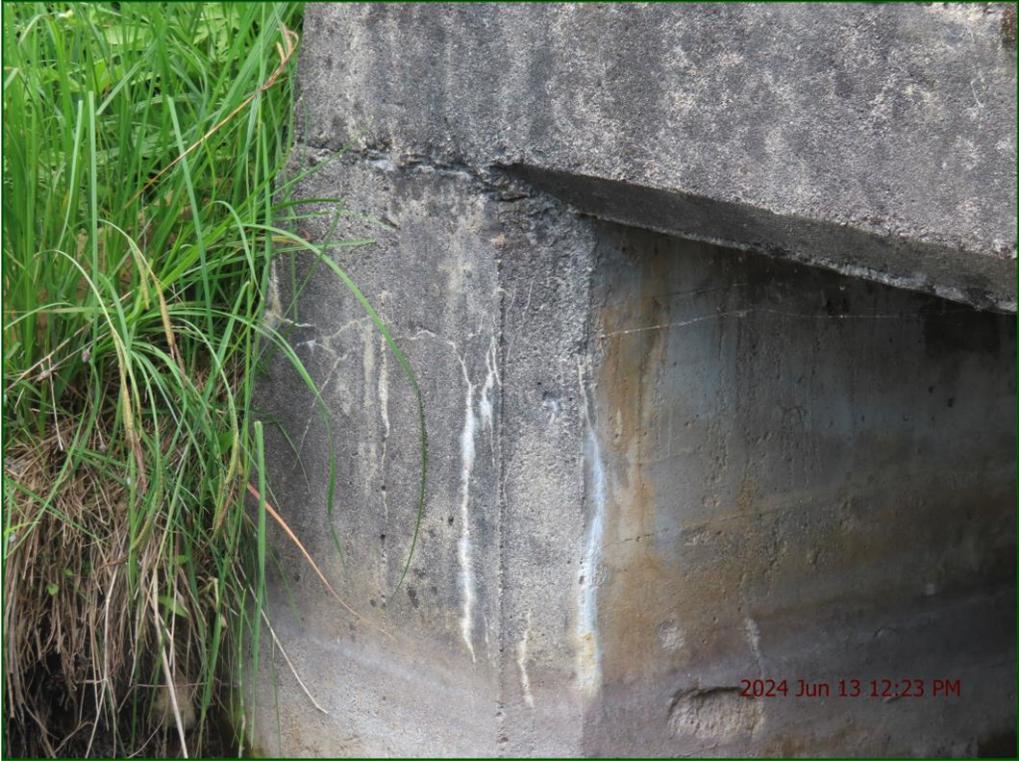
Description: Outlet: Medium cracking and shallow delaminations at construction joints.

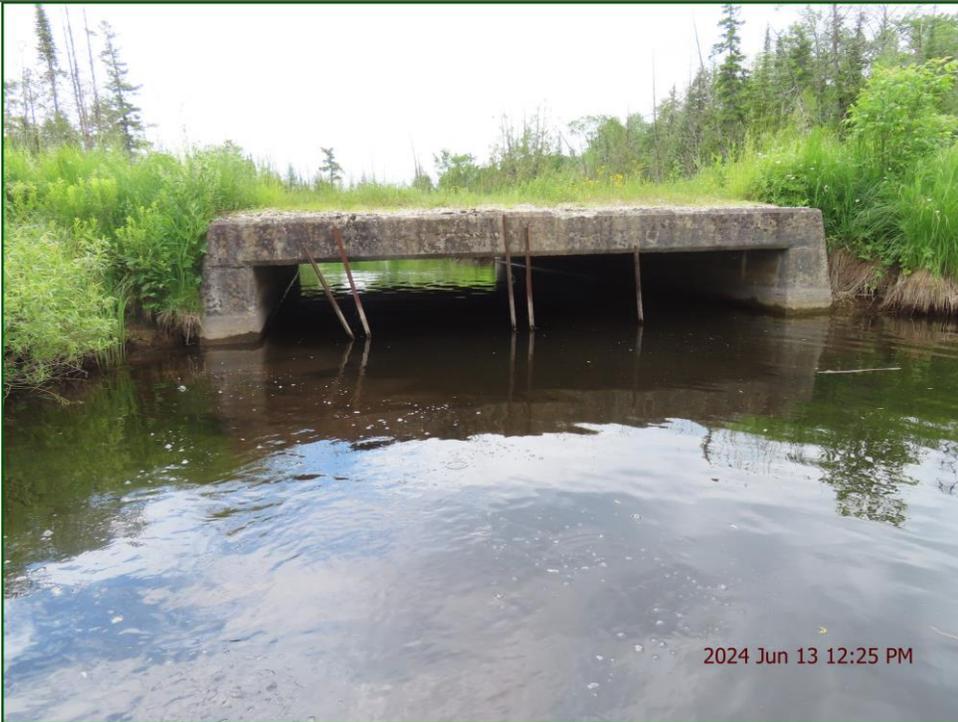
Medium cracking at construction joints, possible sign of inward rotation. No signs of movement since last inspection, continue to monitor for further movement.

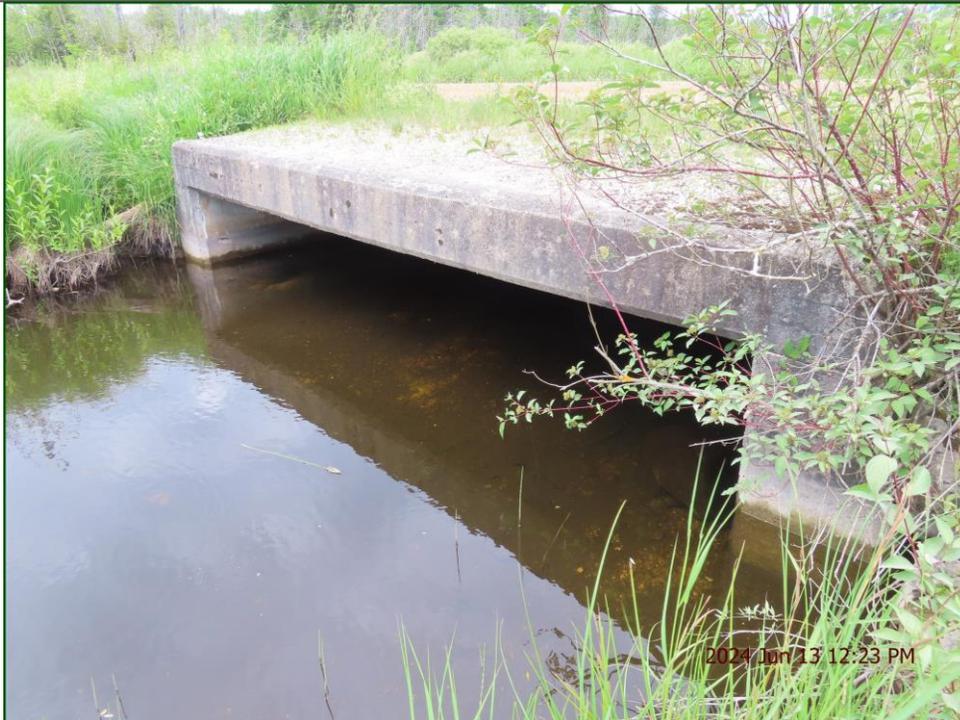
Medium cracking and shallow delaminations at construction joints, possible sign of inward rotation. No signs of movement since last inspection, continue to monitor for further movement.

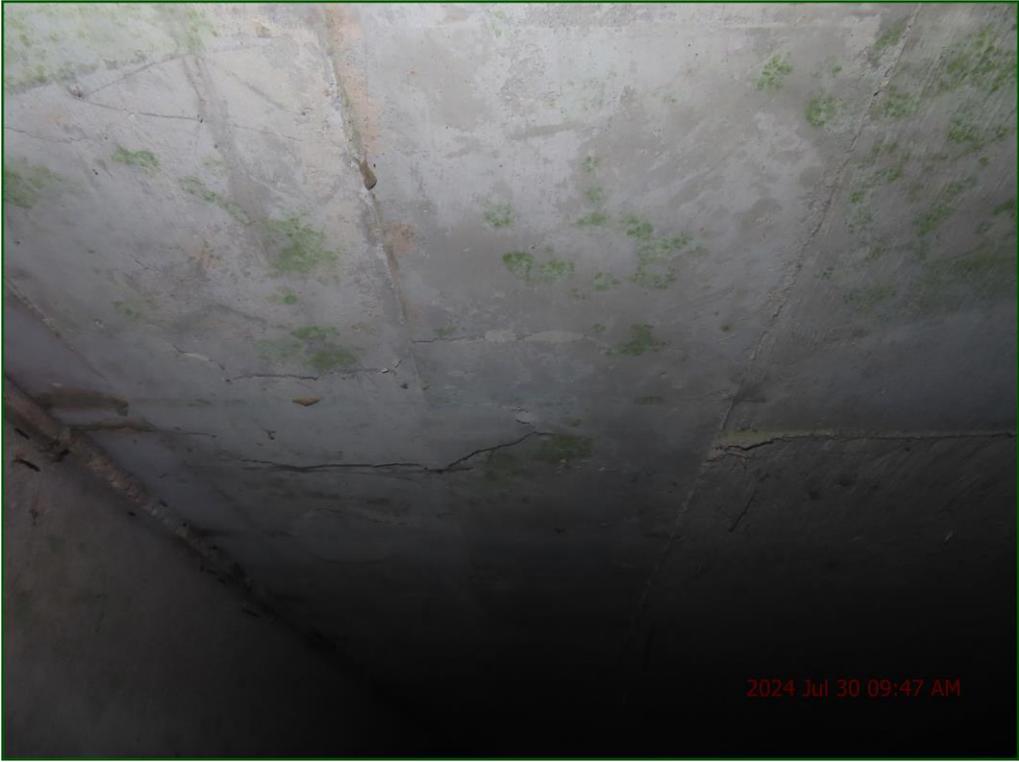
Description: Barrel: Shallow delamination throughout.

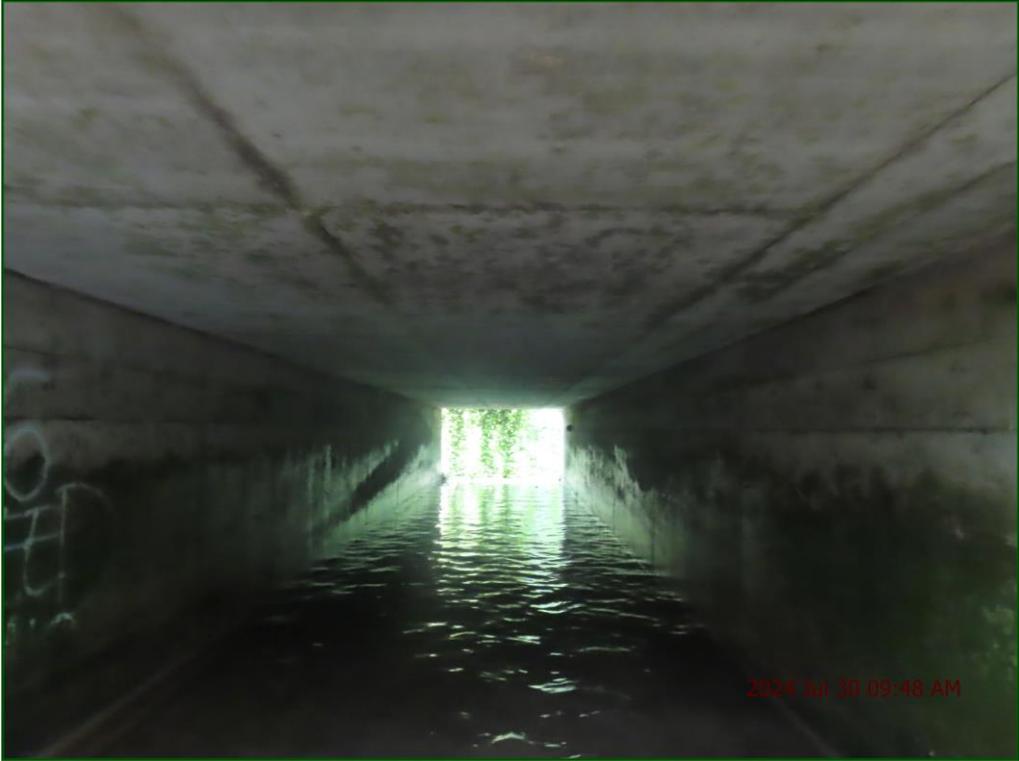
Description: Barrel: View from west.
