Structure Name:	Concession 4 NDR Lot 30 Culvert	Site Number:	B-105
District:		Road Name:	Concession 4
County:	Grey County	Owner:	West Grey
Township:	West Grey	Skew:	0
Bridge or Culvert:	Culvert	AADT:	250
Structure Type:	CSP (arch)	Overall Struct. Width:	25 m
Number of Spans:	2	Roadway Width:	6.6 m
Direction of Structure:	North-South	Total Deck Length:	7.4 m
GPS Coordinates (Degrees)		Span (s):	5.4 m
General	Latitude: 44.211104	Total Deck Area:	185 sq.m
	Longitude: -80.895677	Current Load Limit:	0

Inspection Data

Date of Inspection:	10-Jun-24
Name of Inspector:	A. Burgess P.Eng. & J. Ziegler CET
Equipment Used:	Sounding hammer, measuring equipment, GPS
Weather Conditions:	Cloudy
Temperature:	12
Special Notes:	Culvert is in good condition, recommend railing system repair.

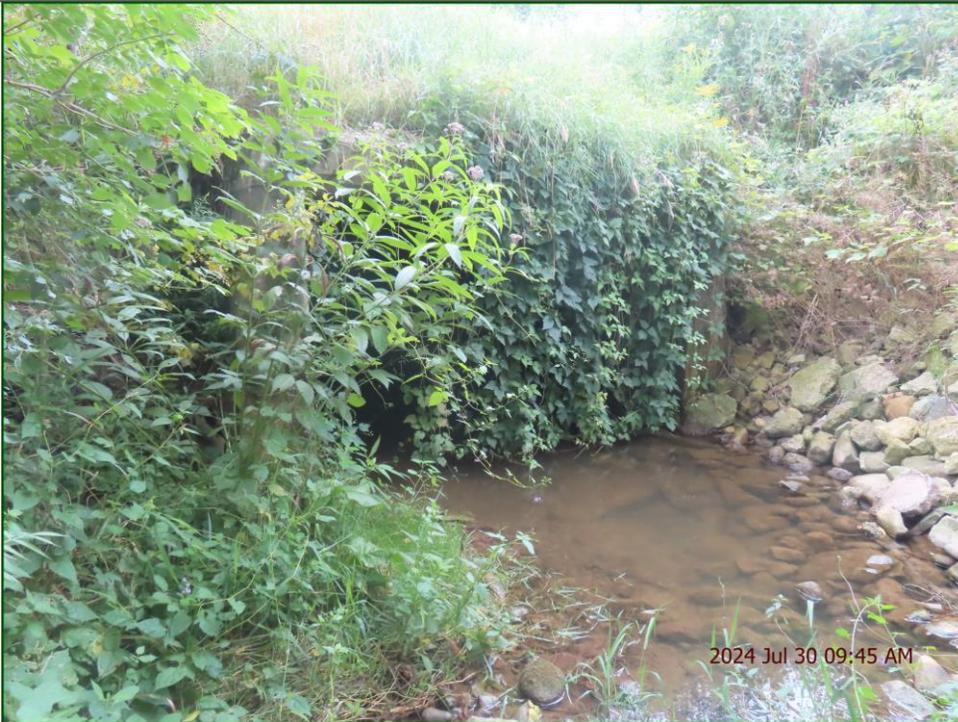
Minor seperation on outside of construction joint, possible sign of slight wall rotation, continue to monitor.

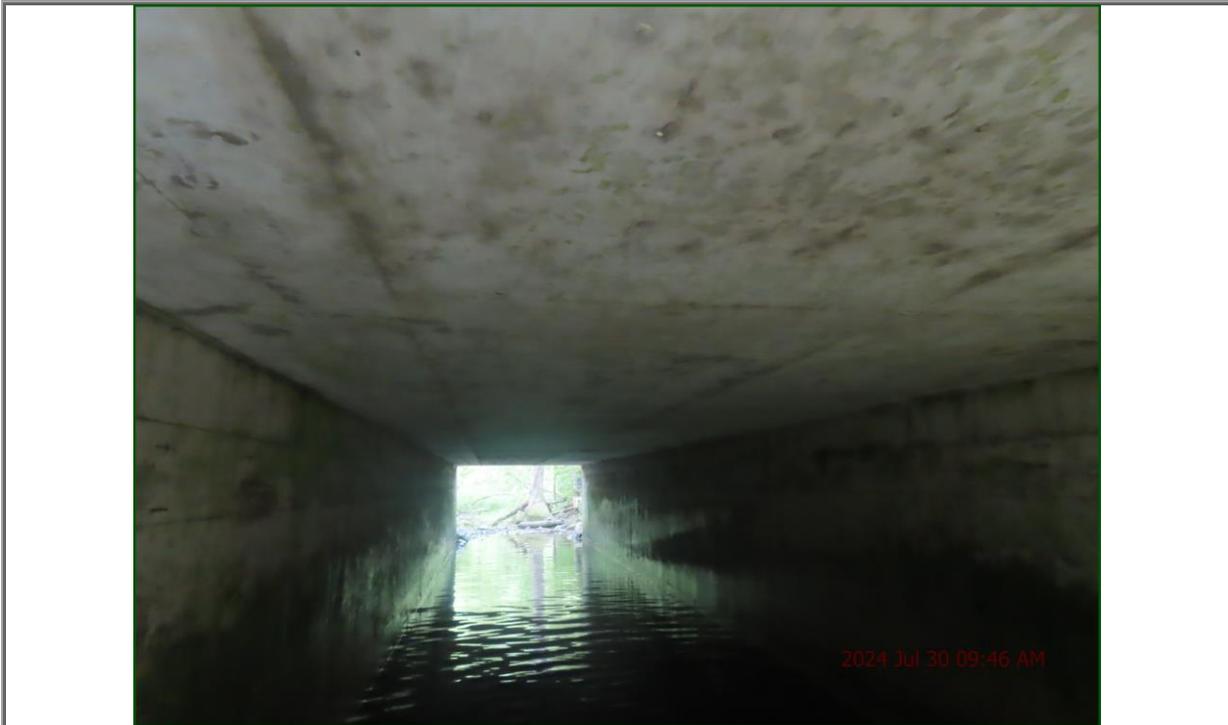
Shallow delamination throughout.

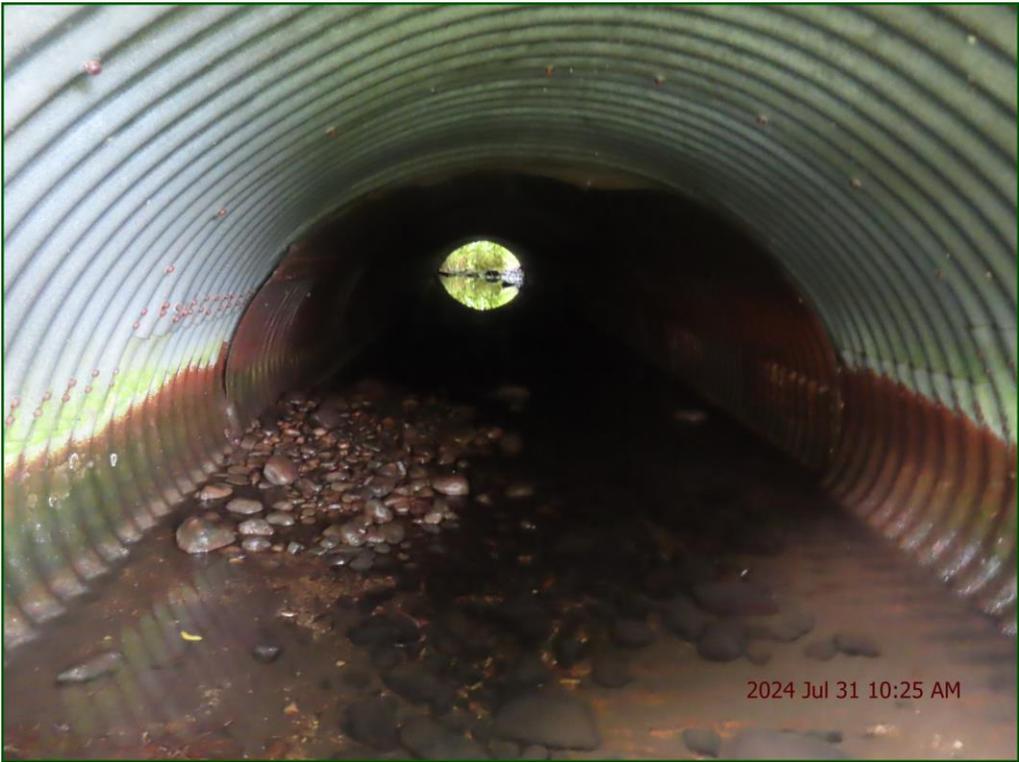
Description: Barrel: View from north.

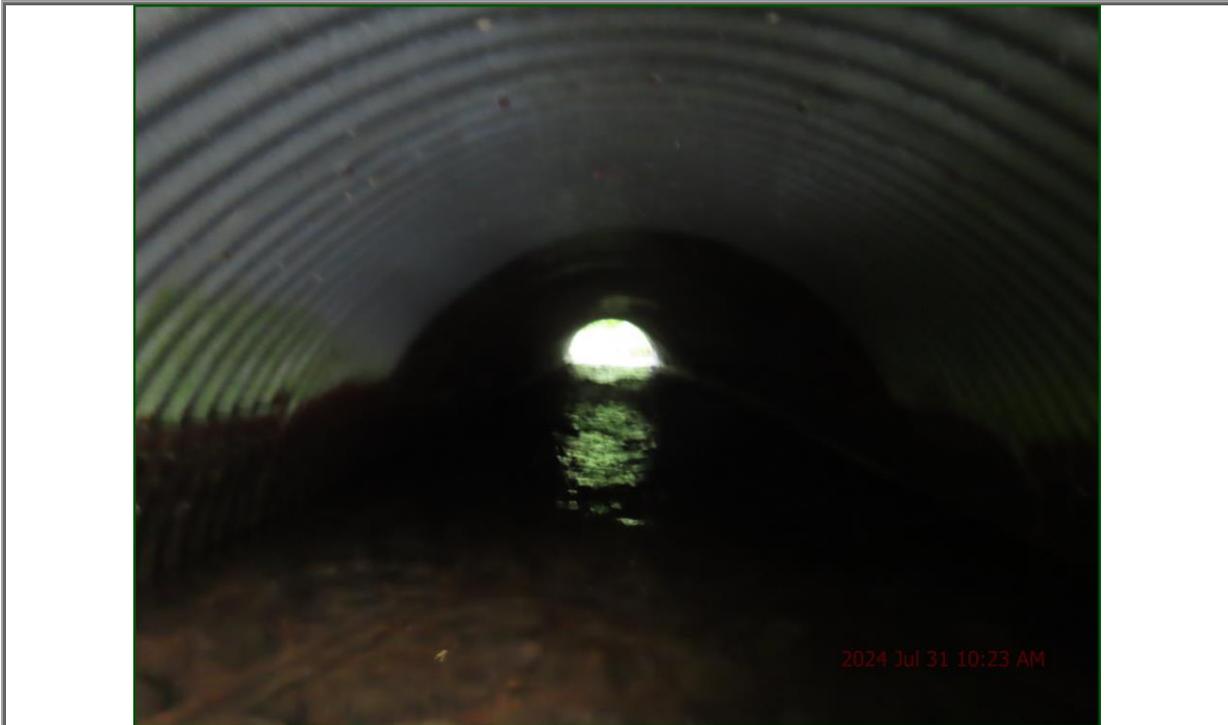
Only middle barrel functioning properly as other two barrels are filled with sediment. Light to medium corrosion in base region.

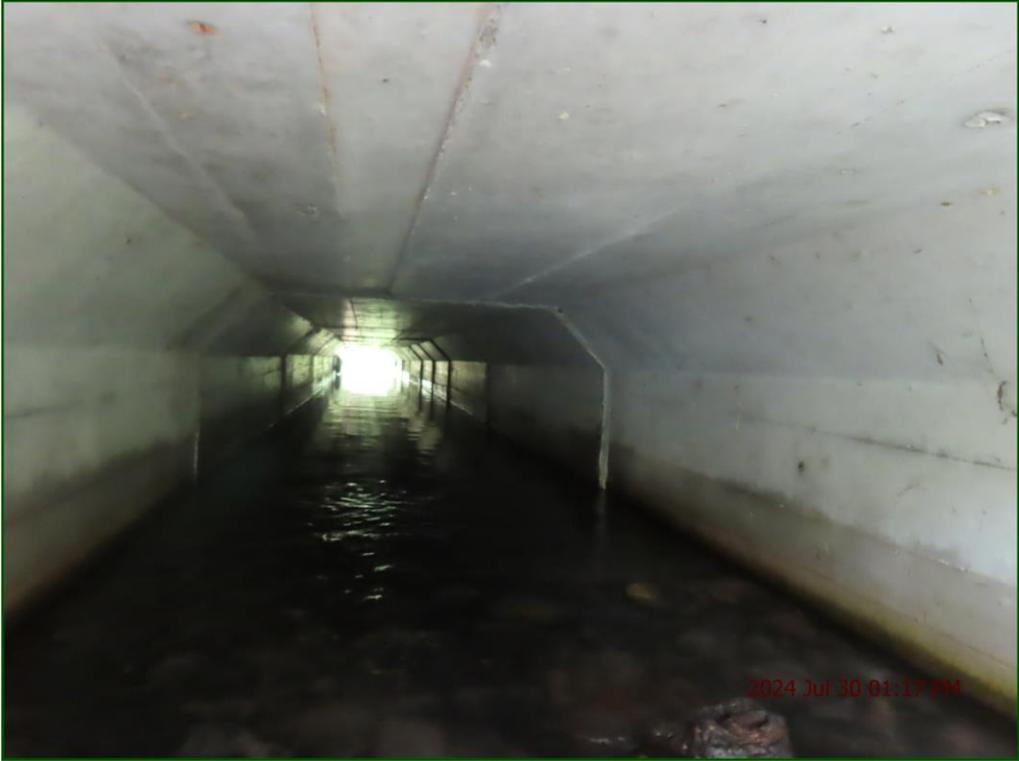
Description: Barrel: View from east.

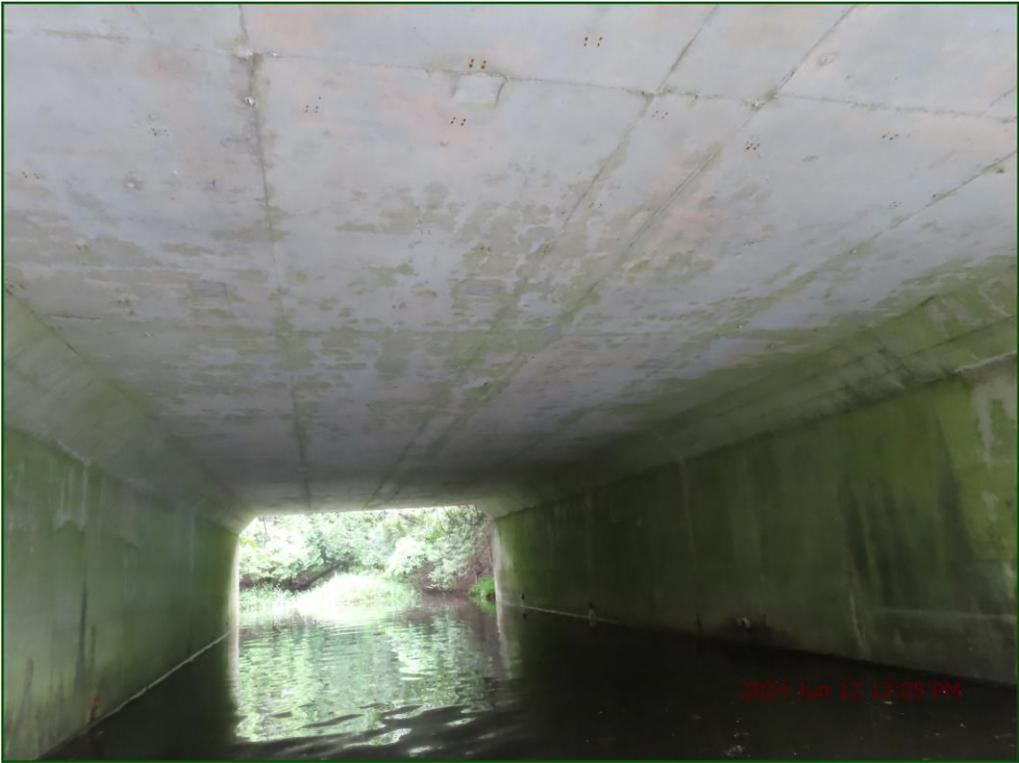
Description: Barrel: View from west.

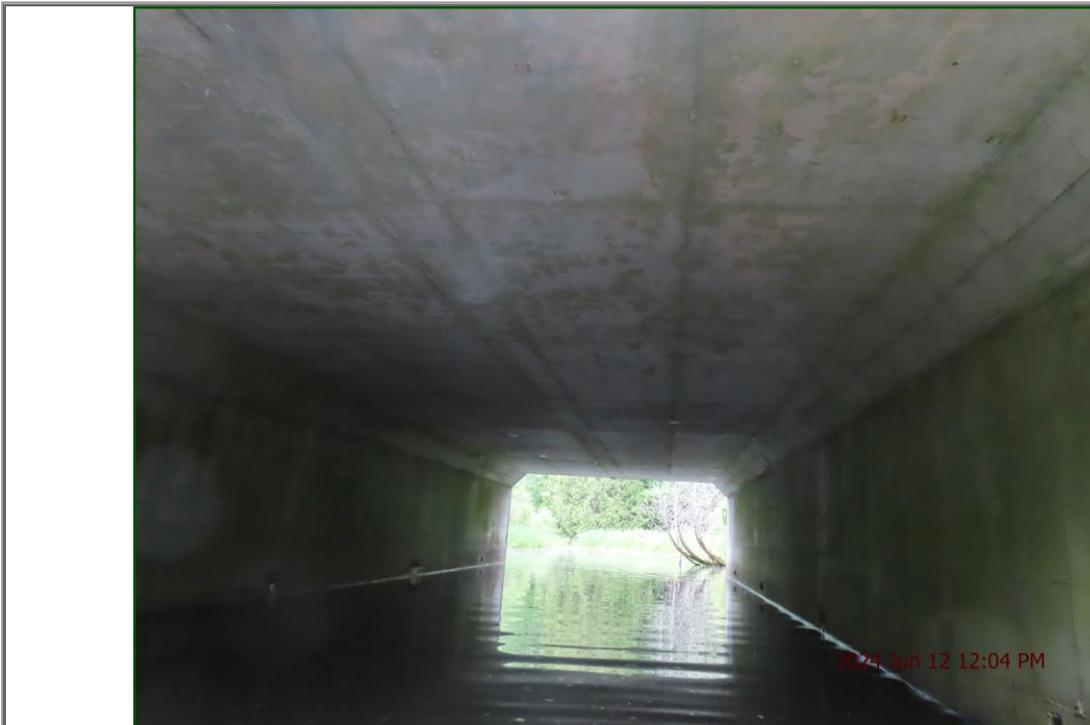
Light to medium vertical cracks with leachate staining.

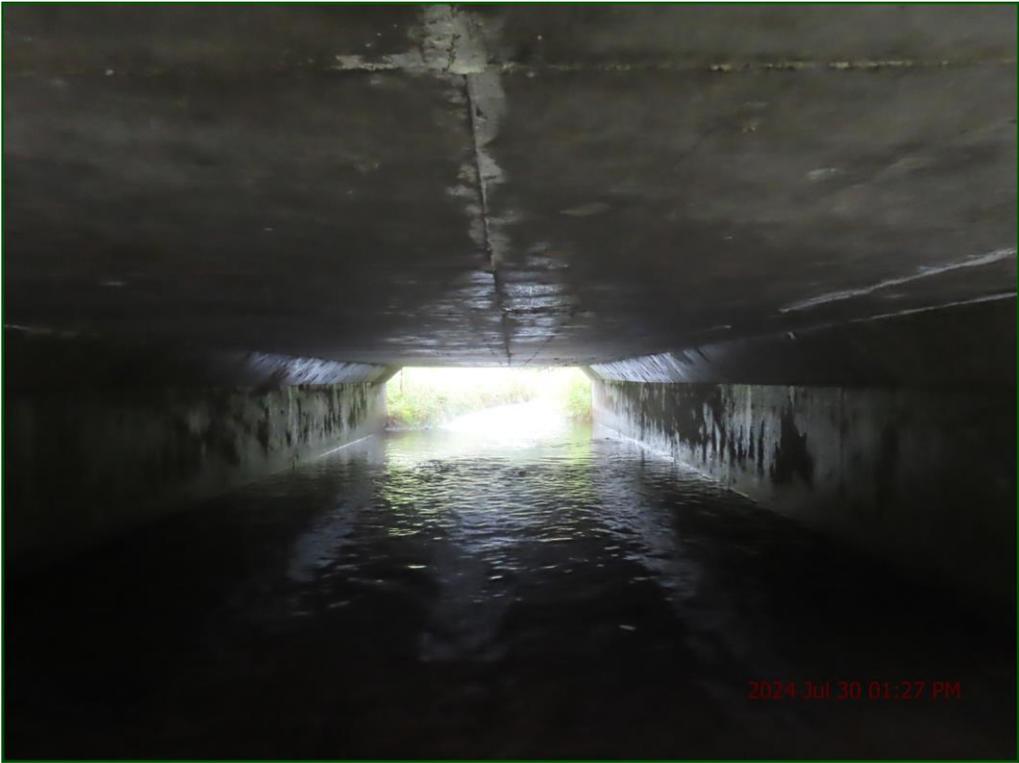
Description: Barrel: View from south.

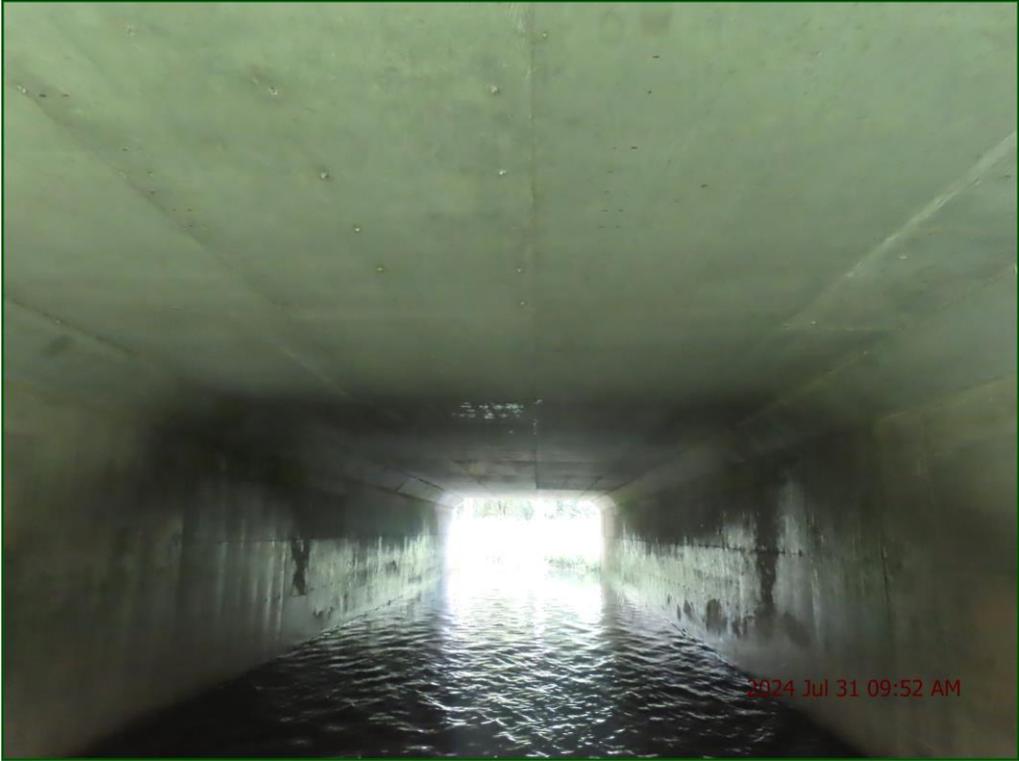
Description: Barrel: View from north.

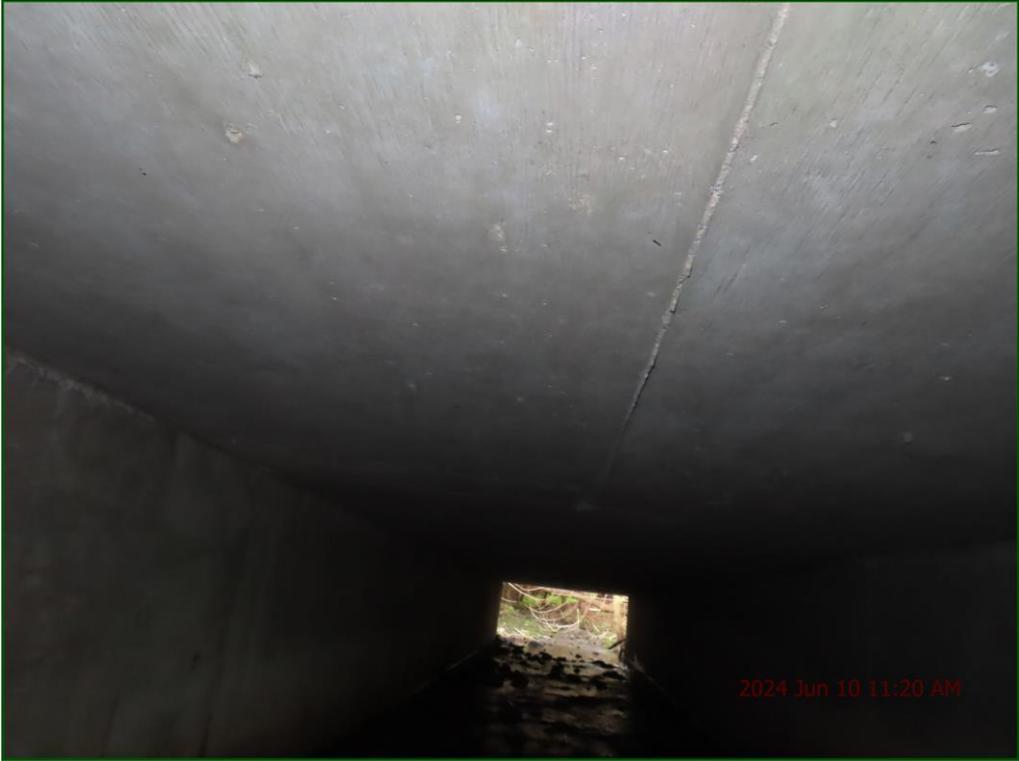
Description: Barrel: View from north.

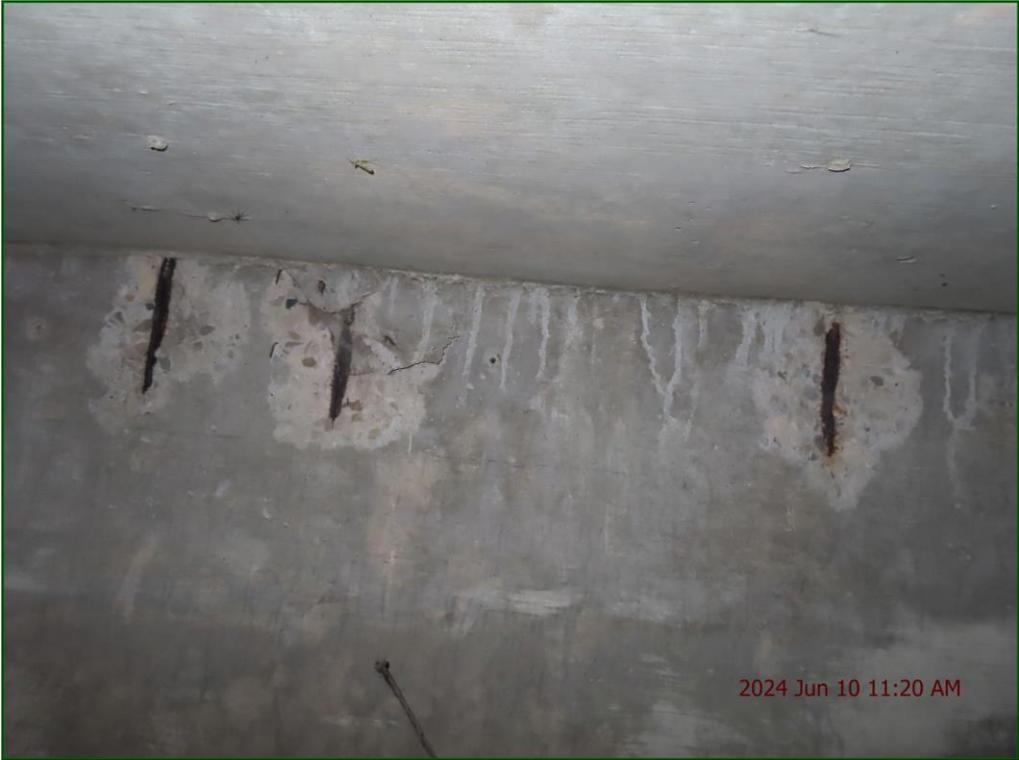
Description: Barrel: Shallow spalling with exposed reinforcing.

Shallow spalling with exposed reinforcing.

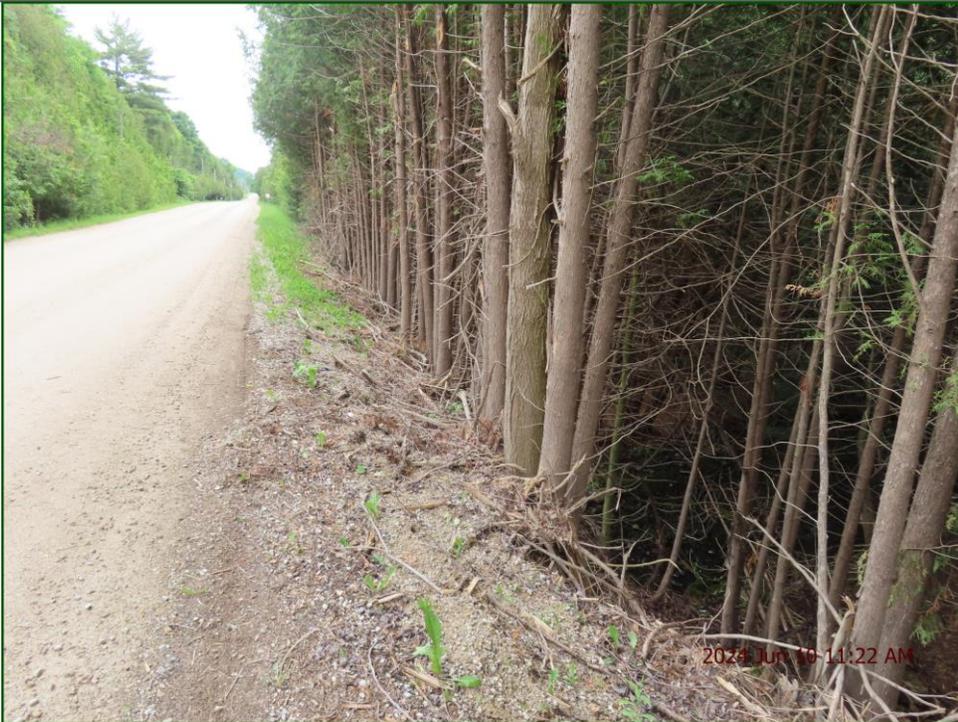
Steep embankments.
